CONDITION ASSESSMENT OF **THE ACADEMY OF MEDICINE** FOR THE GEORGIA INSTITUTE OF TECHNOLOGY

01.07.2009

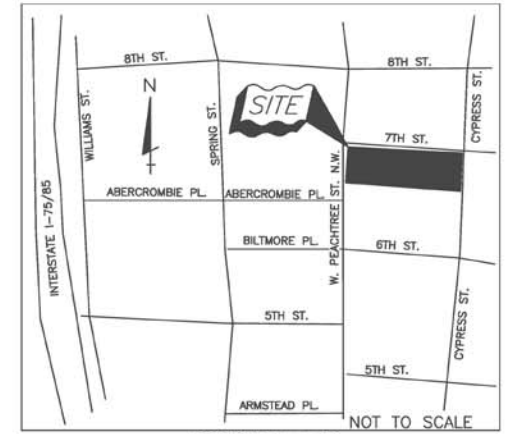
(R-1) LOCATION MAP
NOT TO SCALE

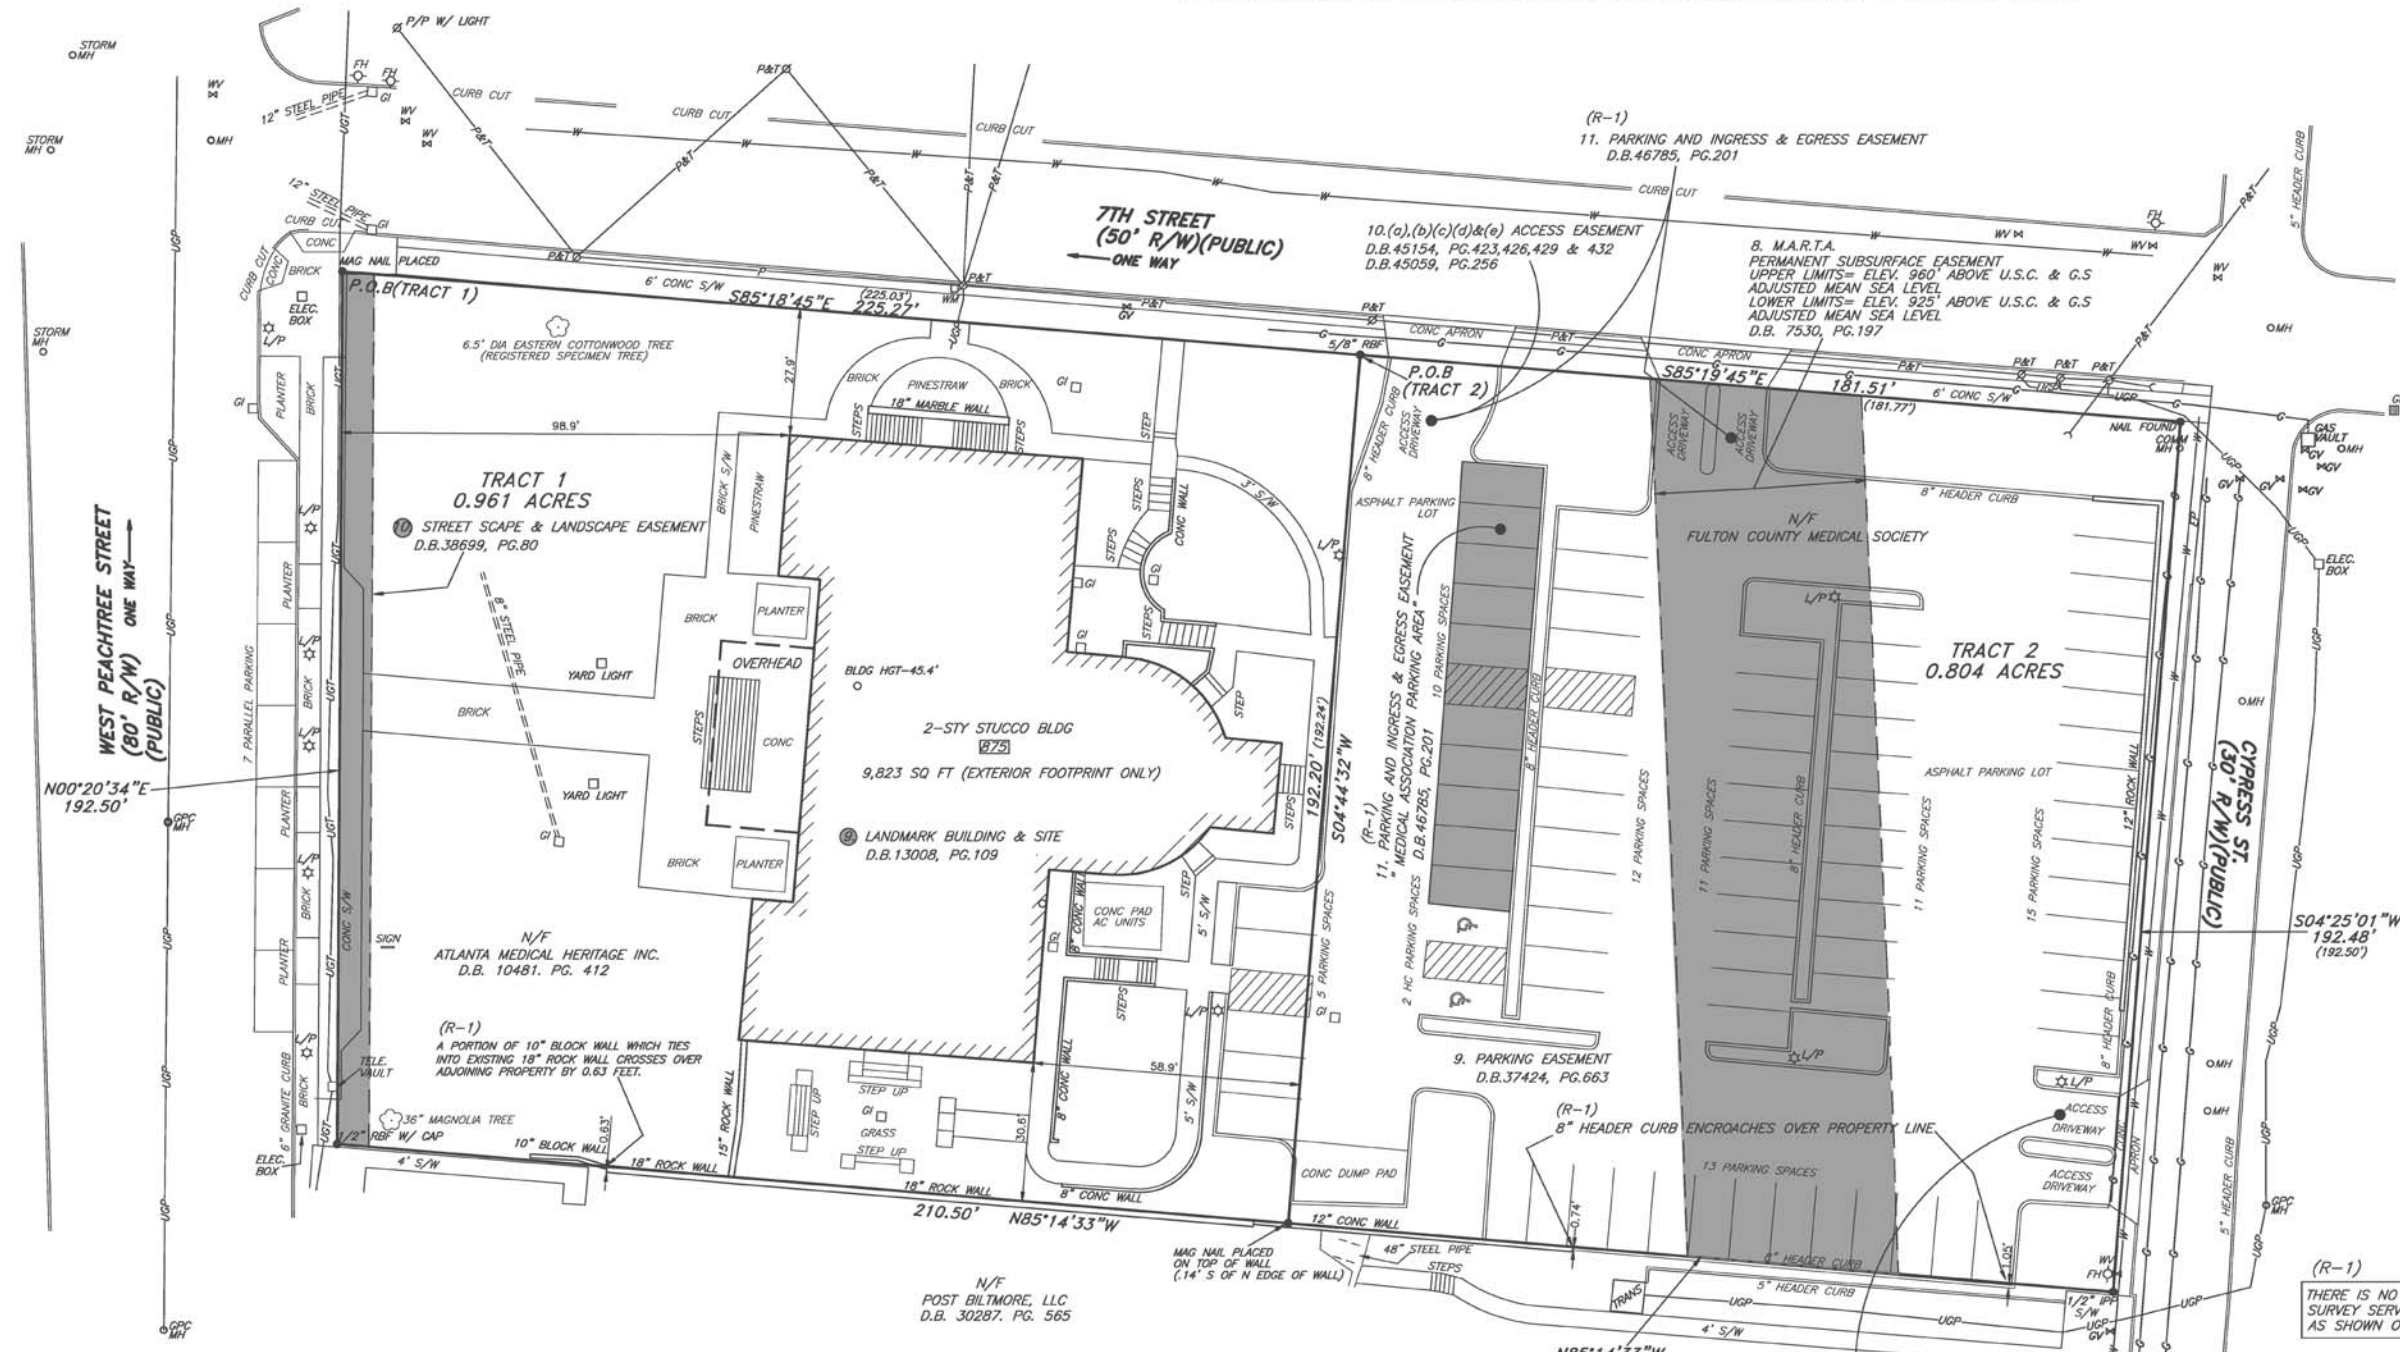
TRACT 1: 0.961 ACRES (41,848 SQ FT)
TRACT 2: 0.804 ACRES (35,016 SQ FT)
TOTAL AREA: 1.765 ACRES (76,864 SQ FT)

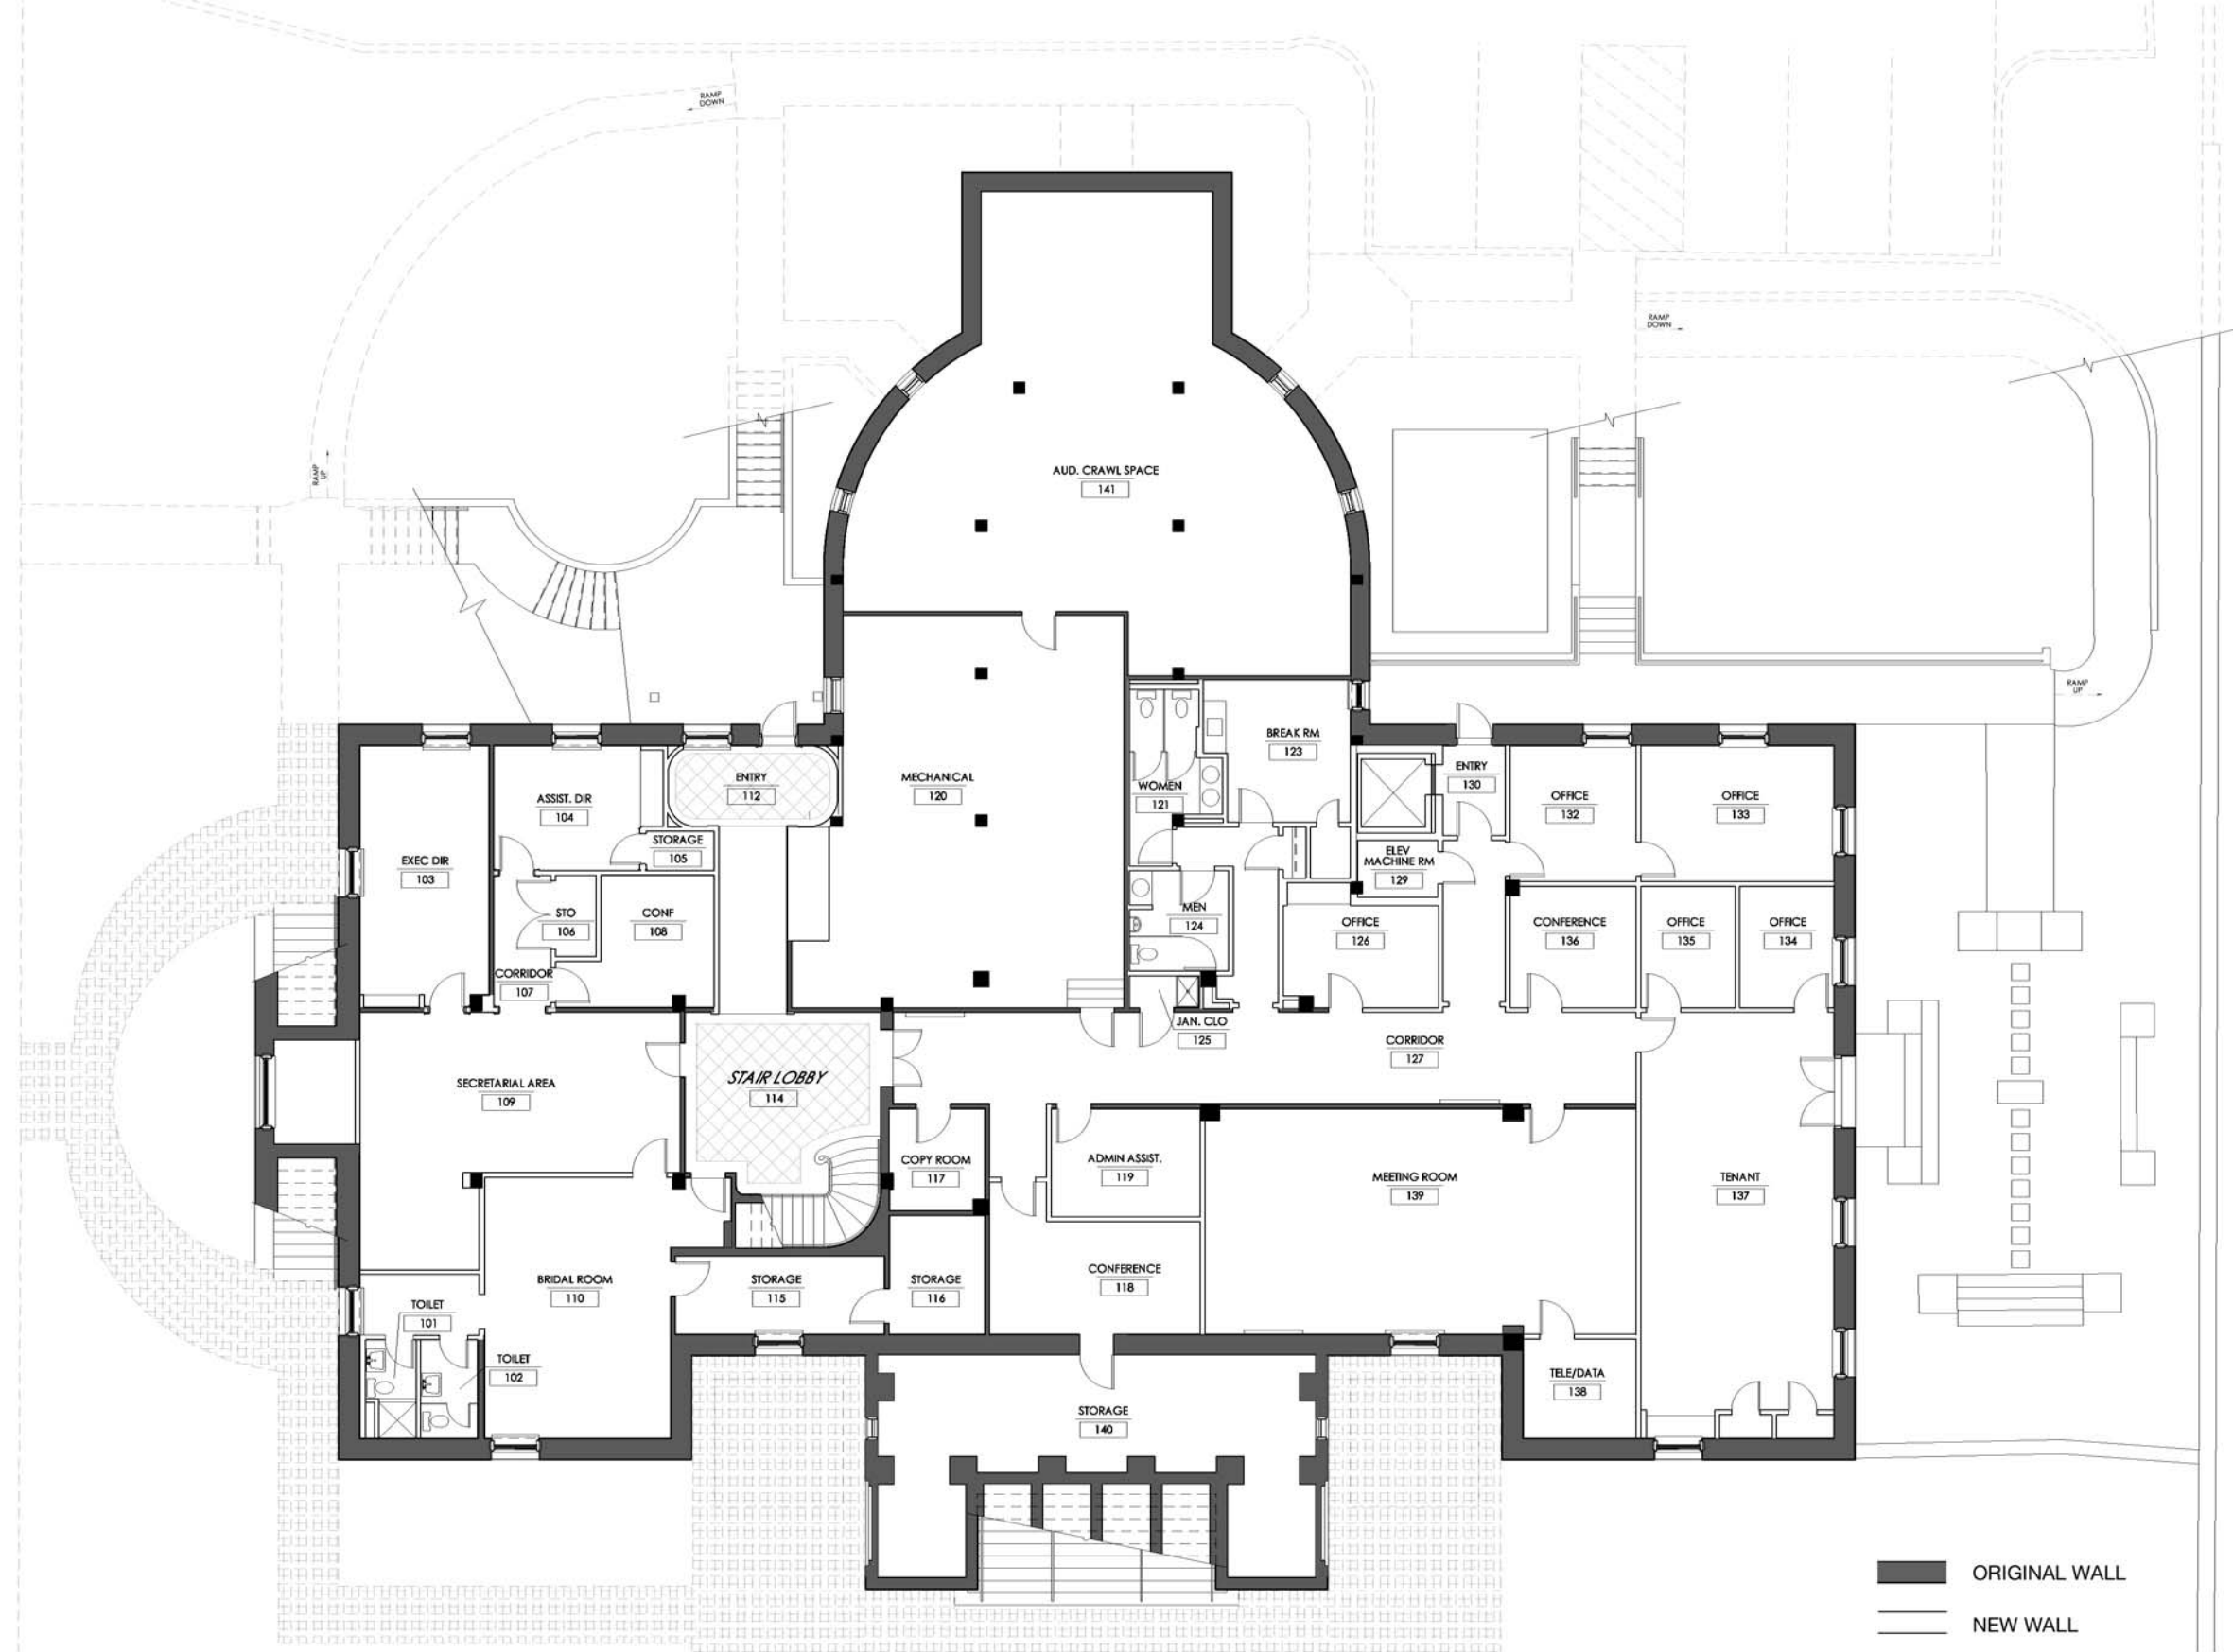
ACADEMY OF MEDICINE - CONDITION ASSESSMENT 875 WEST PEACHTREE STREET NE ATLANTA, GEORGIA 30309	TITLE SURVEY / SITE PLAN	
		DATE 11.21.08	SHEET NUMBER 2

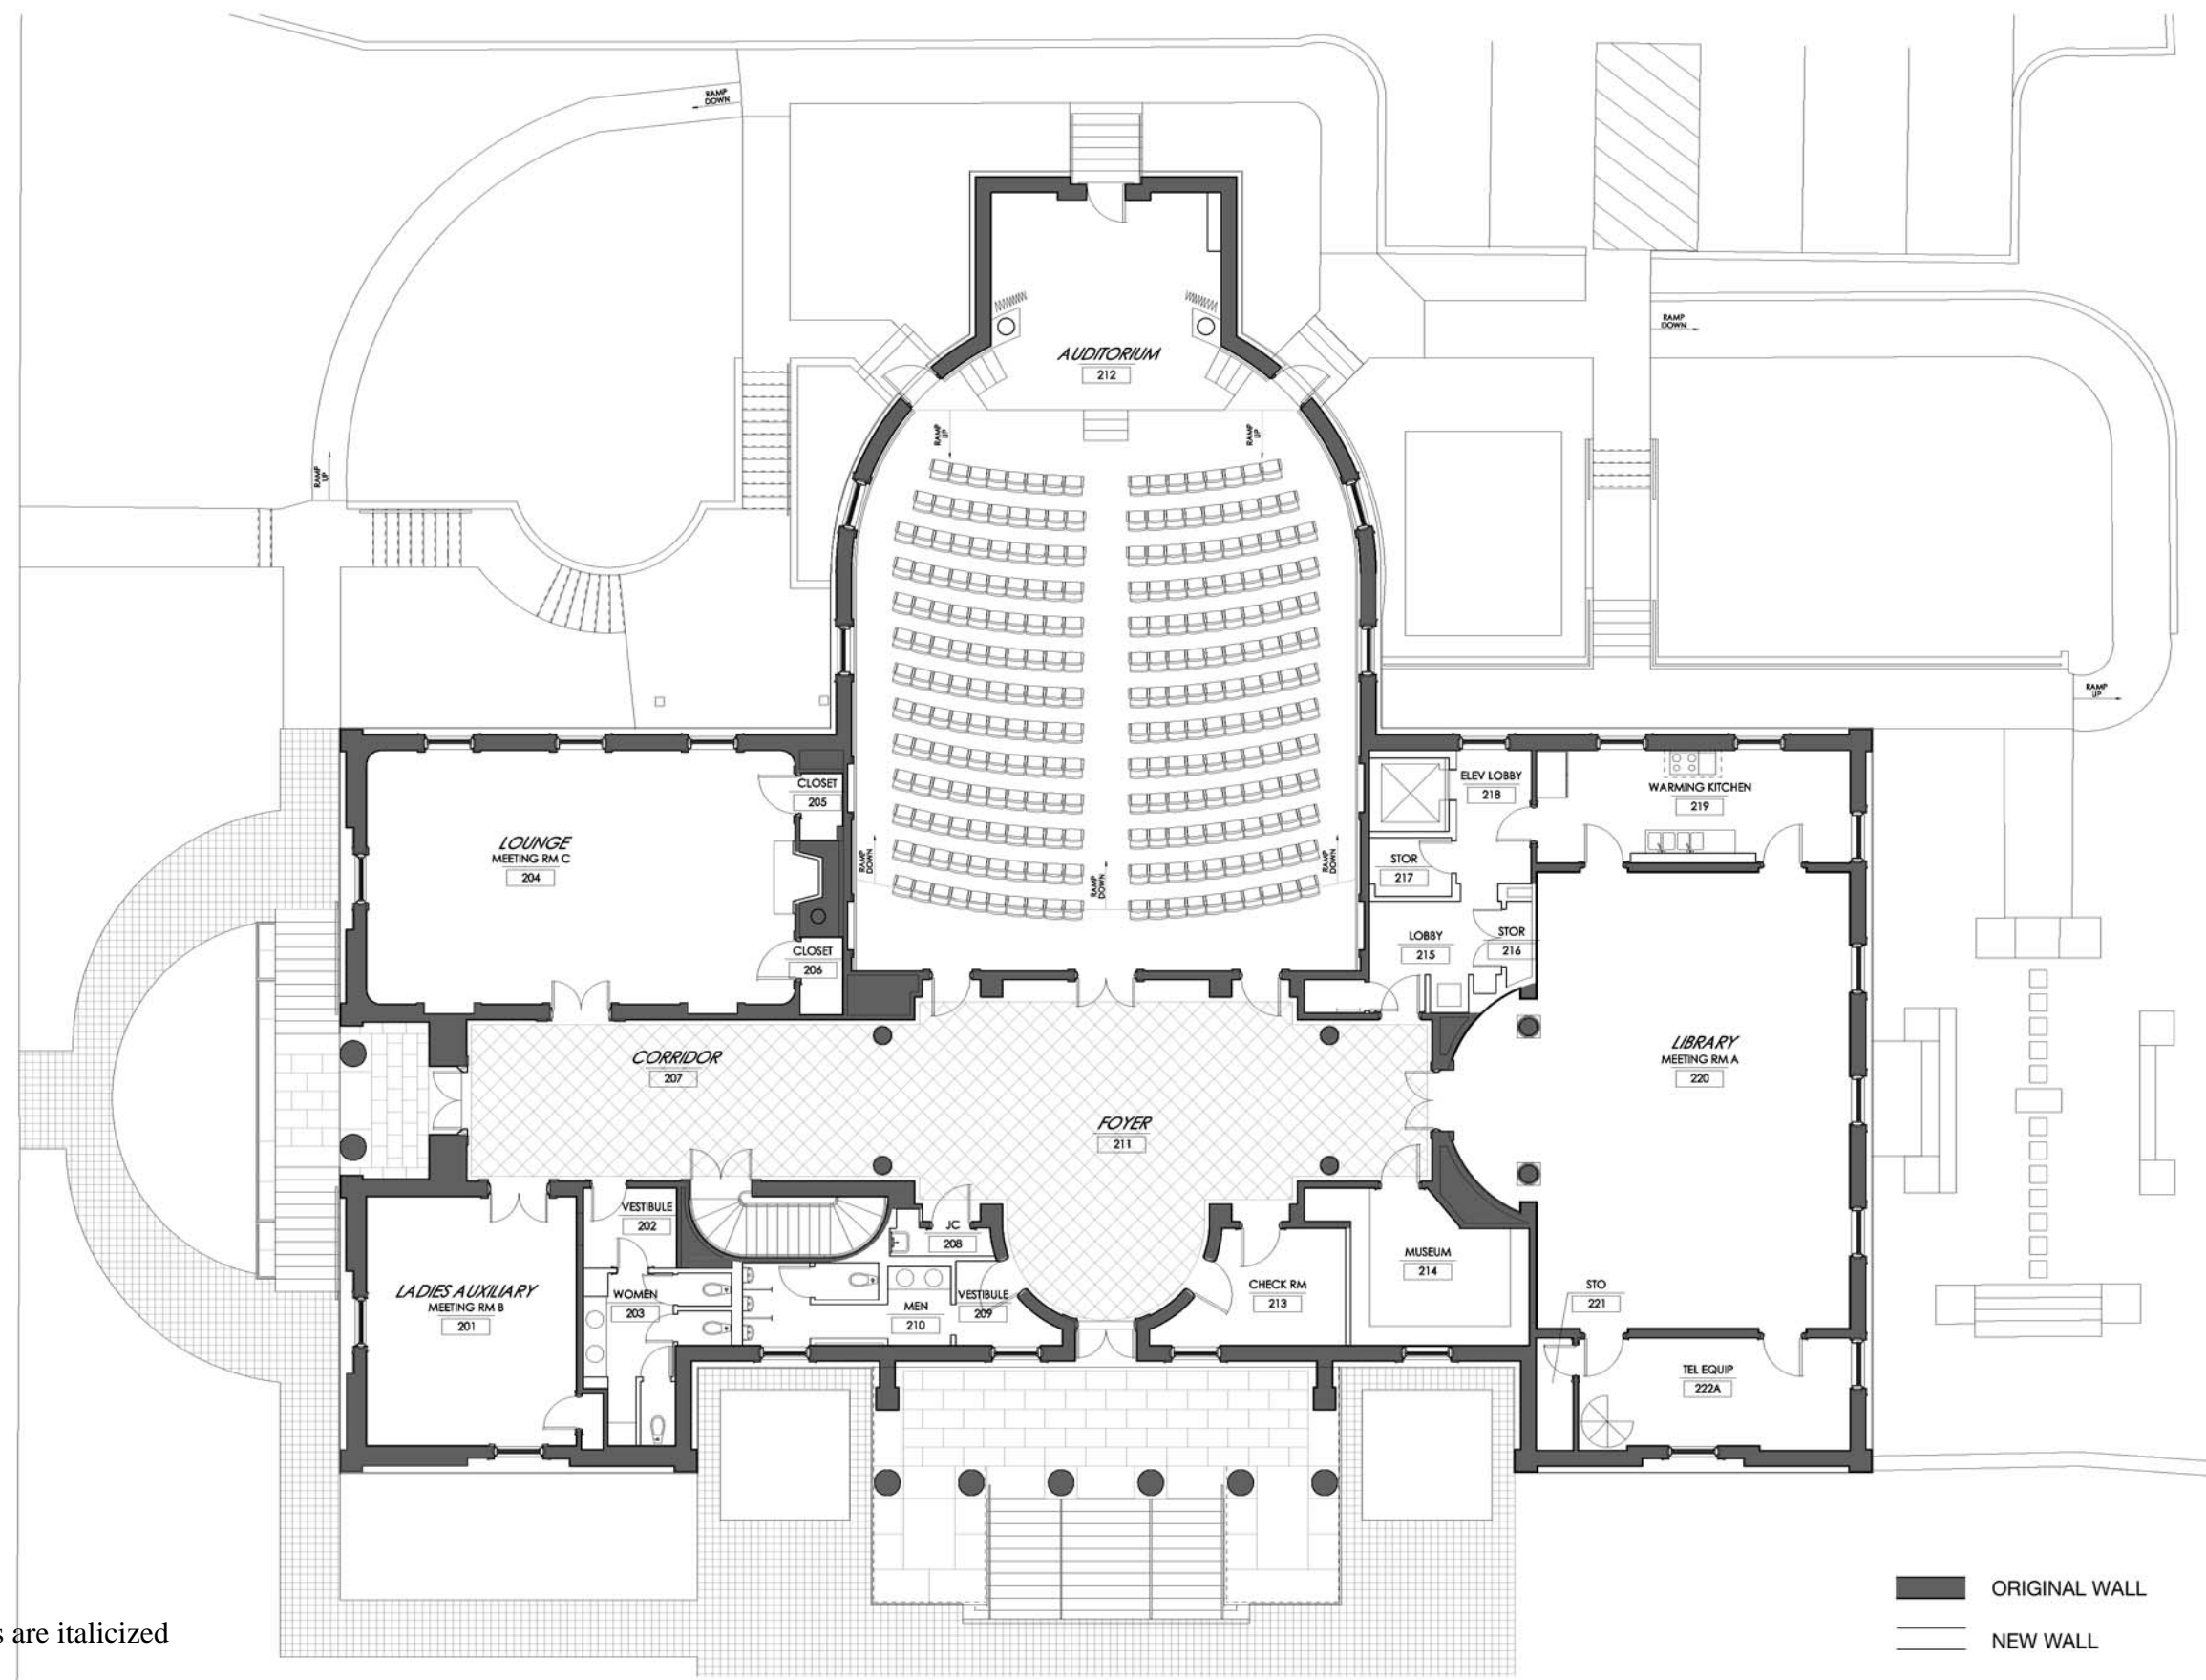
*Historic room names are italicized

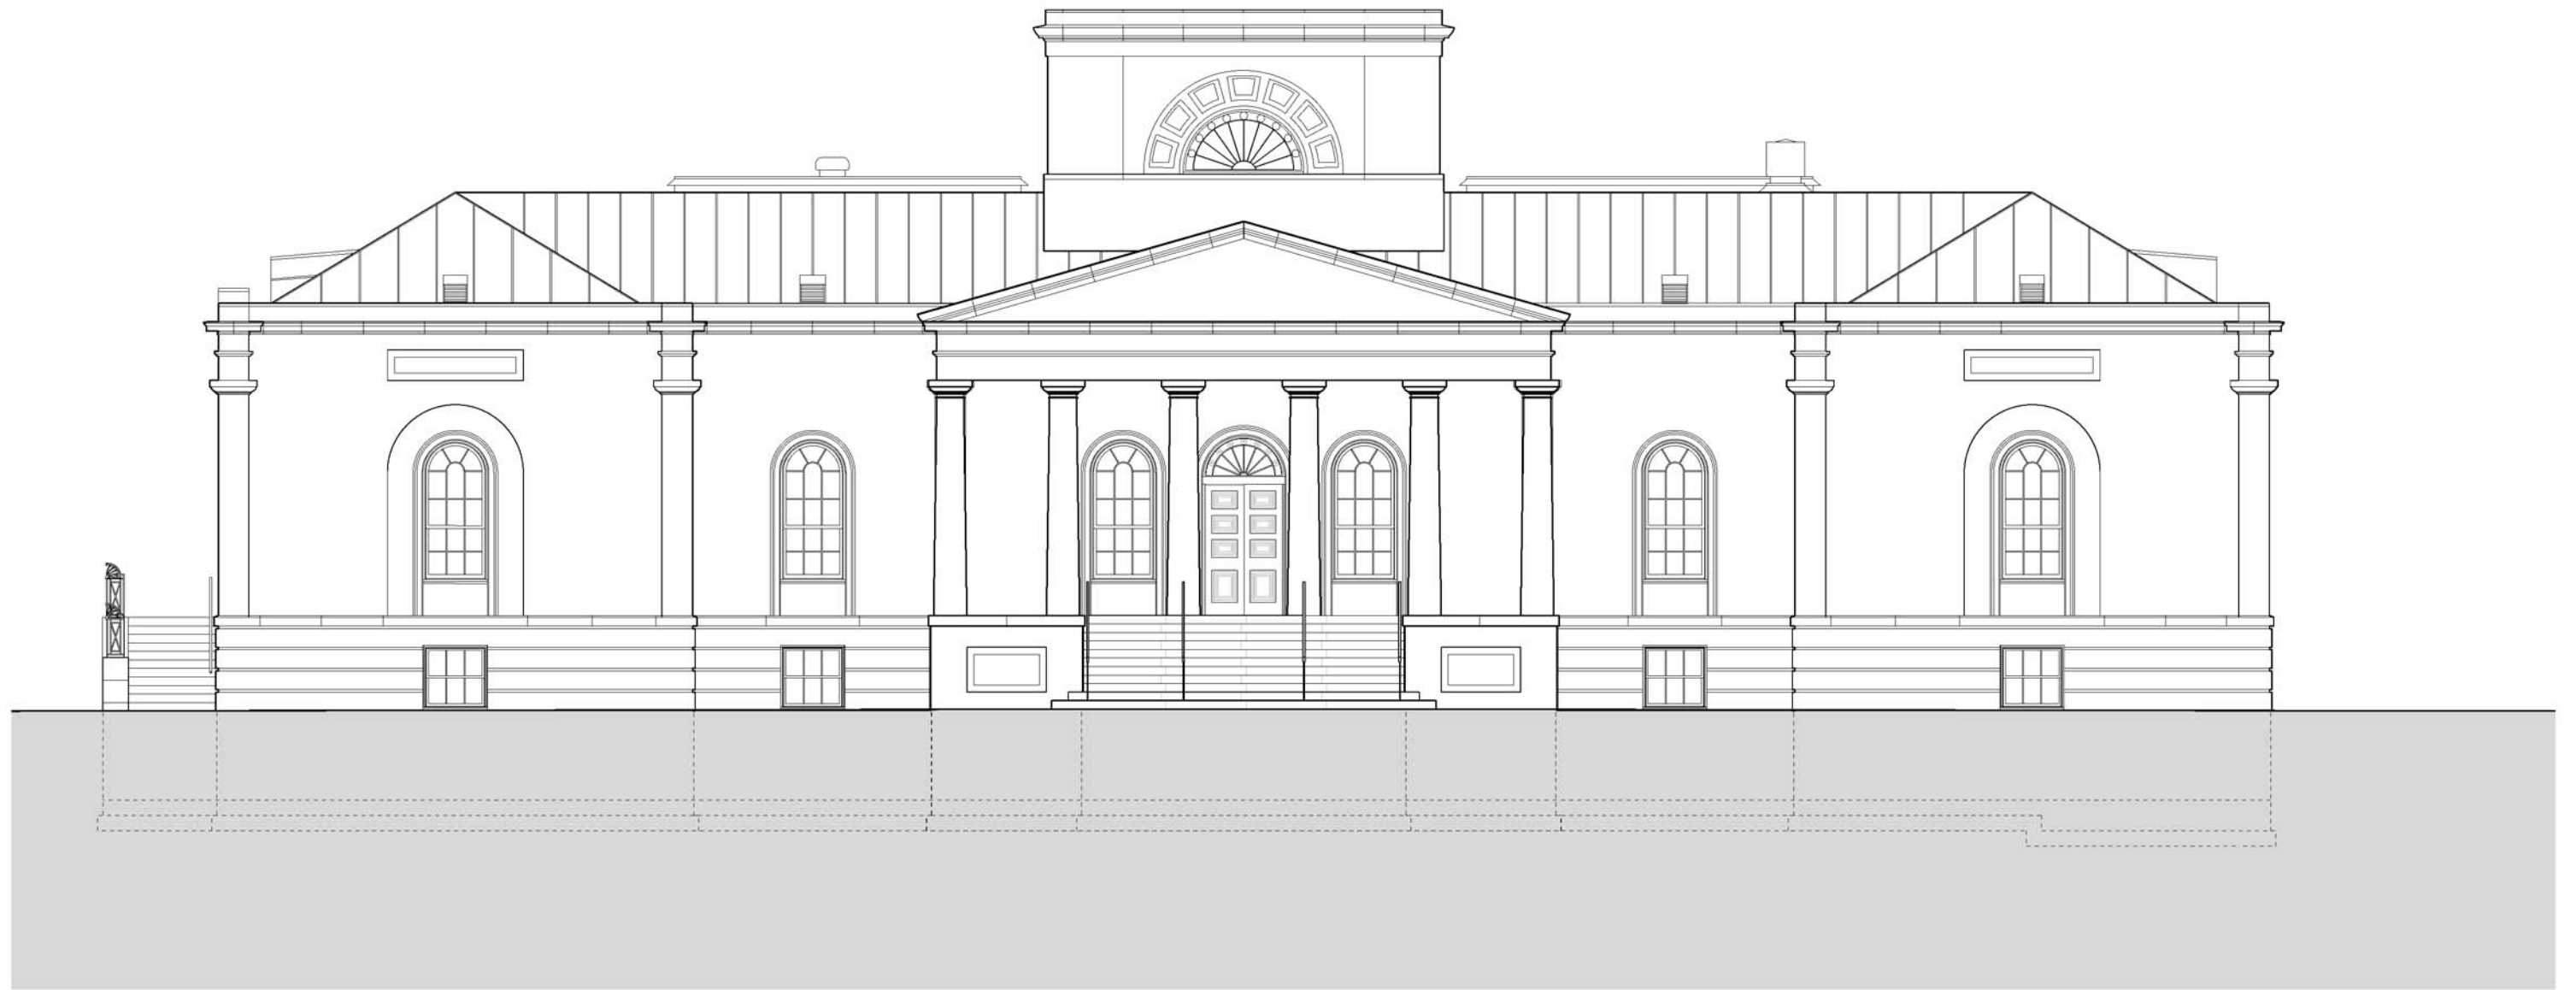
ACADEMY OF MEDICINE - CONDITION ASSESSMENT 875 WEST PEACHTREE STREET NE ATLANTA, GEORGIA 30309	TITLE	
		EXISTING ROOF PLAN	SHEET NUMBER
		DATE	5
		11.21.08

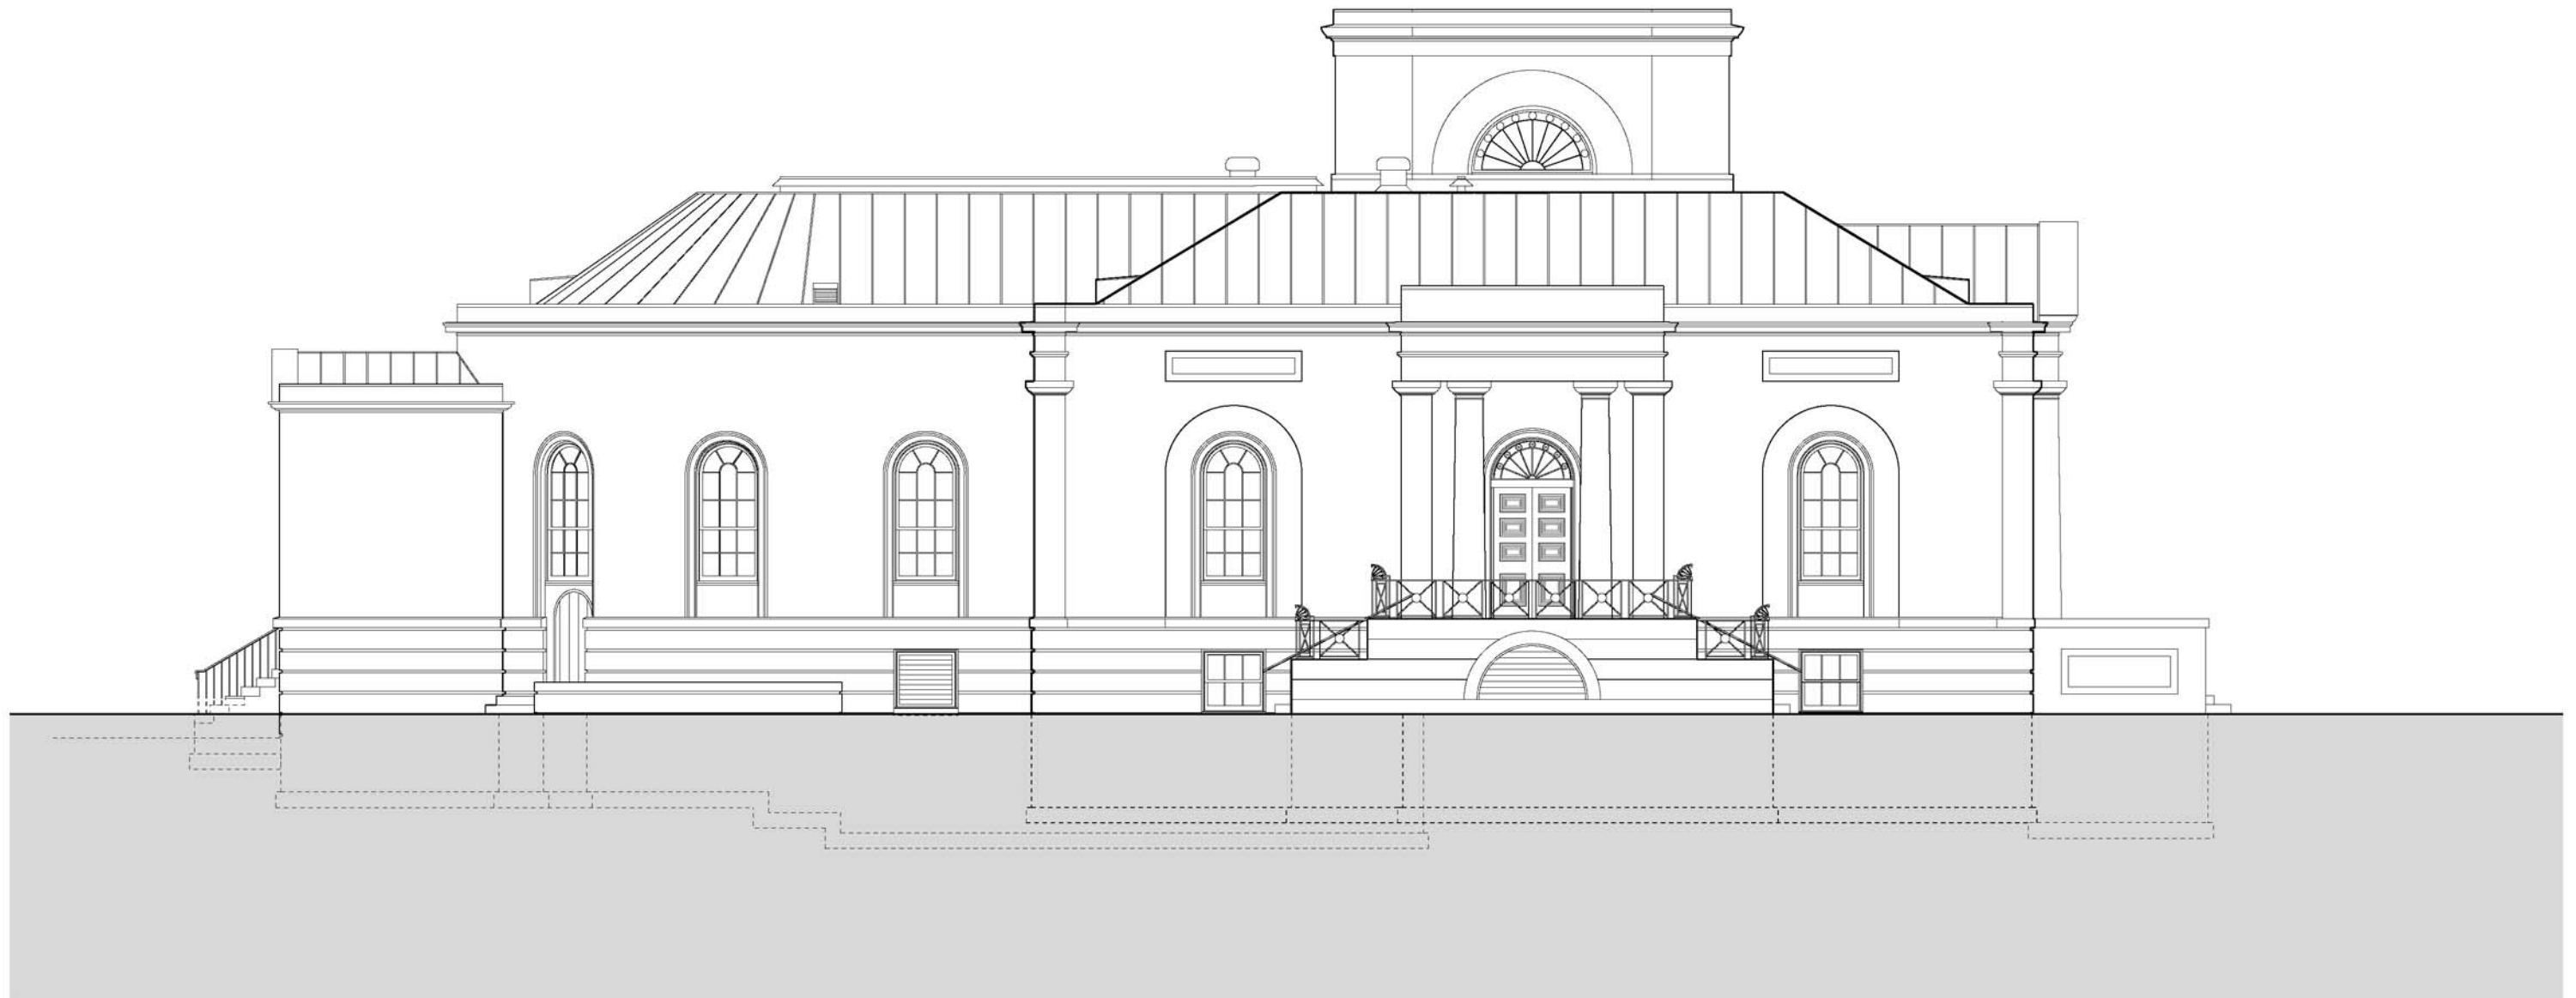
ACADEMY OF MEDICINE - CONDITION ASSESSMENT 875 WEST PEACHTREE STREET NE ATLANTA, GEORGIA 30309	TITLE	
		EXISTING WEST ELEVATION	
		DATE	SHEET NUMBER
		11.21.08	6

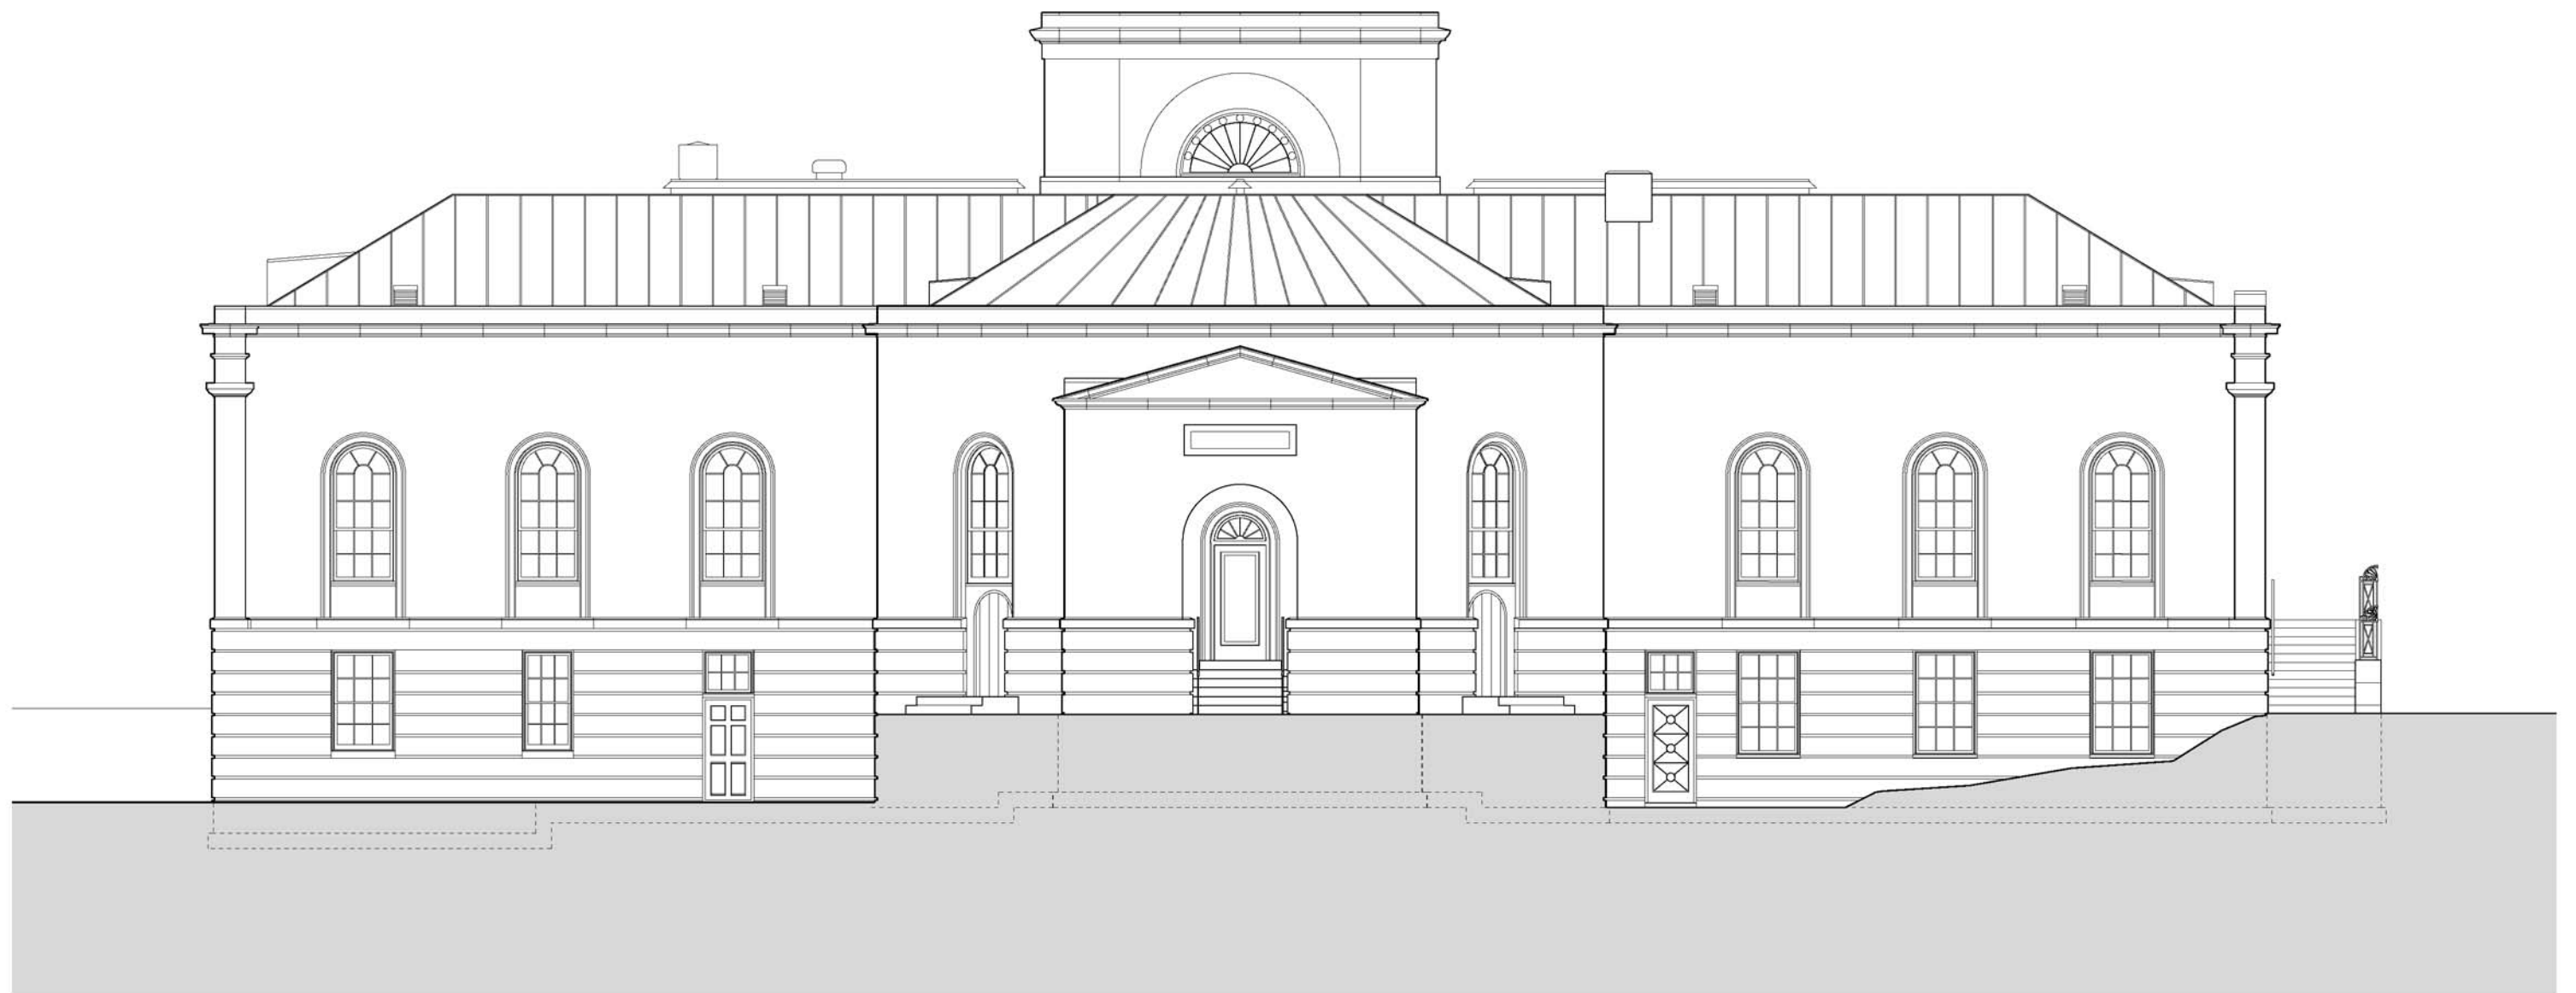
ACADEMY OF MEDICINE - CONDITION ASSESSMENT 875 WEST PEACHTREE STREET NE ATLANTA, GEORGIA 30309	TITLE EXISTING NORTH ELEVATION	
		DATE 11.21.08	SHEET NUMBER 7

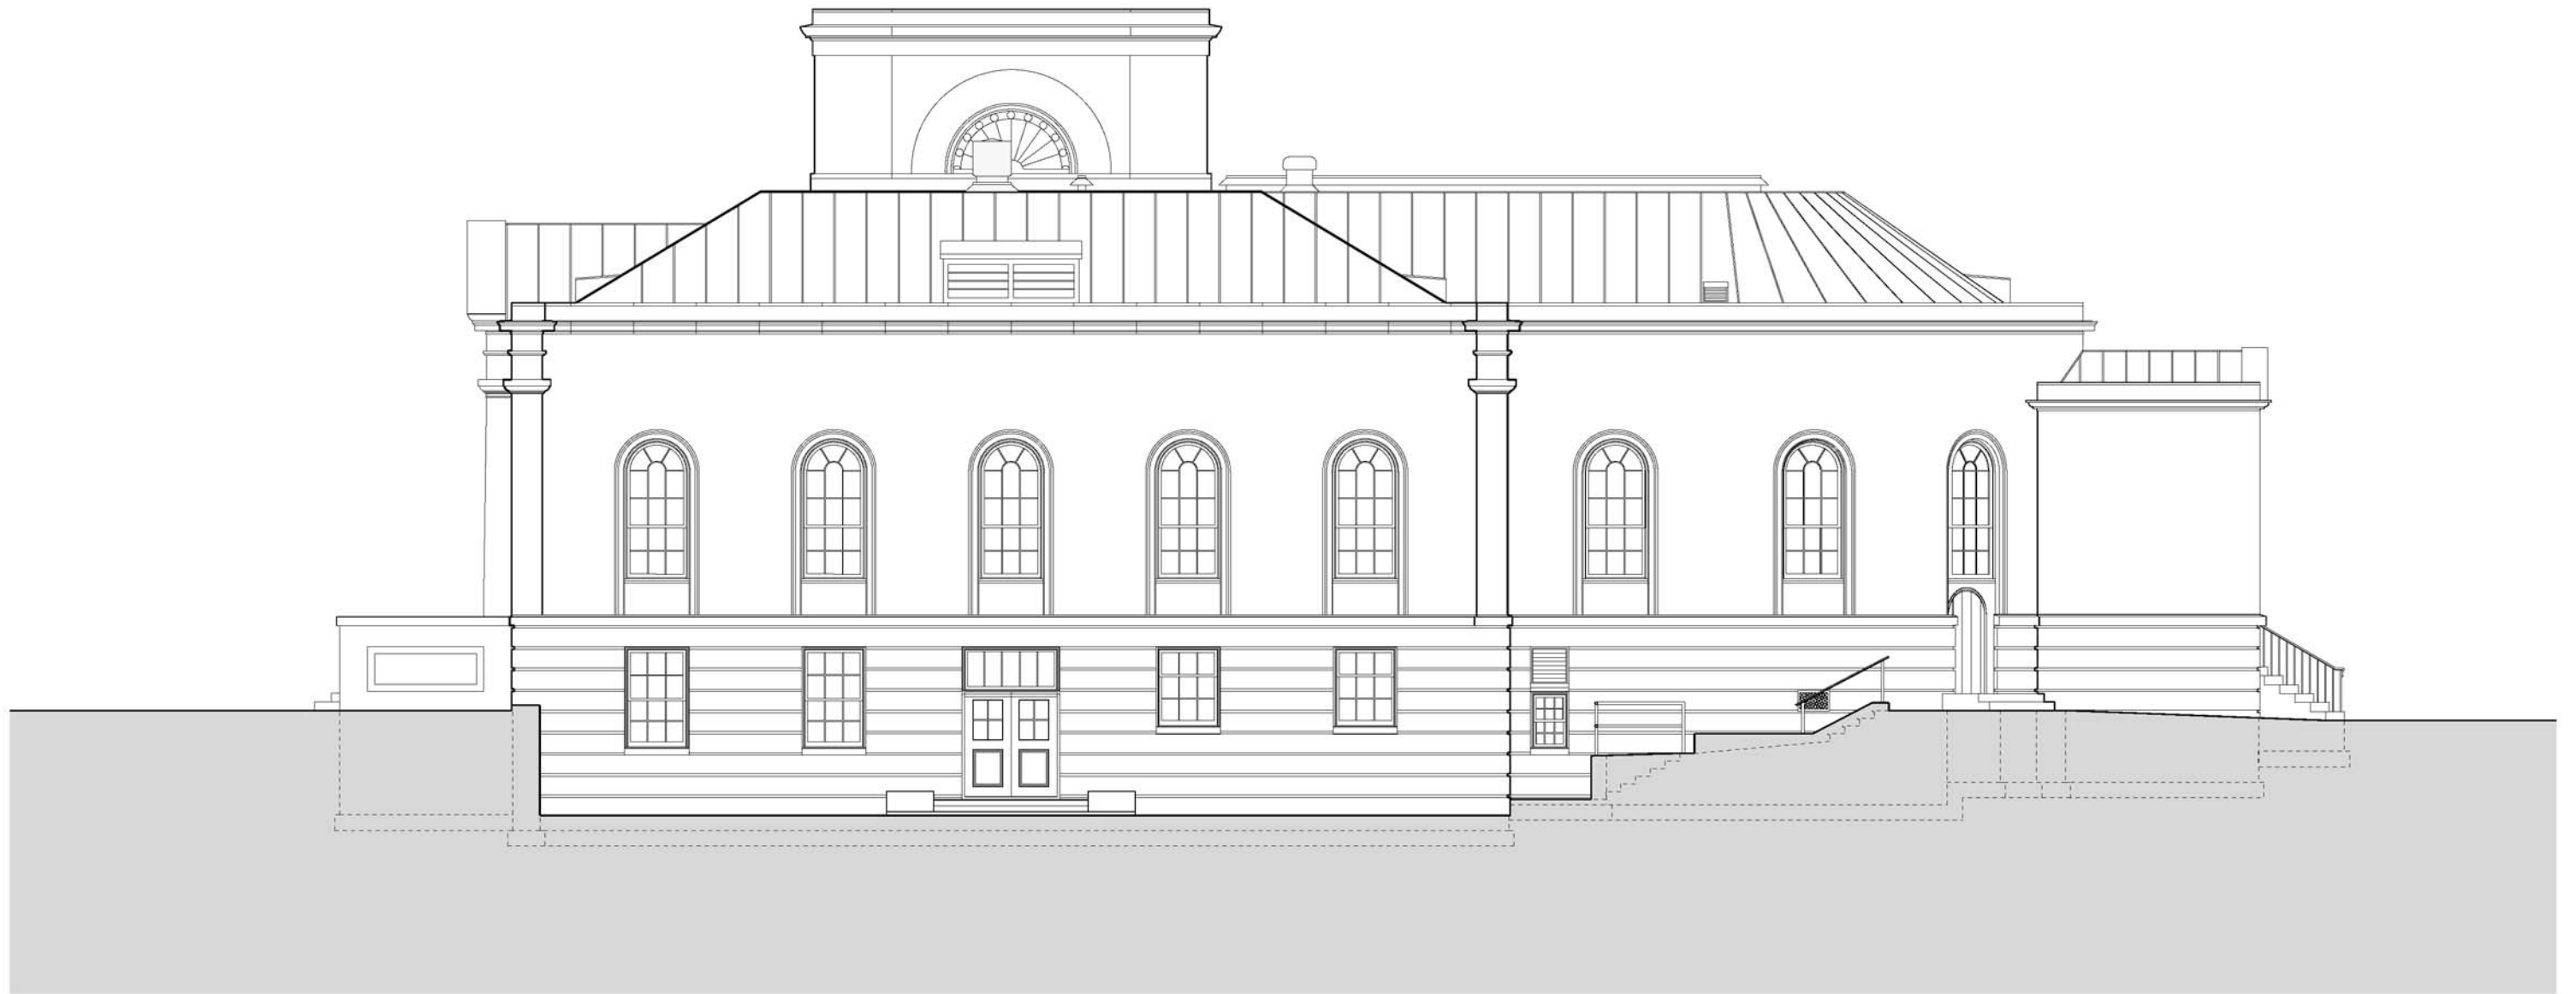
ACADEMY OF MEDICINE - CONDITION ASSESSMENT 875 WEST PEACHTREE STREET NE ATLANTA, GEORGIA 30309	TITLE	
		EXISTING EAST ELEVATION	
		DATE	SHEET NUMBER
		11.21.08	8
