CONDITION ASSESSMENT OF **THE ACADEMY OF MEDICINE** FOR THE GEORGIA INSTITUTE OF TECHNOLOGY

01.07.2009

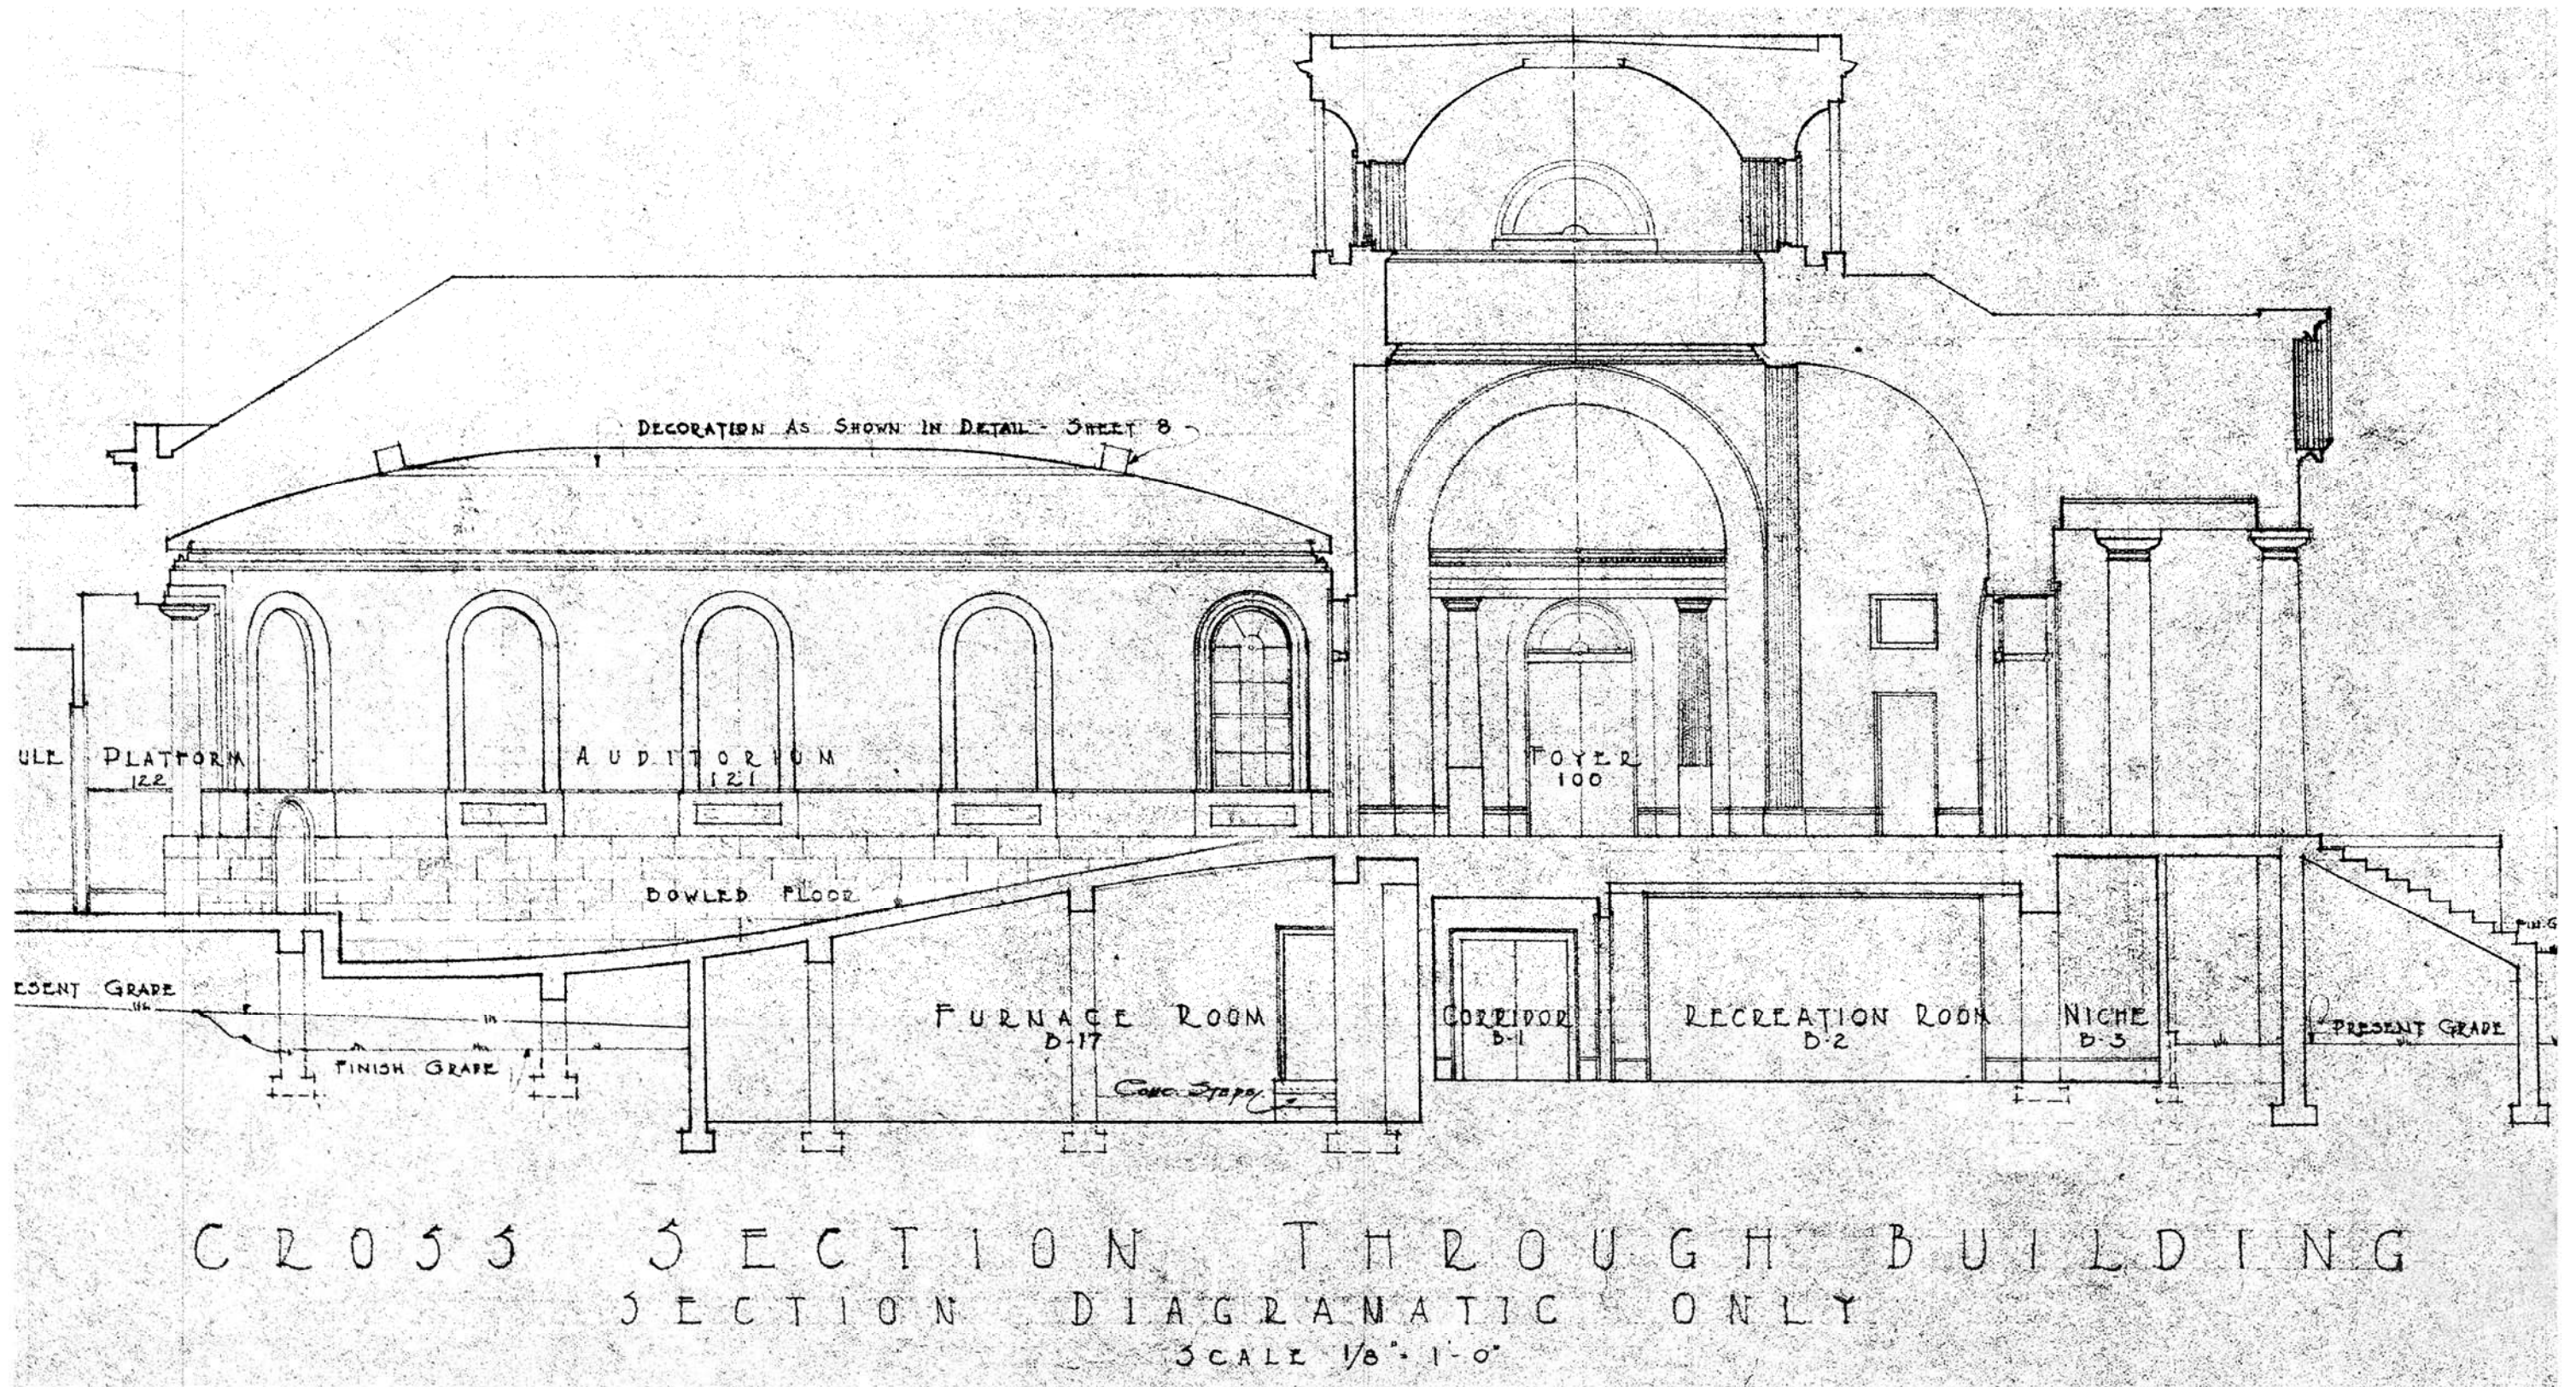
R Kennon Perry, Architect
 Hentz-Adler & Shutze, Consulting Architects
 21 May 1941

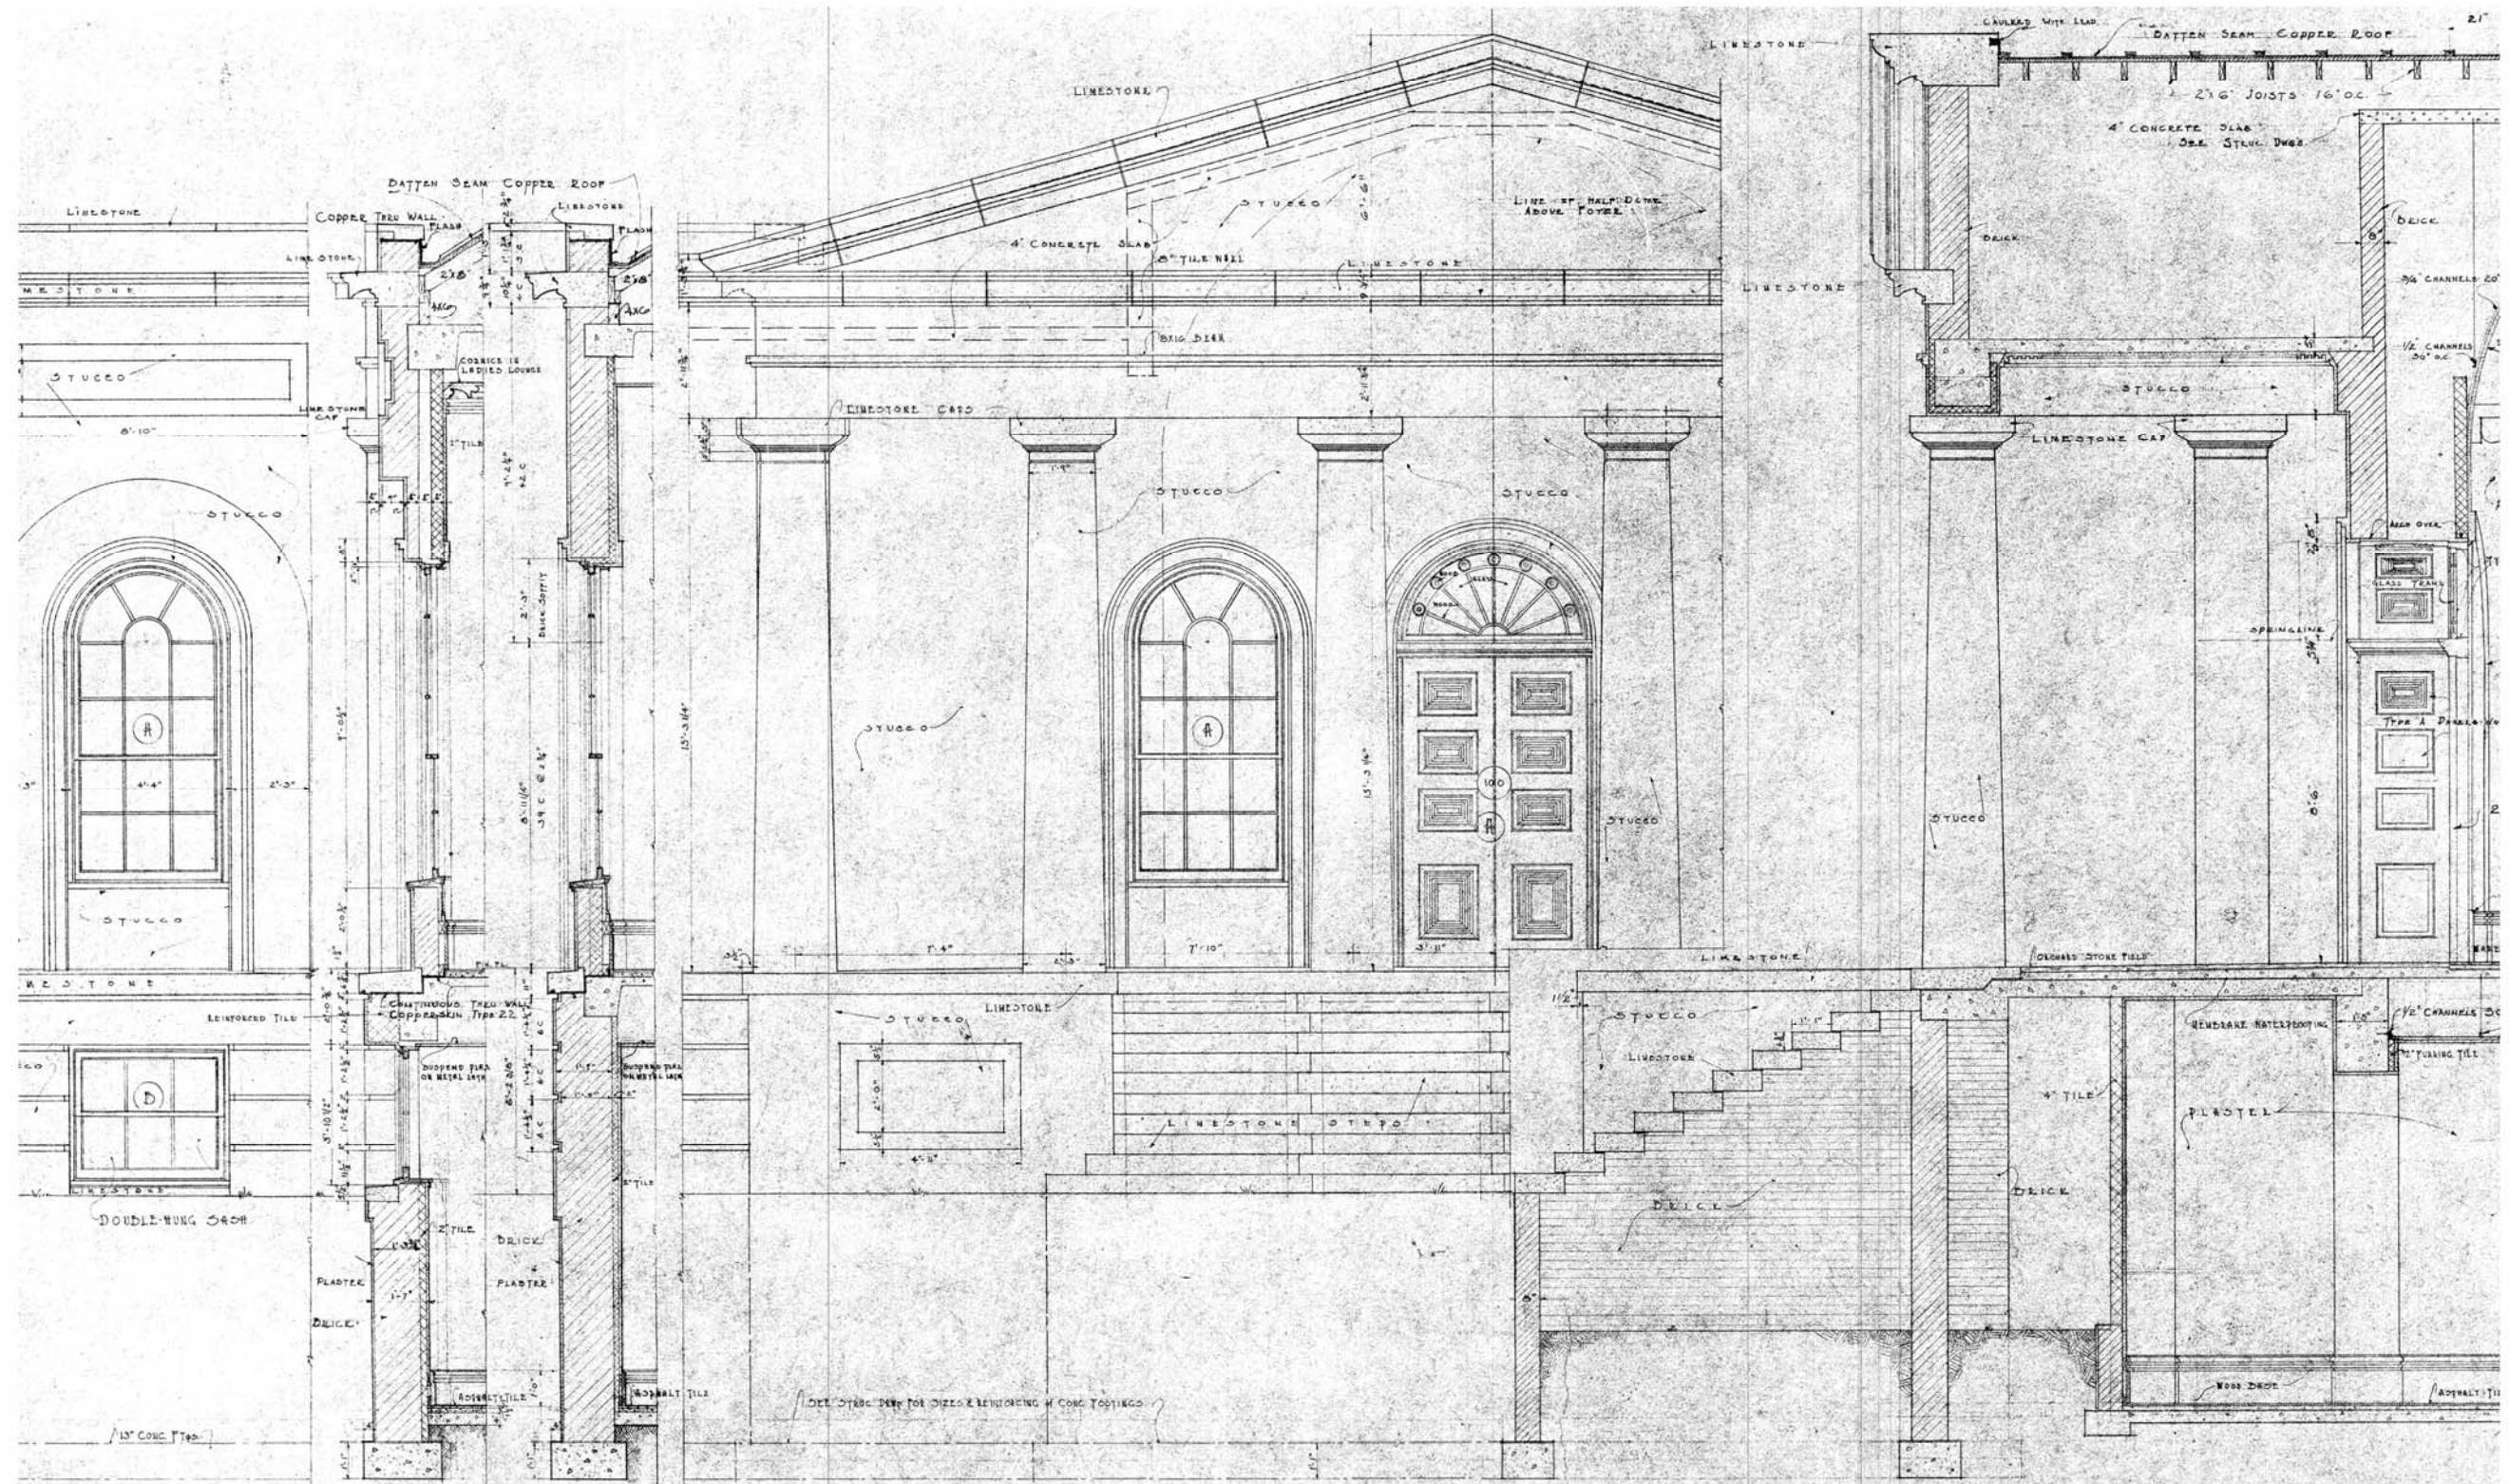
ACADEMY OF MEDICINE - CONDITION ASSESSMENT 875 WEST PEACHTREE STREET NE ATLANTA, GEORGIA 30309		TITLE HISTORIC BUILDING SECTION	
			DATE 11.21.08	SHEET NUMBER 10

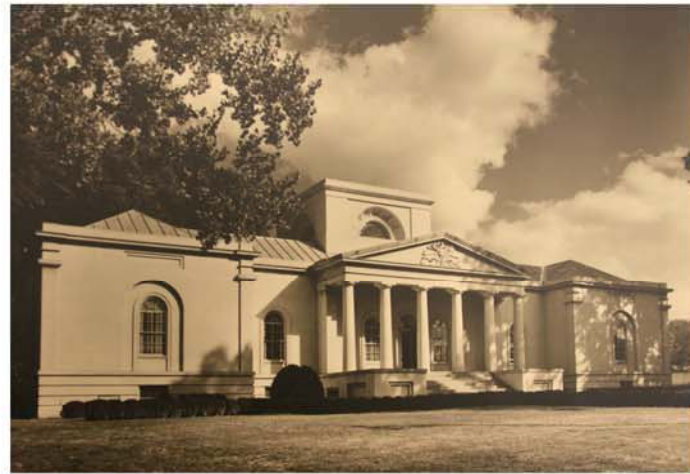
ACADEMY OF MEDICINE - CONDITION ASSESSMENT 875 WEST PEACHTREE STREET NE ATLANTA, GEORGIA 30309	TITLE HISTORIC CHARACTER- PHOTO KEYNOTES	
		DATE 11.21.08	SHEET NUMBER 16

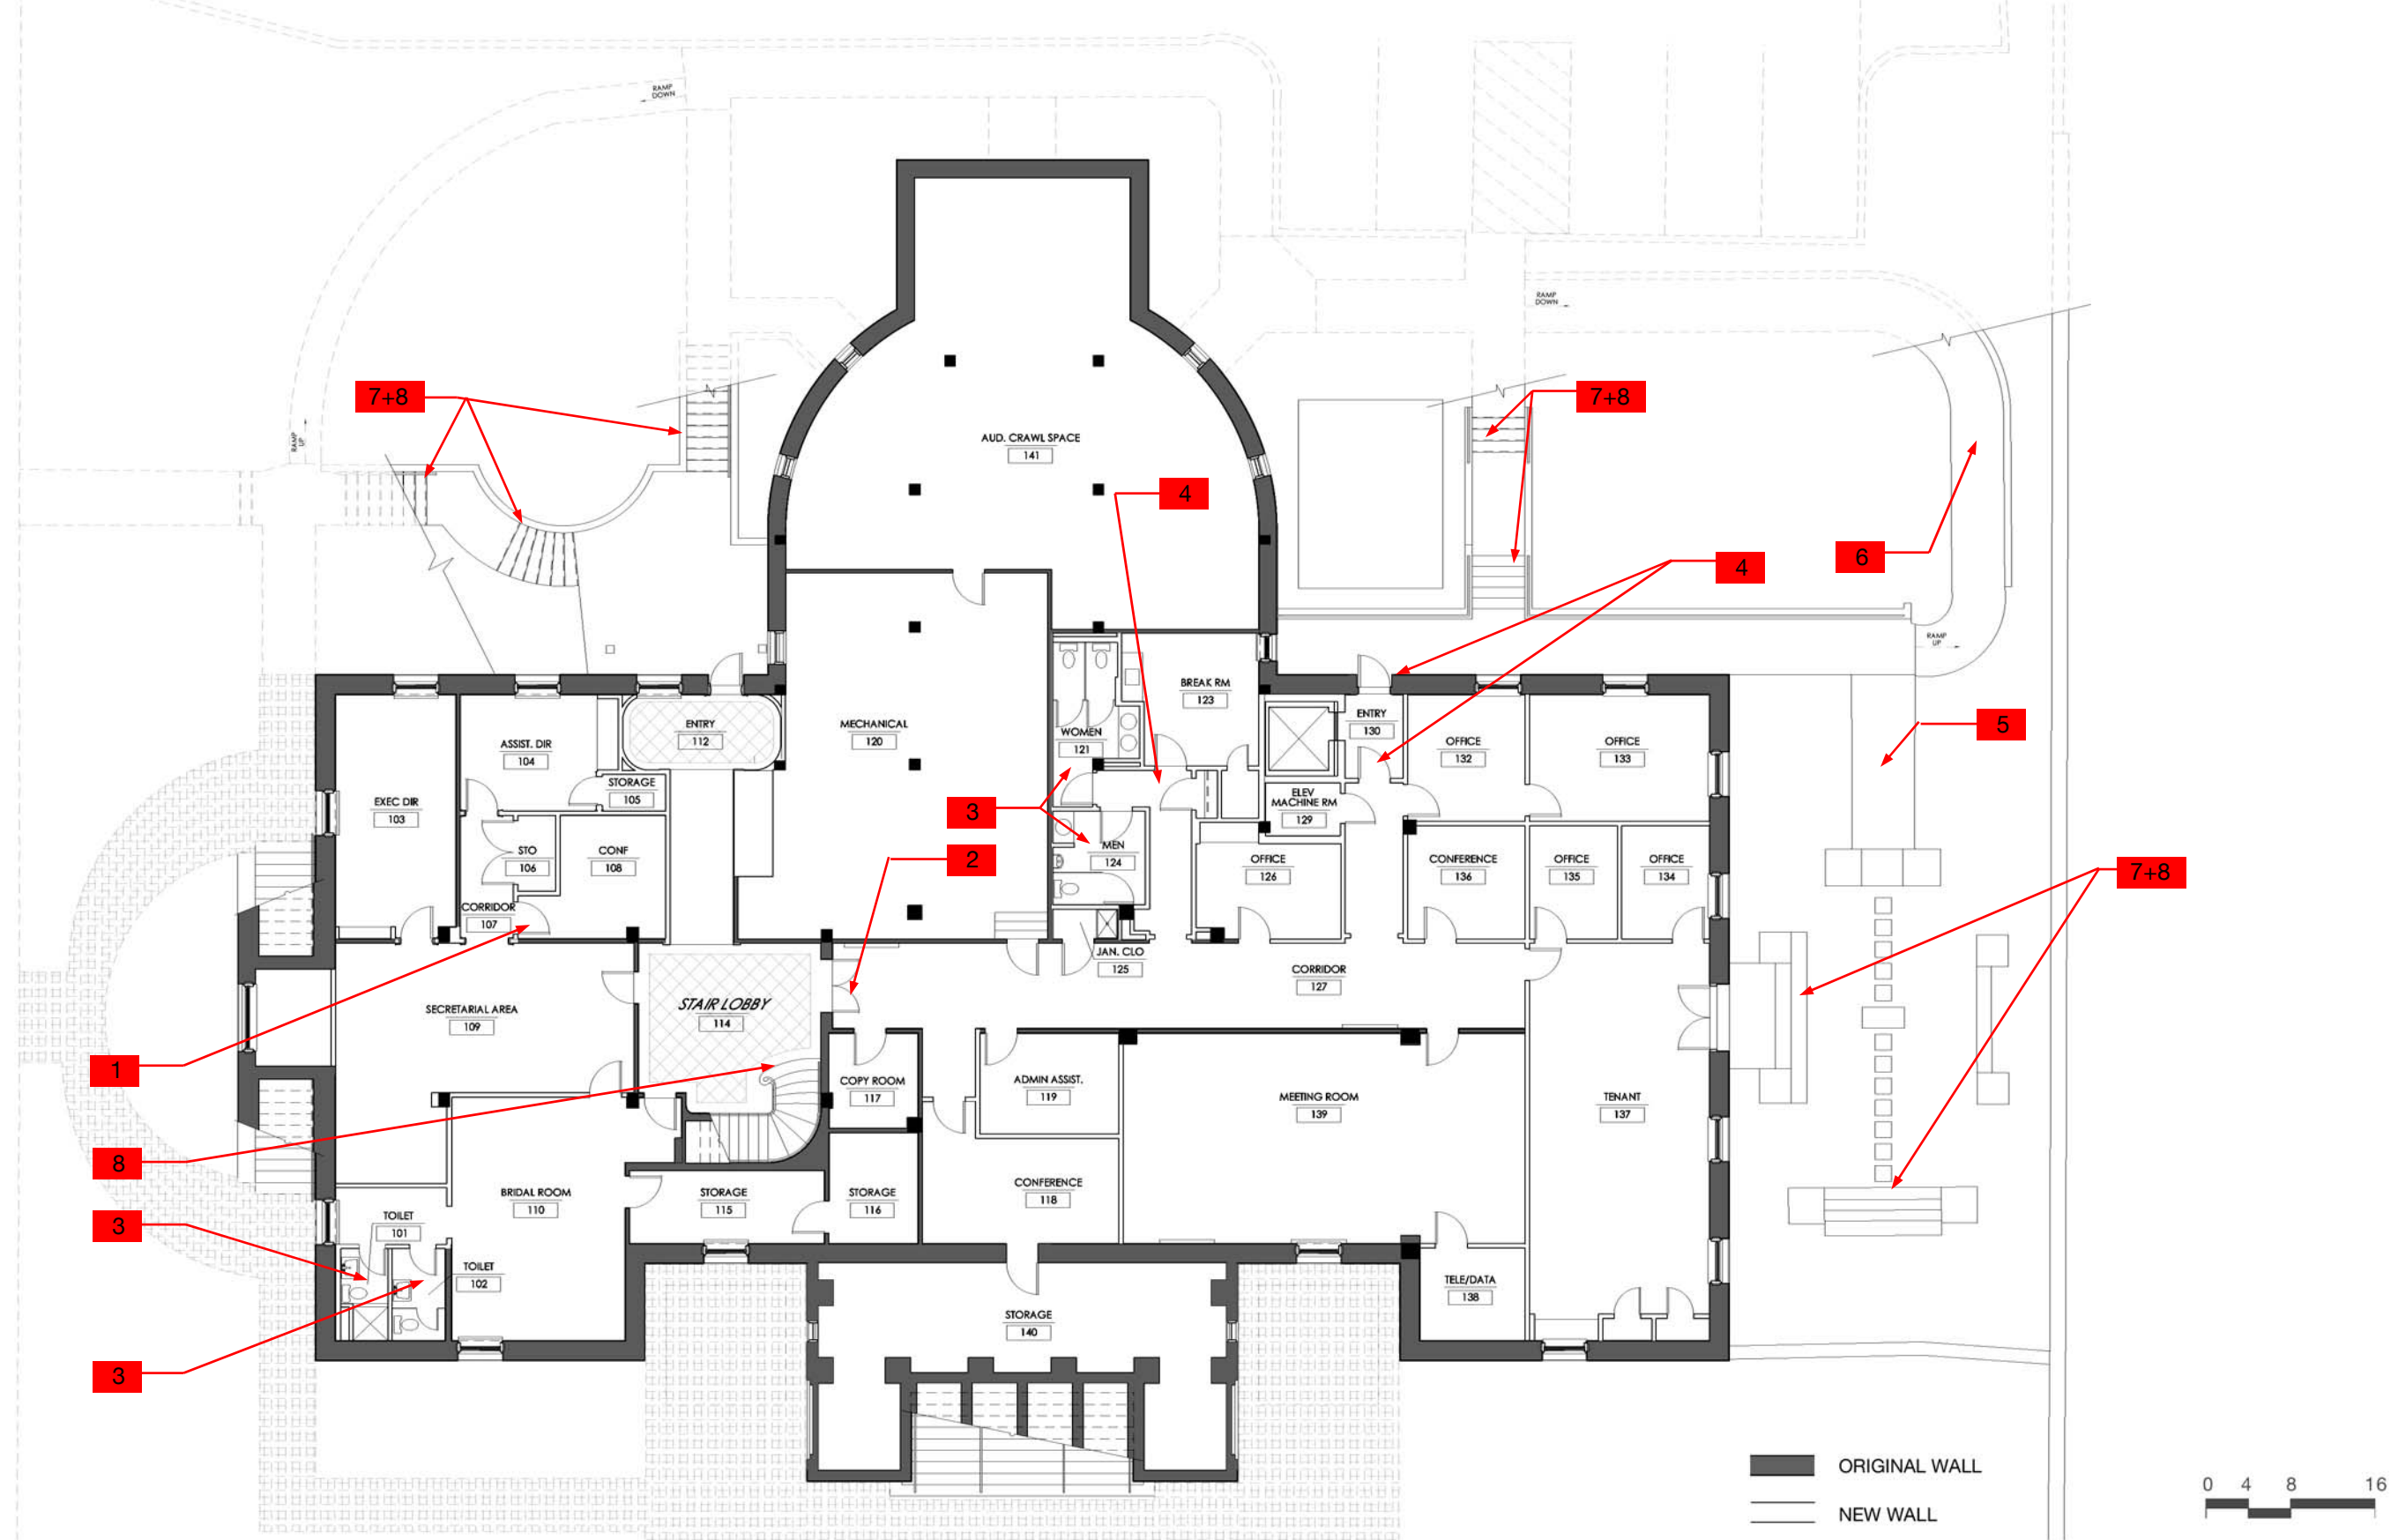
200825: GEORGIA INSTITUTE OF TECHNOLOGY CONDITION ASSESSMENT - ACADEMY OF MEDICINE	<small>TITLE</small> ADA KEYNOTES & RECOMMENDATIONS	
		<small>DATE</small> 11.14.2008 <small>REVISED 01.07.09</small>	<small>SHEET NUMBER</small> 24

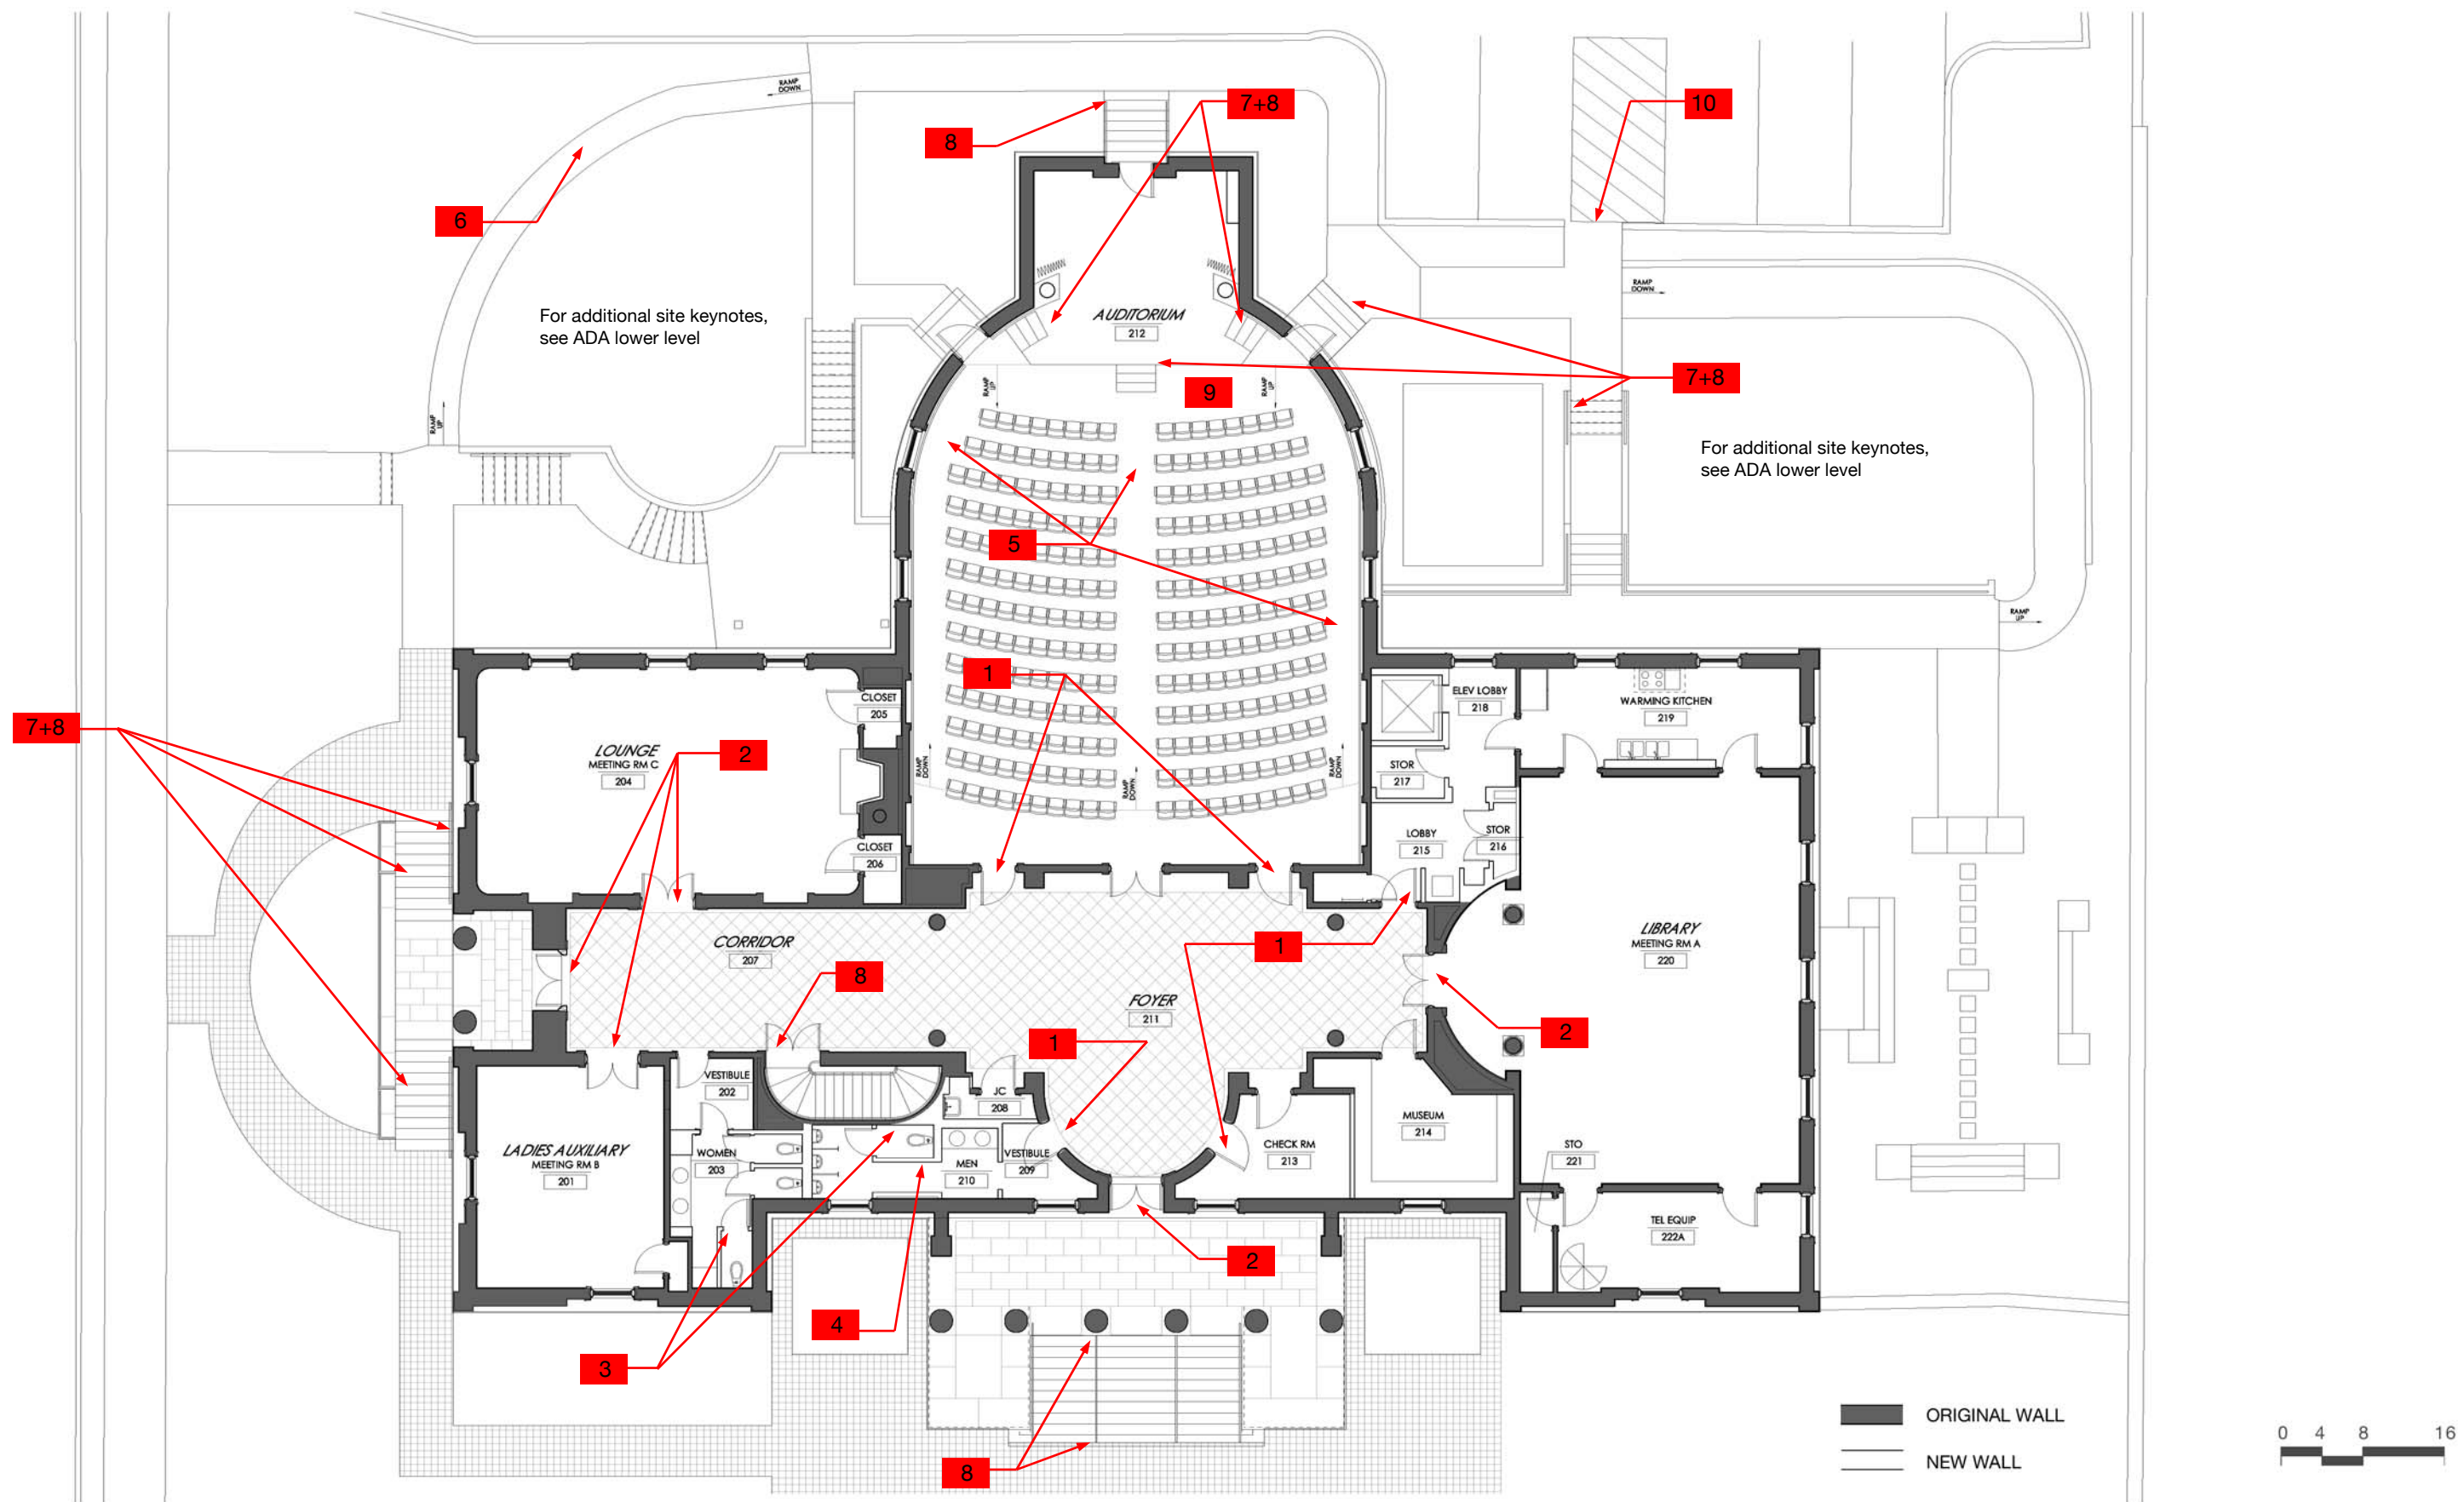
SUMMARY OF CODE ENFORCEMENT

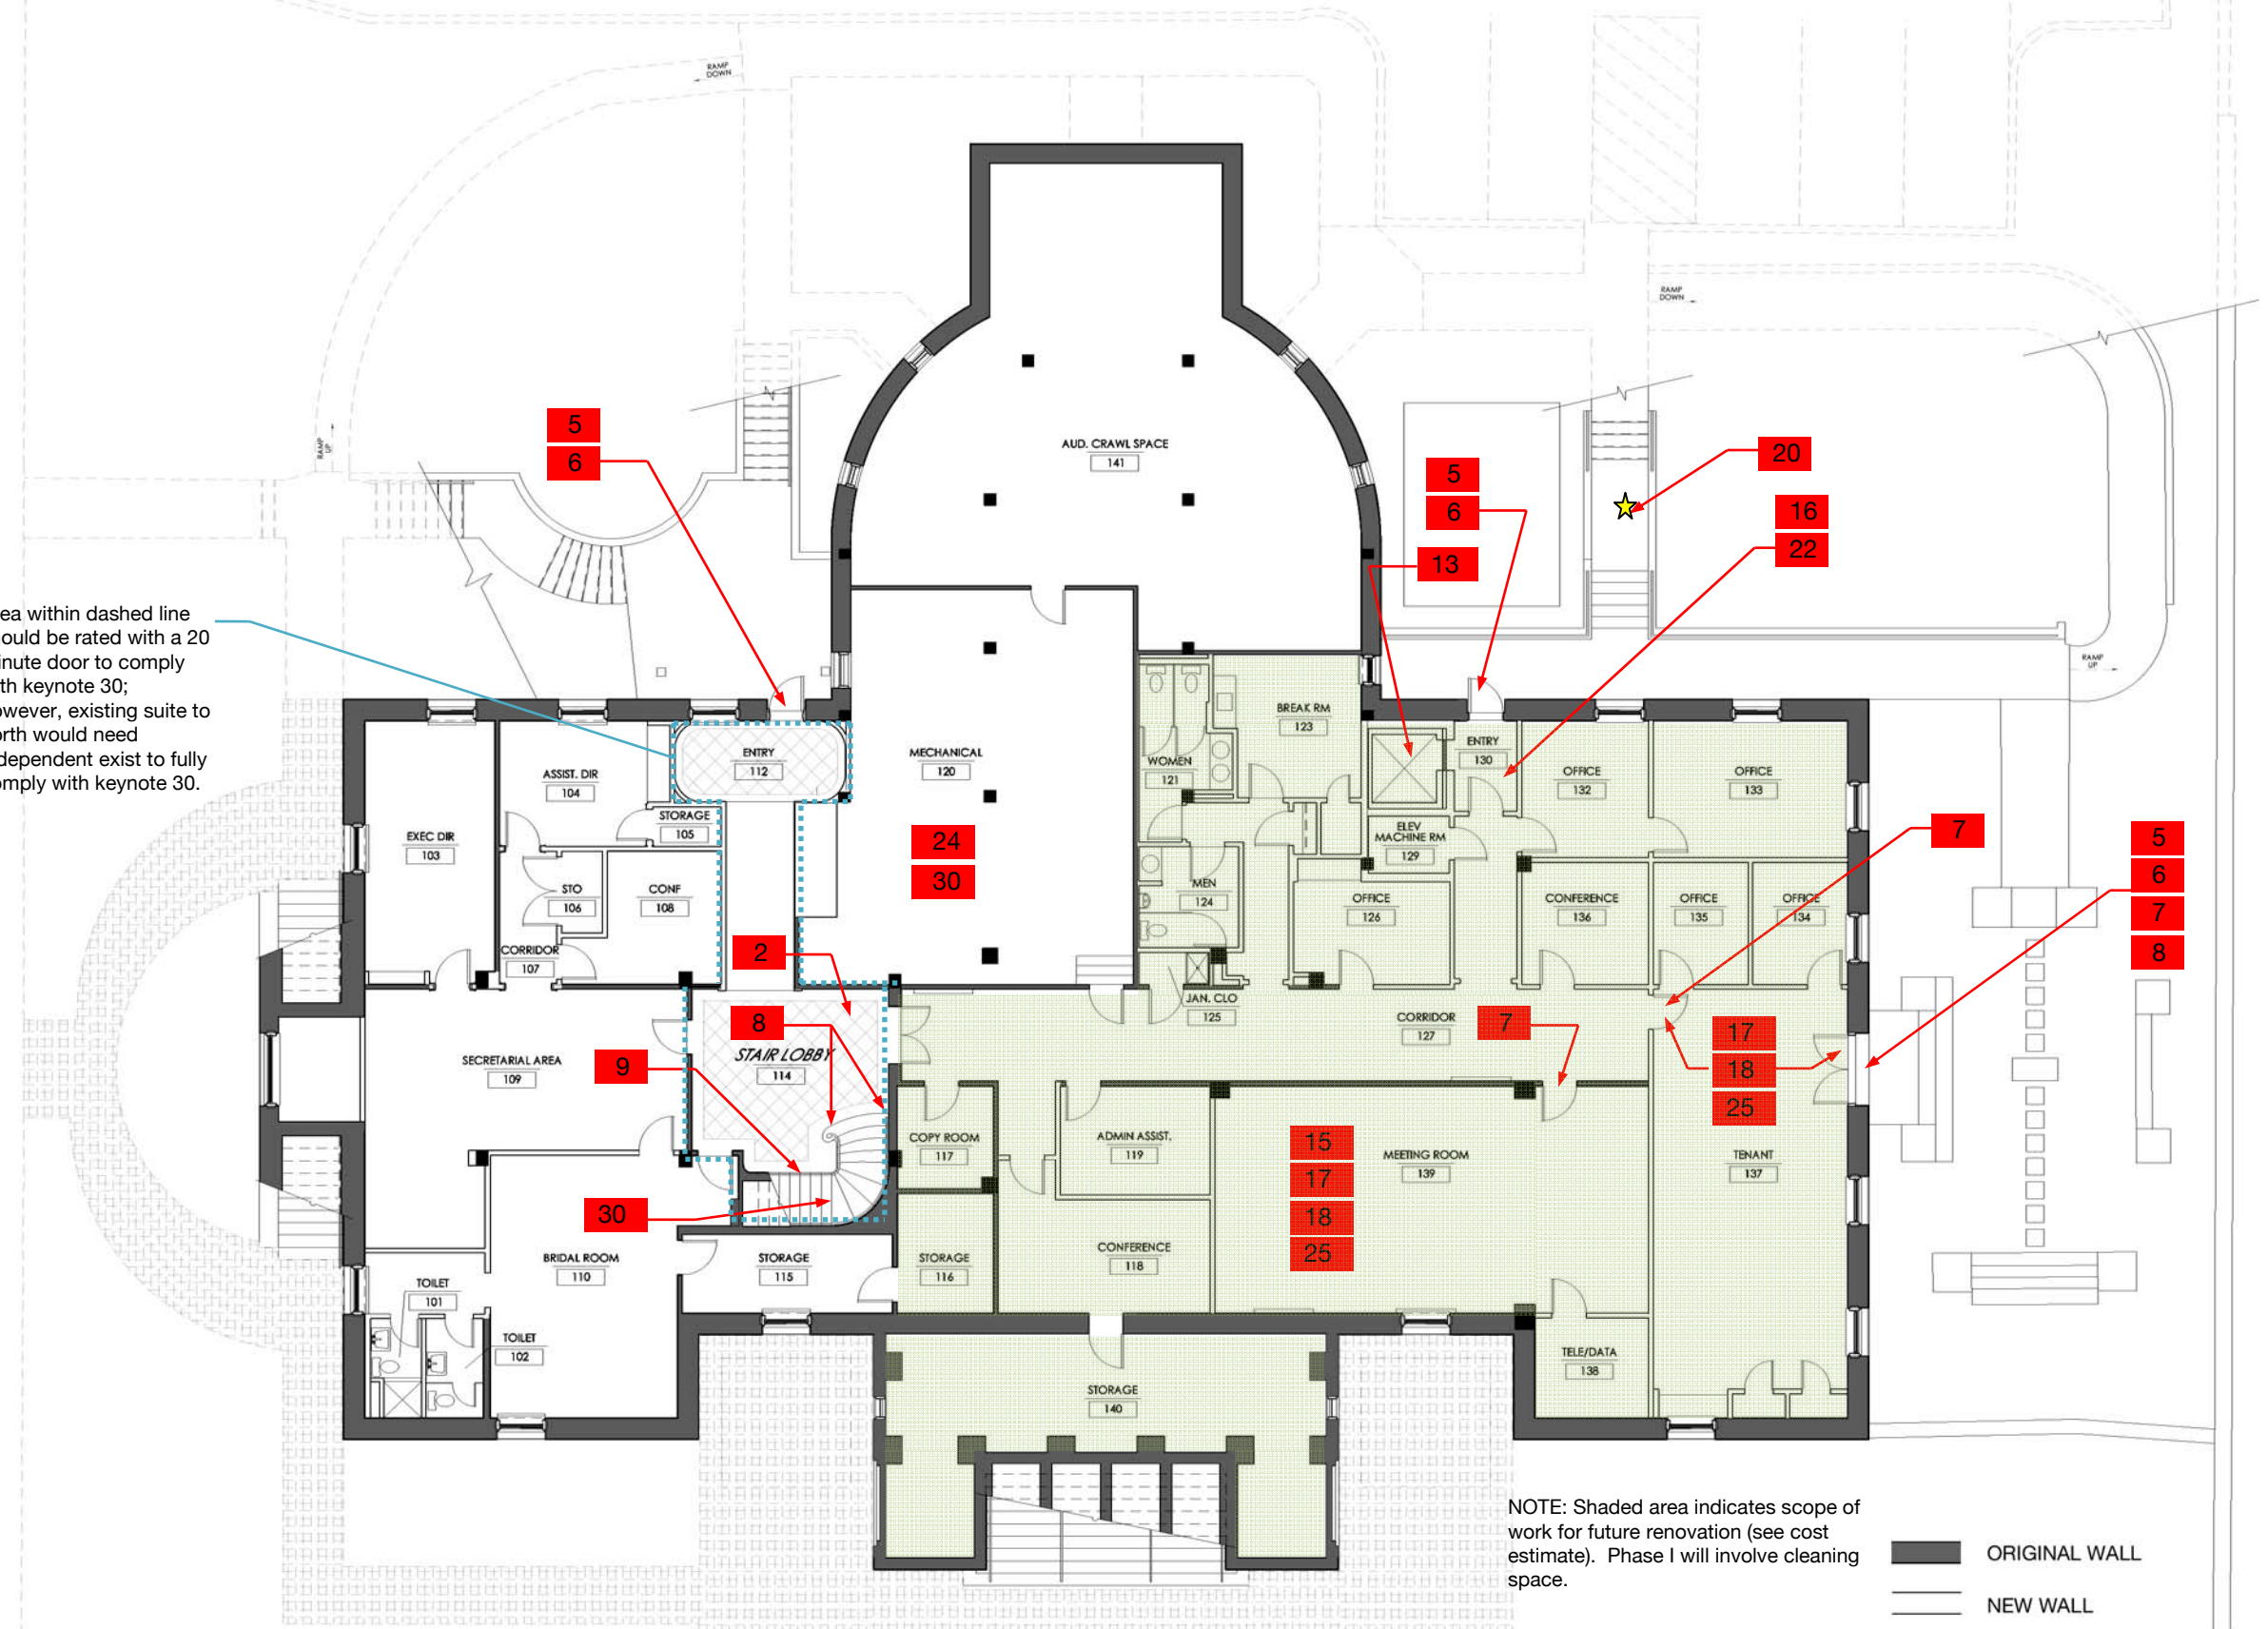
NOTE: Shaded area indicates scope of work for future renovation (see cost estimate). Phase I will involve cleaning space.

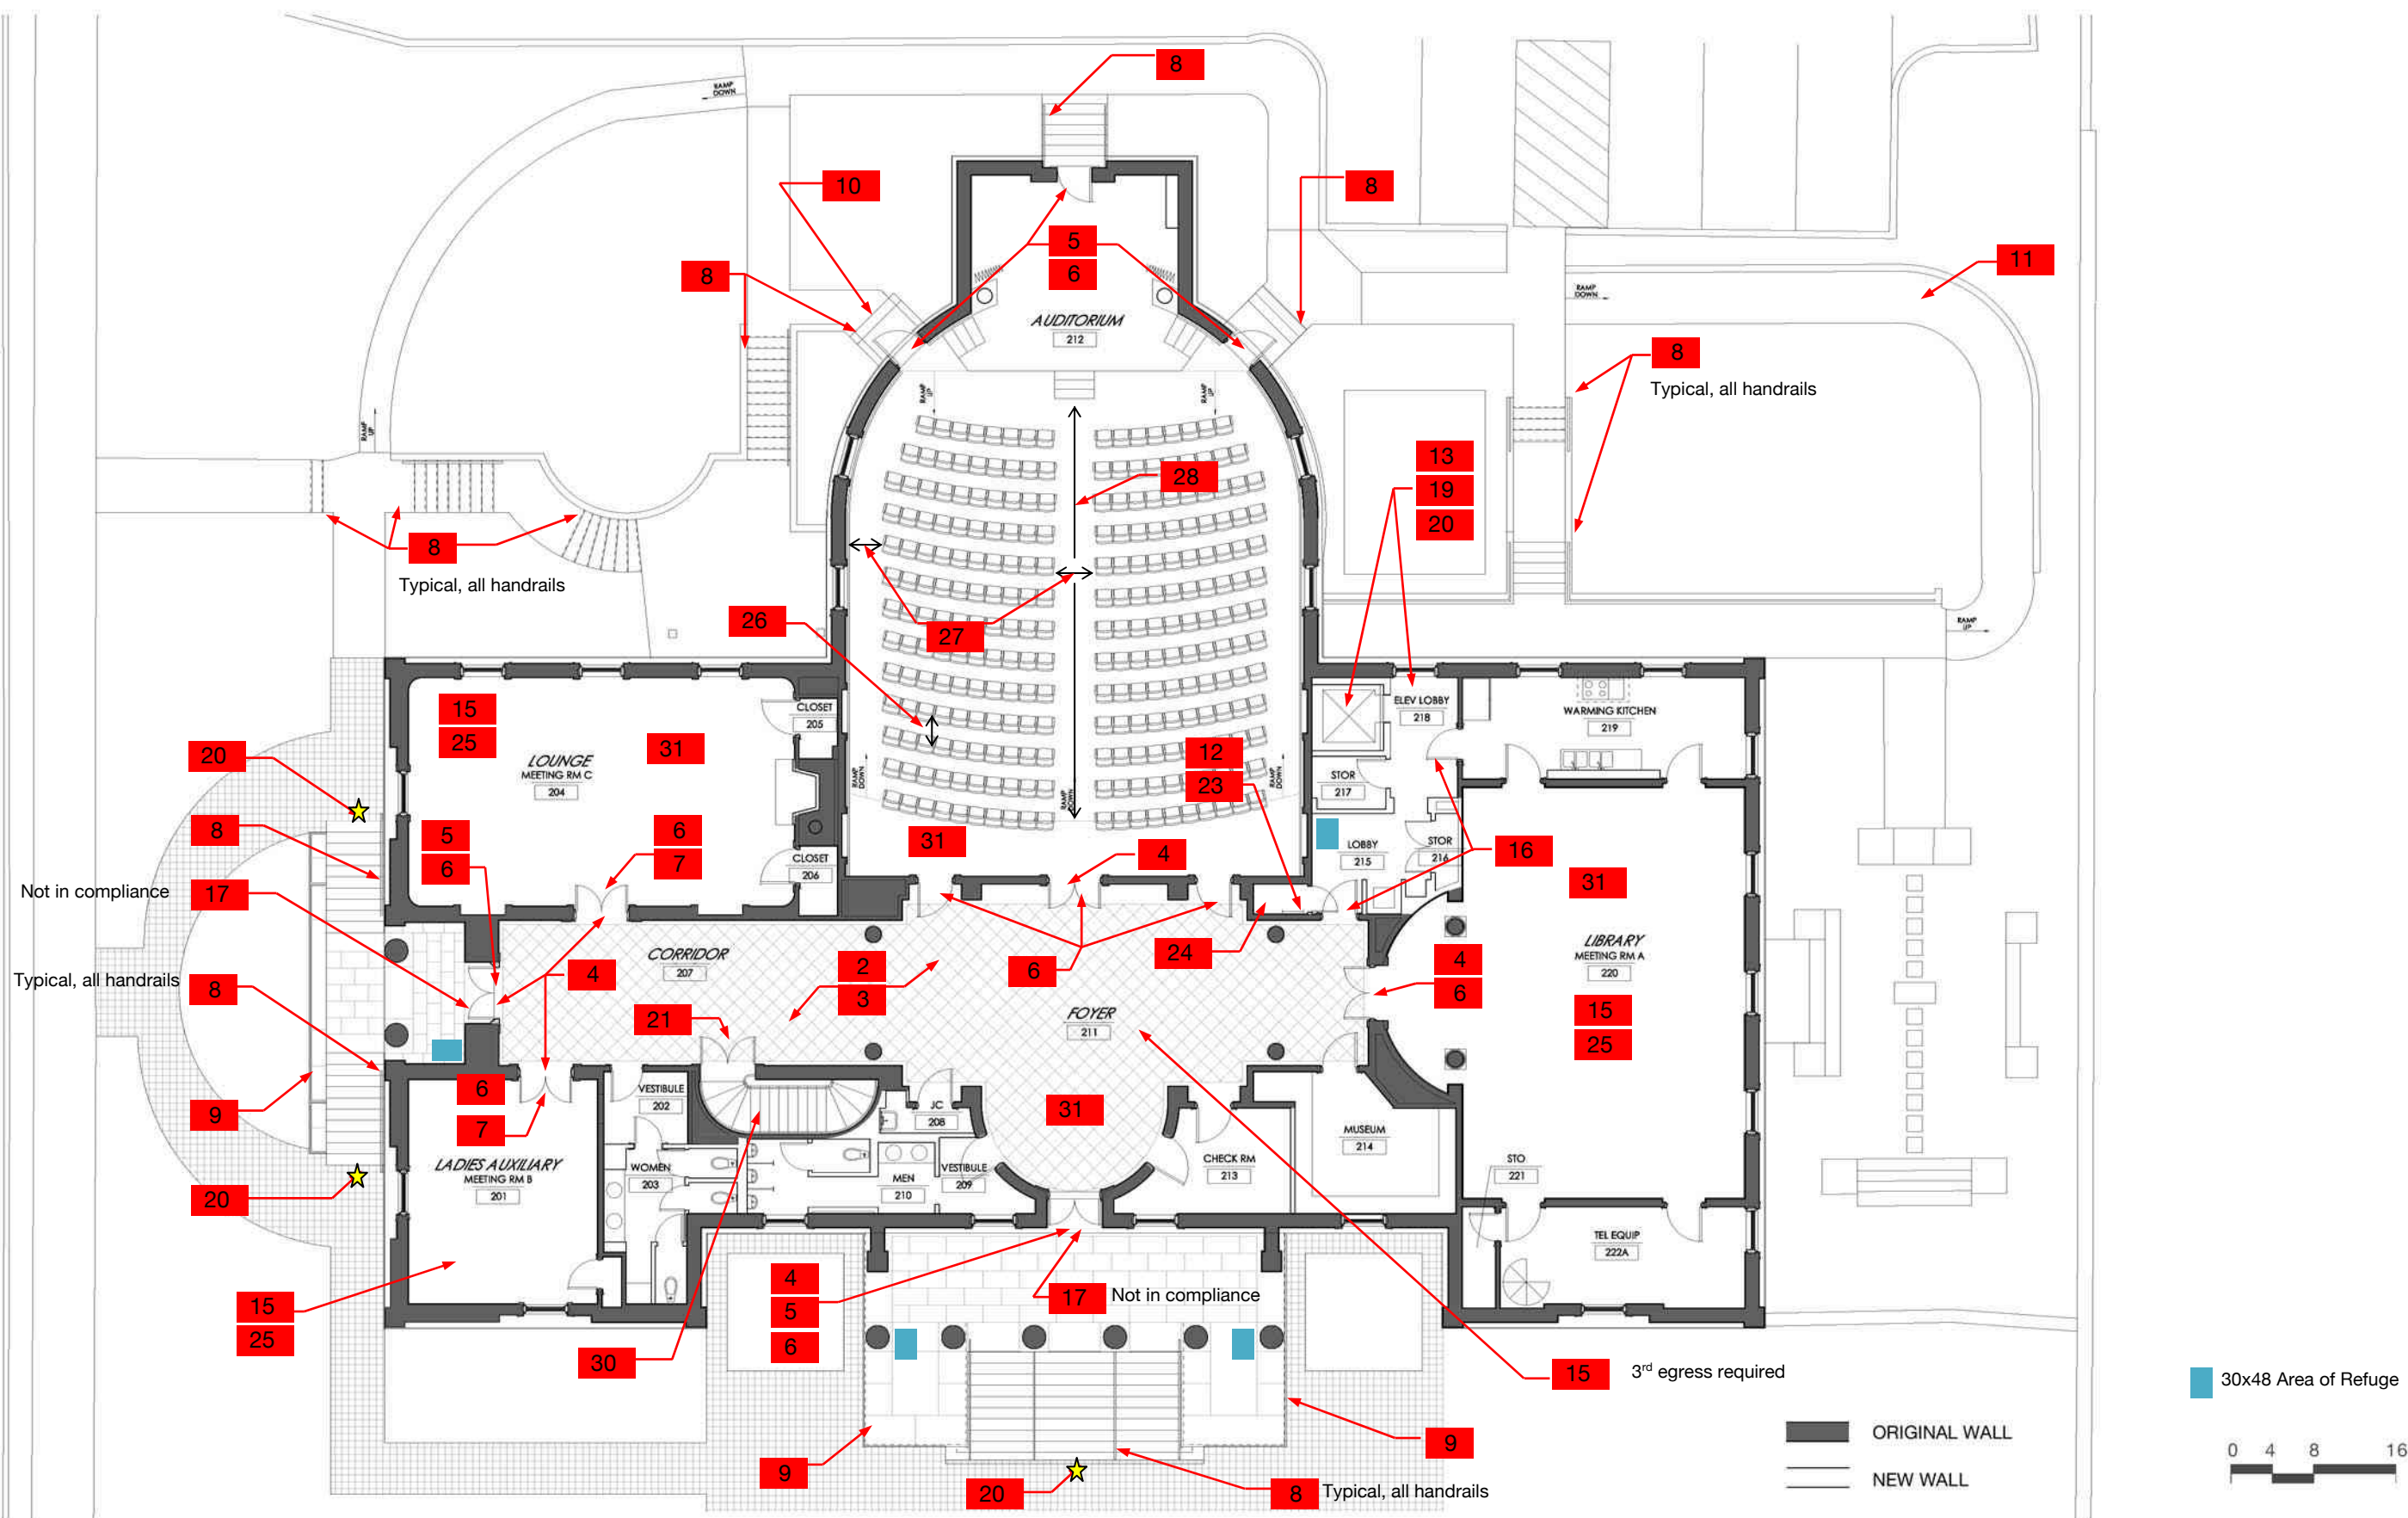
ACADEMY OF MEDICINE - CONDITION ASSESSMENT 875 WEST PEACHTREE STREET NE ATLANTA, GEORGIA 30309		TITLE NFPA LOWER LEVEL PLAN	
		DATE 11.21.08		SHEET NUMBER 29
