CONDITION ASSESSMENT OF **THE ACADEMY OF MEDICINE** FOR THE GEORGIA INSTITUTE OF TECHNOLOGY

01.07.2009

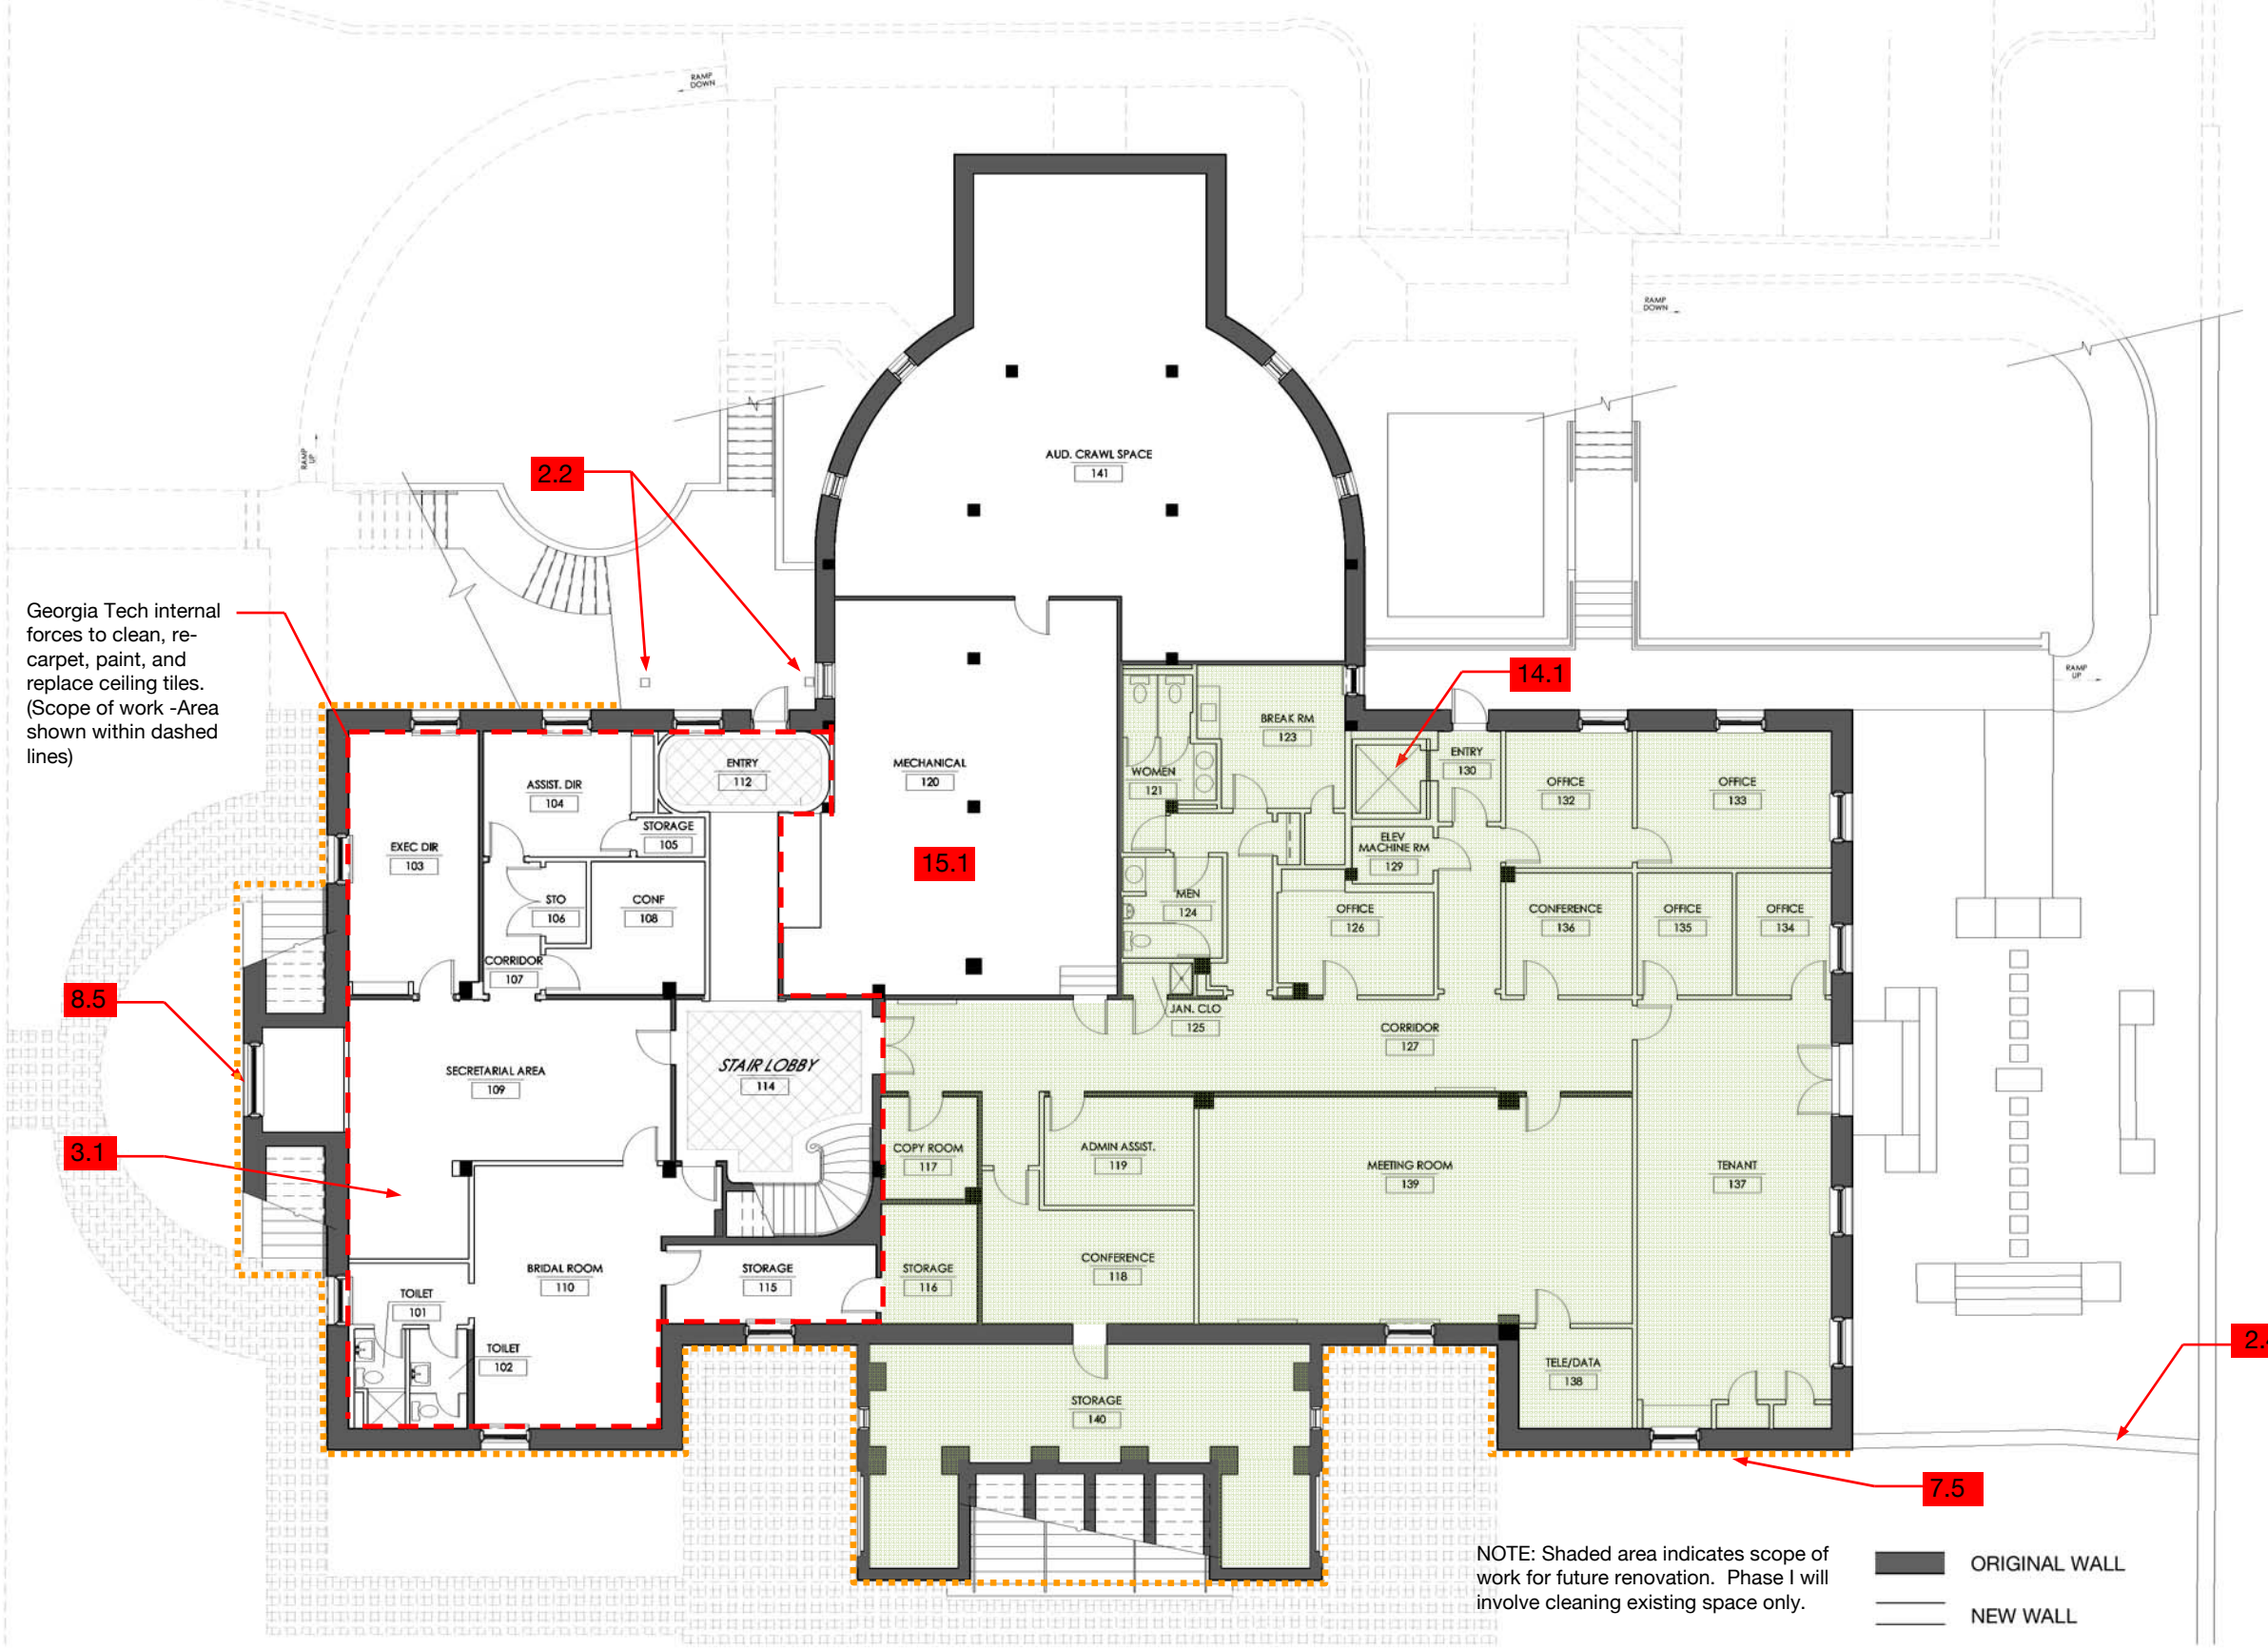
Georgia Tech internal forces to clean, re-carpet, paint, and replace ceiling tiles. (Scope of work -Area shown within dashed lines)

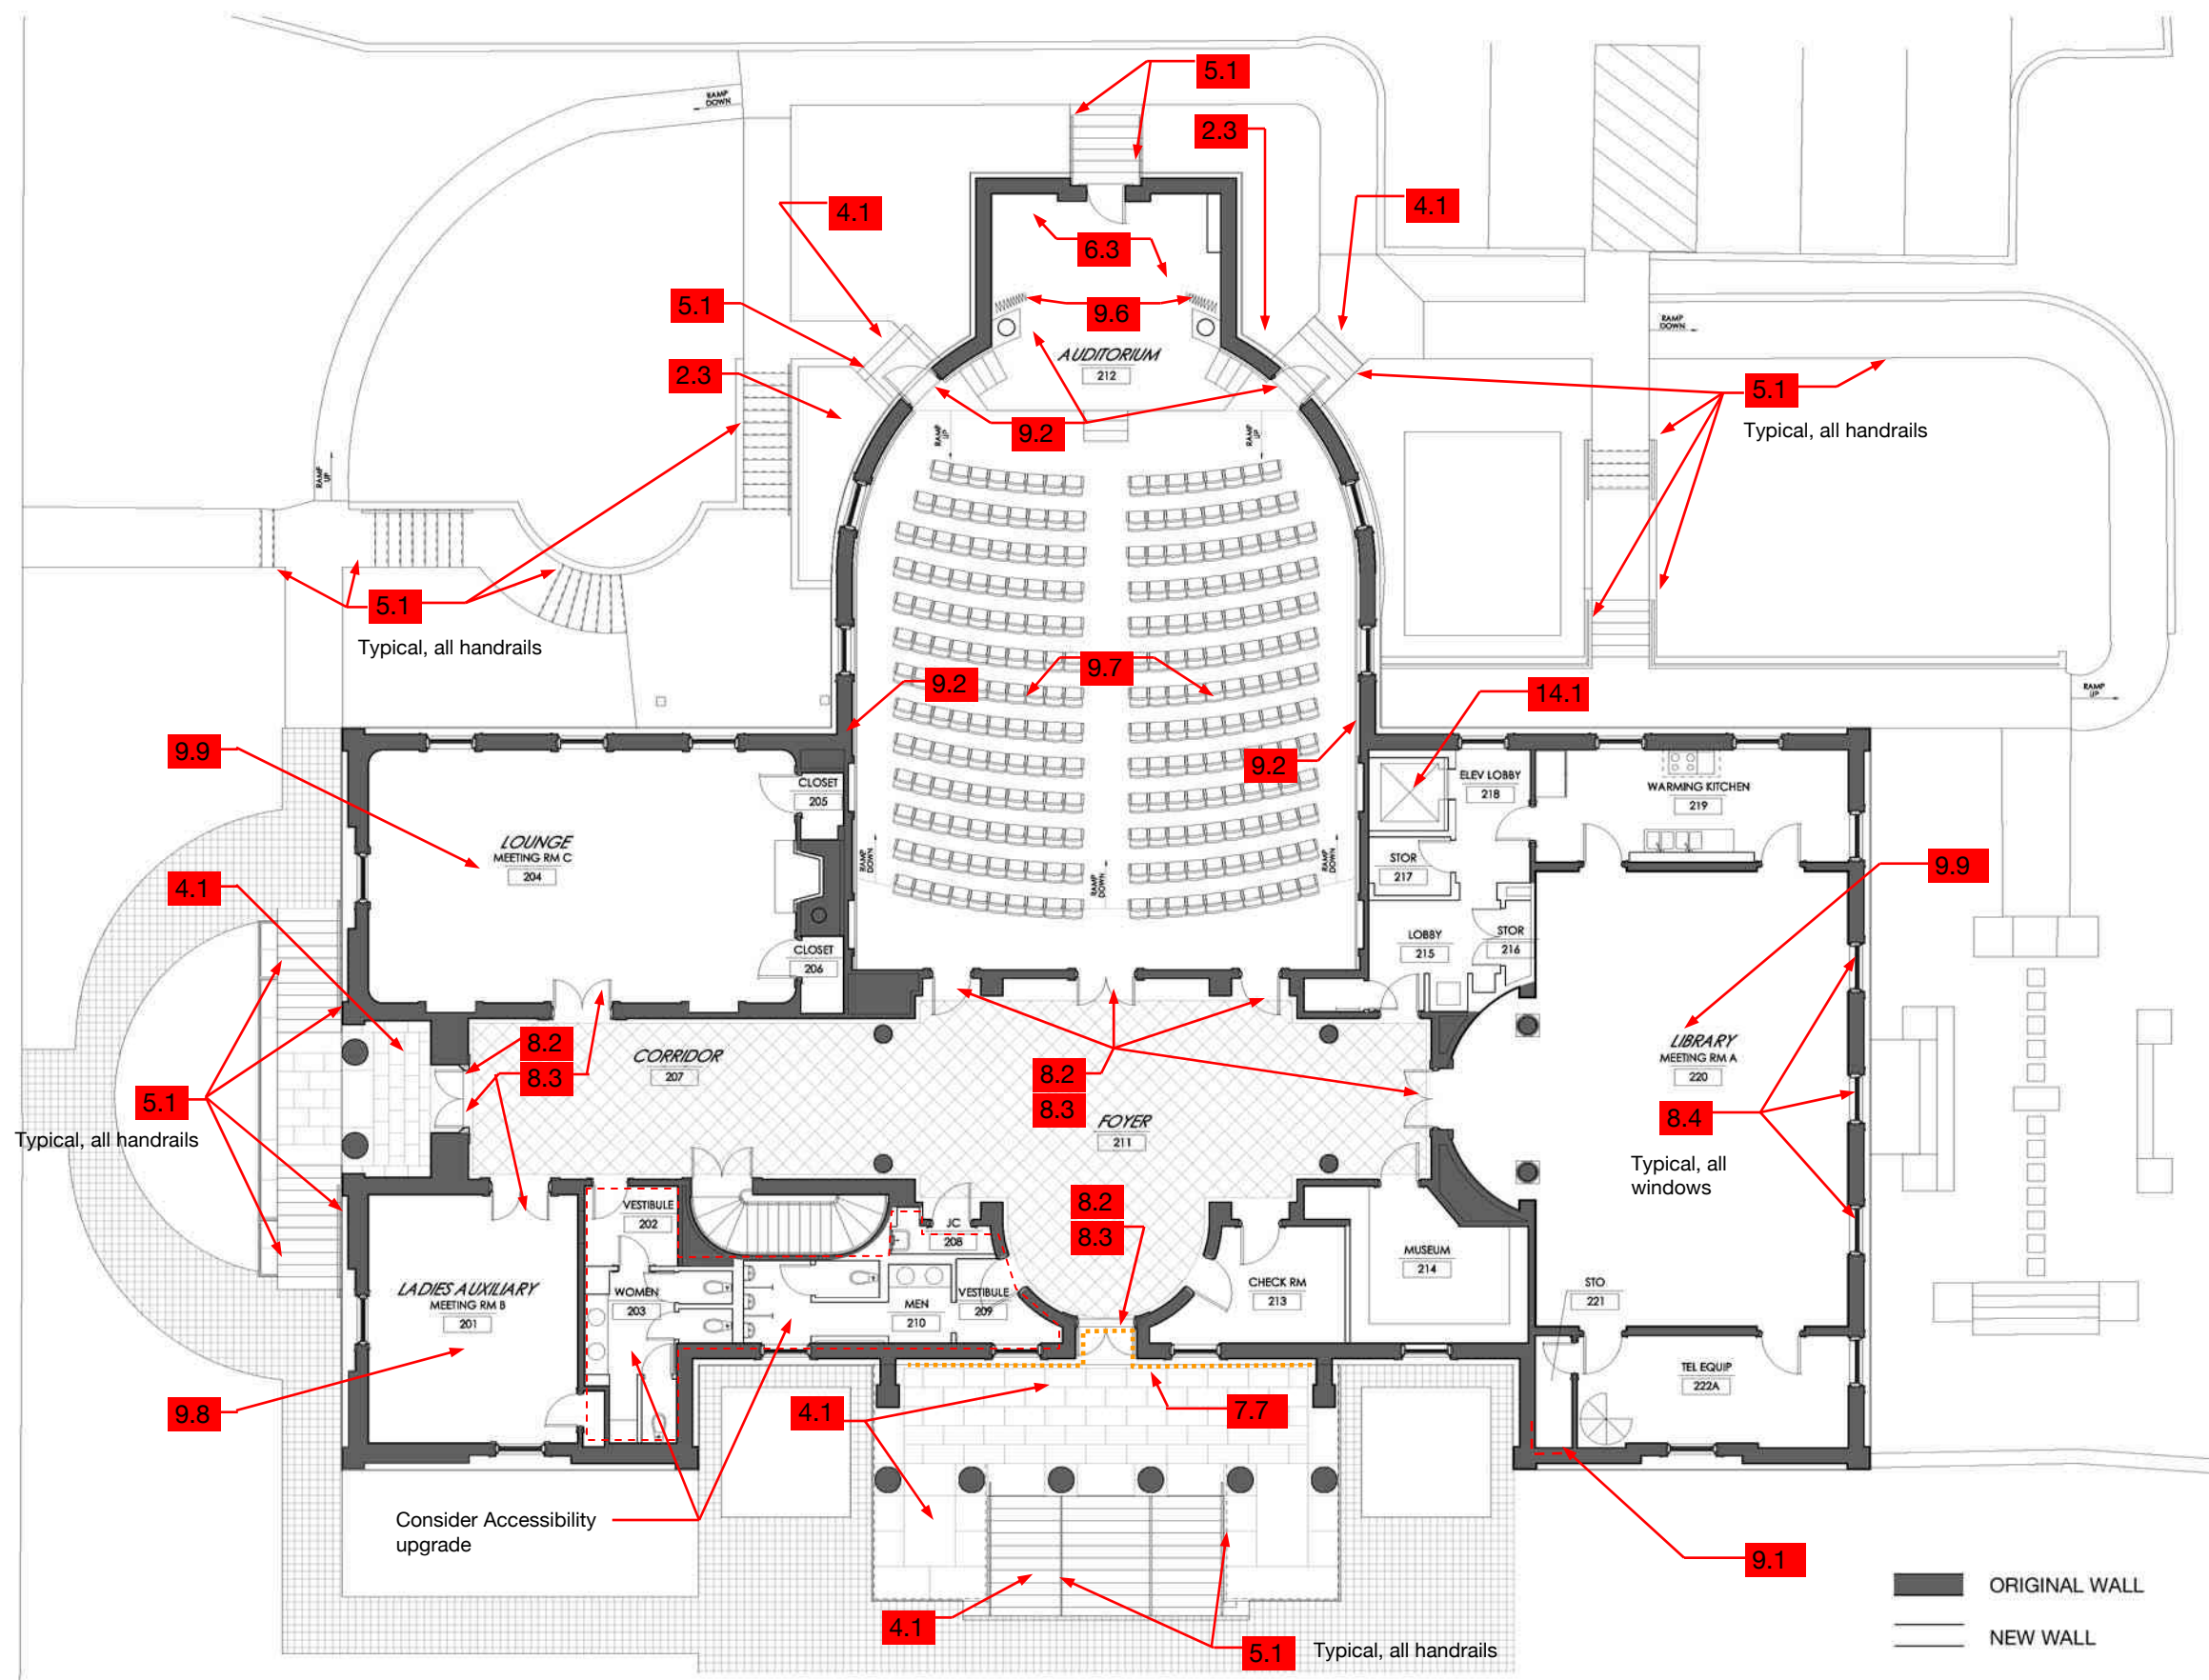
ACADEMY OF MEDICINE - CONDITION ASSESSMENT 875 WEST PEACHTREE STREET NE ATLANTA, GEORGIA 30309		TITLE RECOMMENDED TREATMENT - LOWER LEVEL	
				DATE 11.21.08	SHEET NUMBER 36

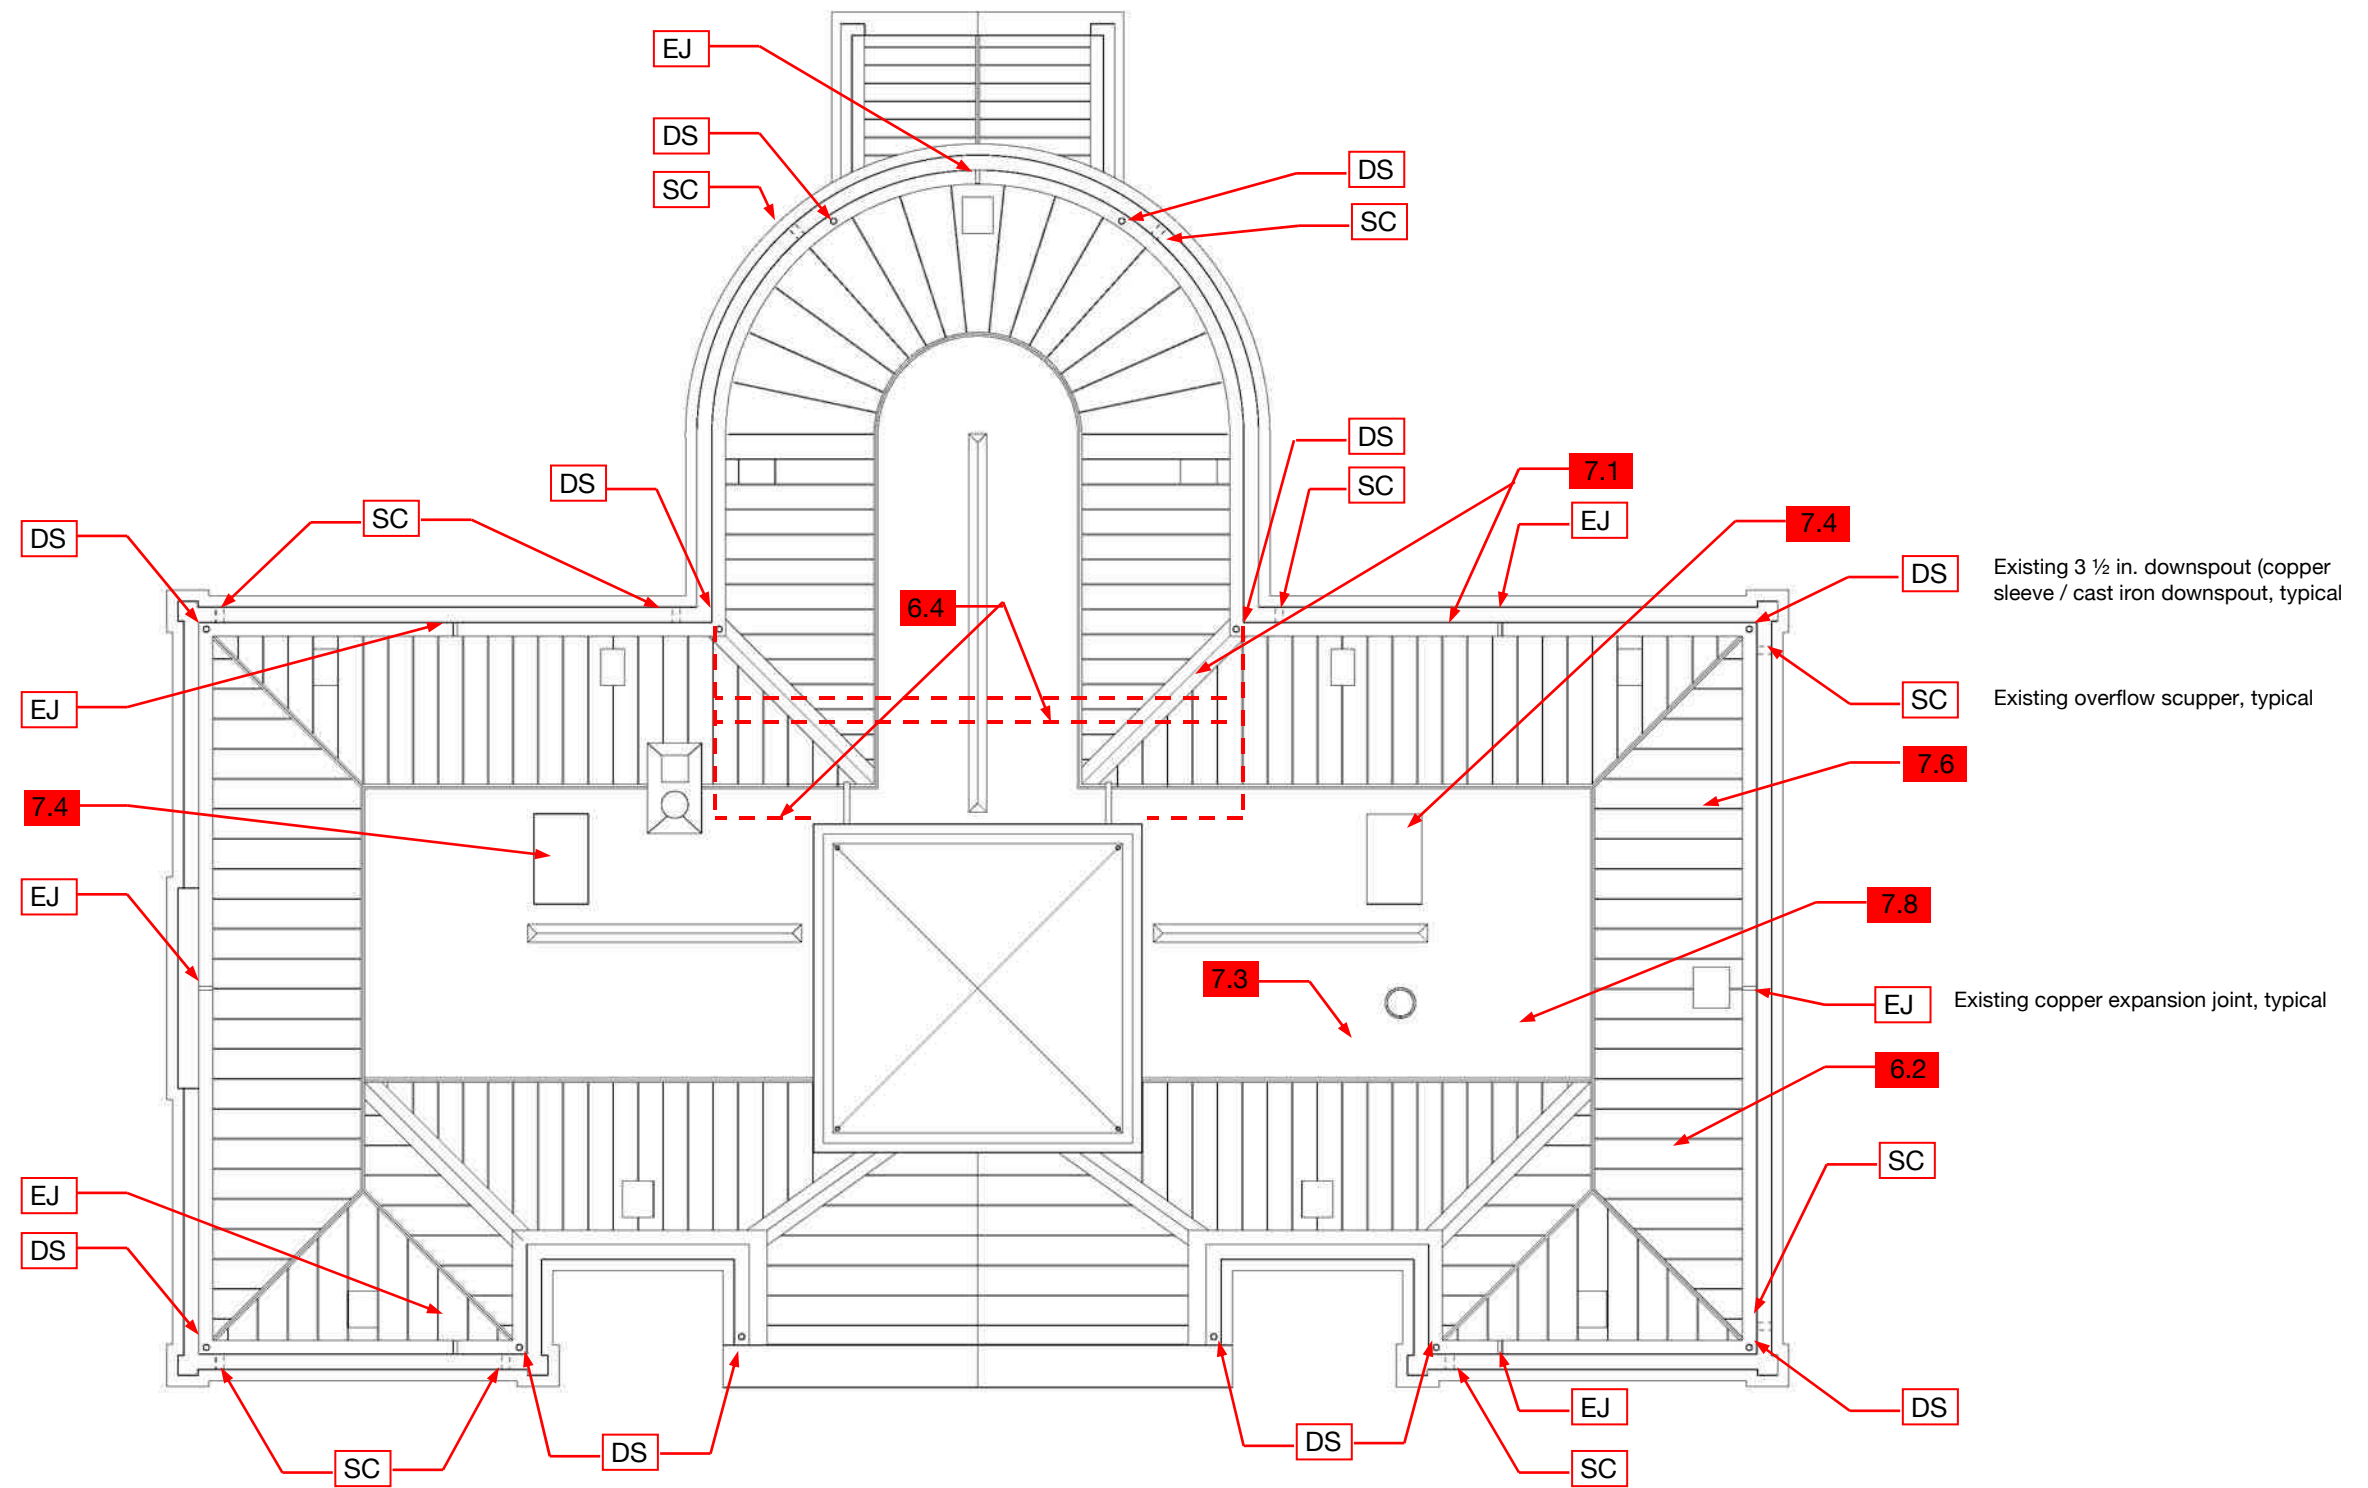
Existing 3 1/2 in. downspout (copper sleeve / cast iron downspout, typical)

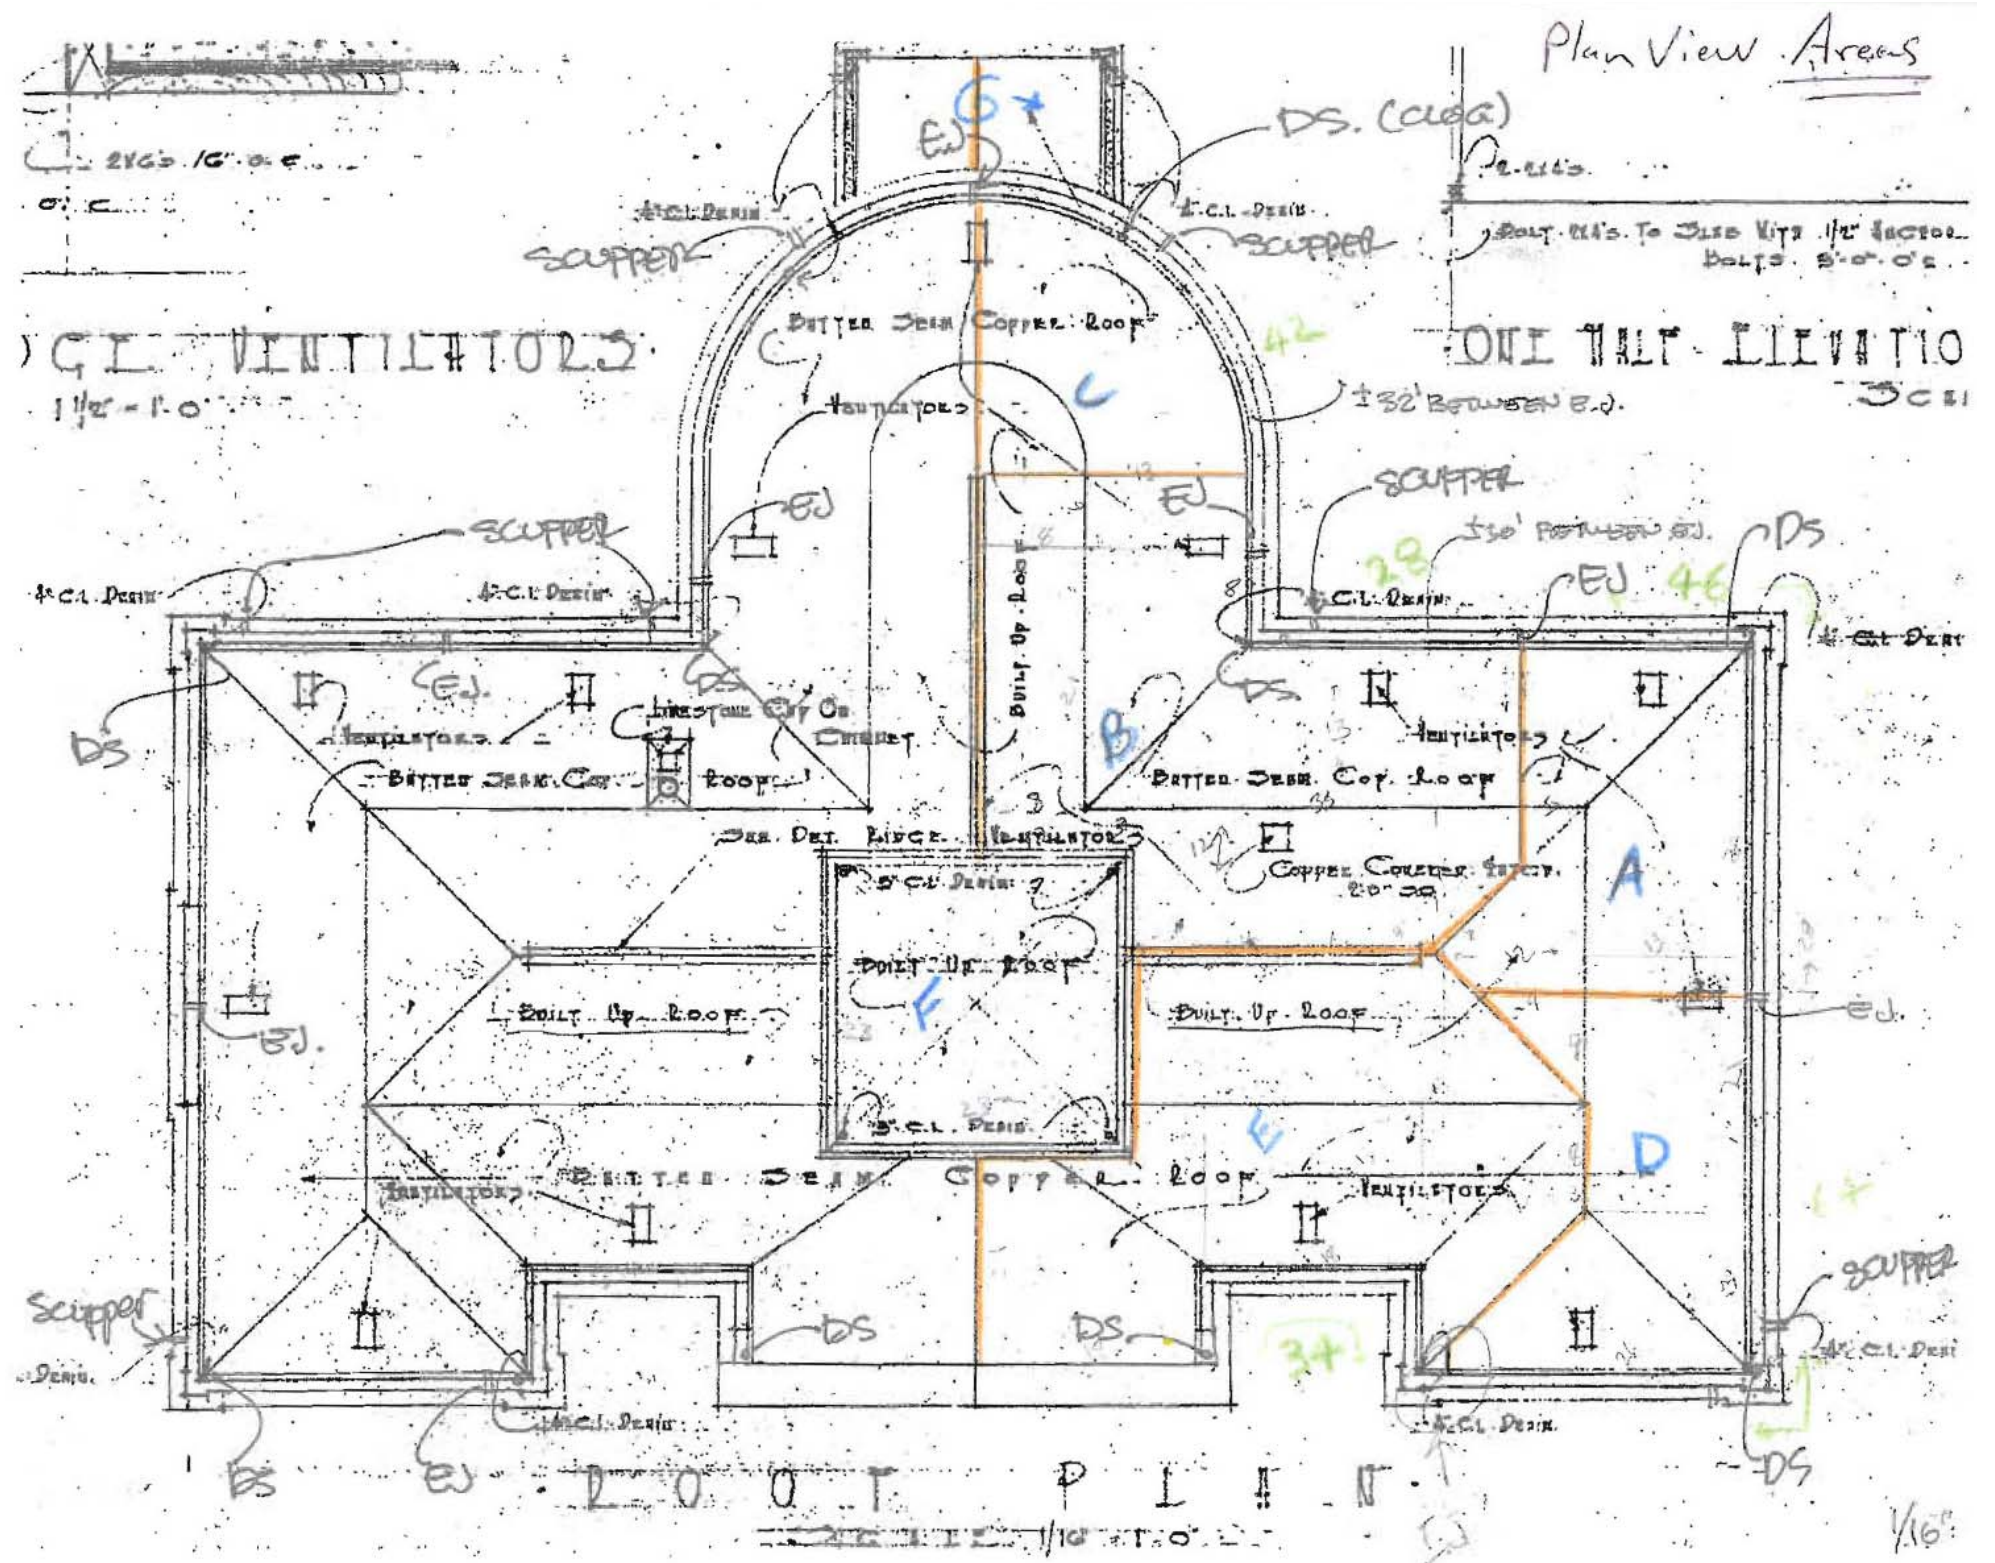
Note: Roof Plan to the right is not to scale

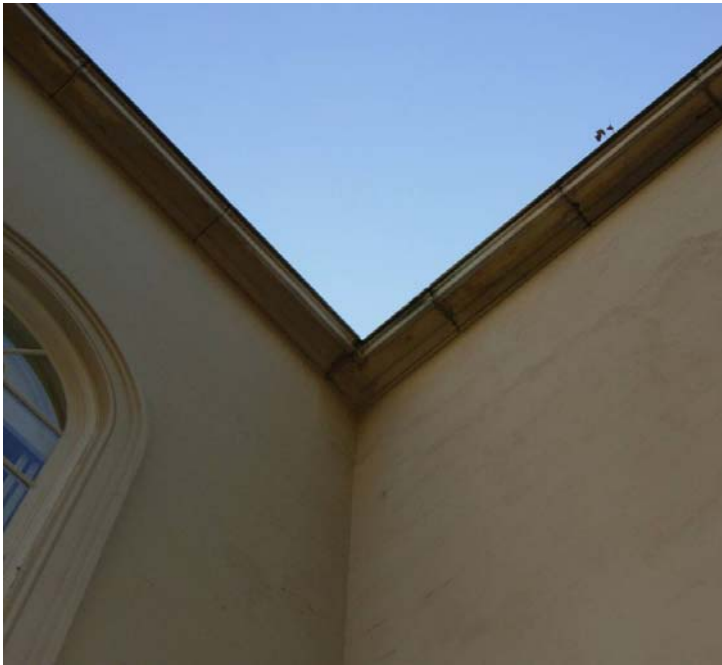
Image 1: Fascia/Soffit Water damage corresponding to downspout, valley, scupper roof area "B" North

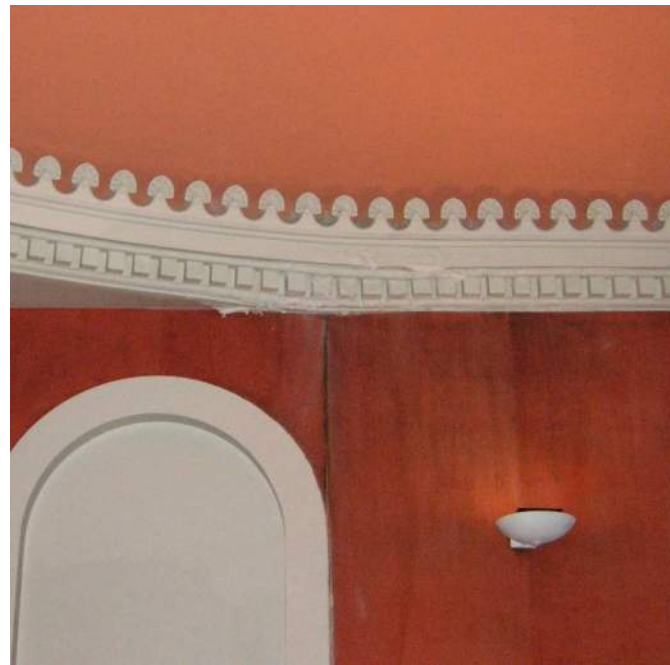
Image 3: Interior Plaster Damage corresponding to downspout, valley, scupper roof area "B" North

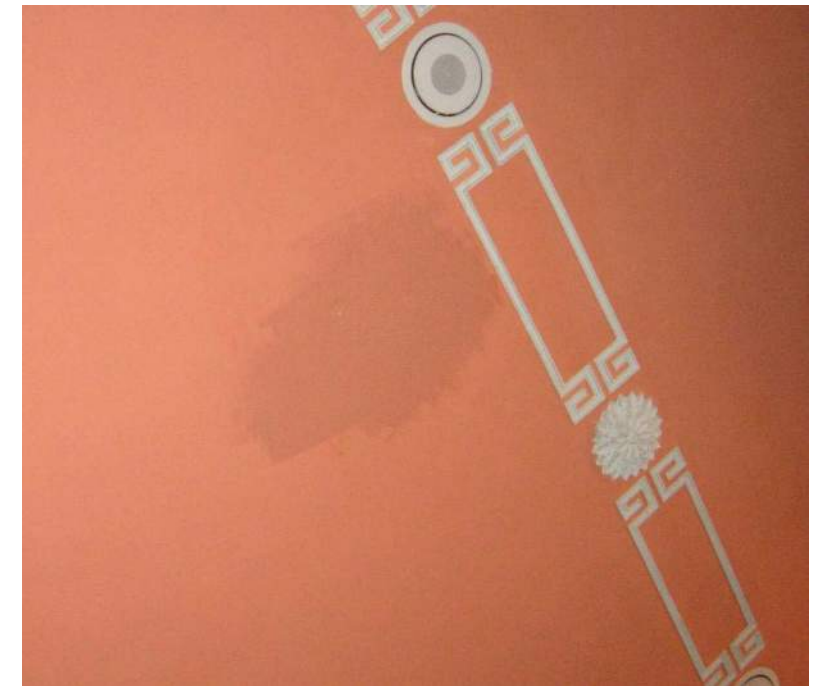
Image 5: Ceiling central portion under roof area "B"— area of prior plaster damage repainted

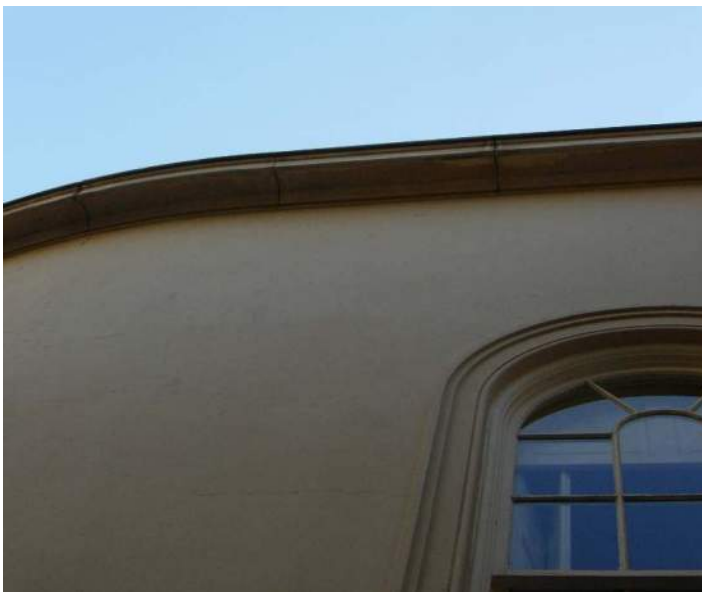
Image 2: Fascia/Soffit Water damage corresponding to downspout and scupper, roof area "C" North

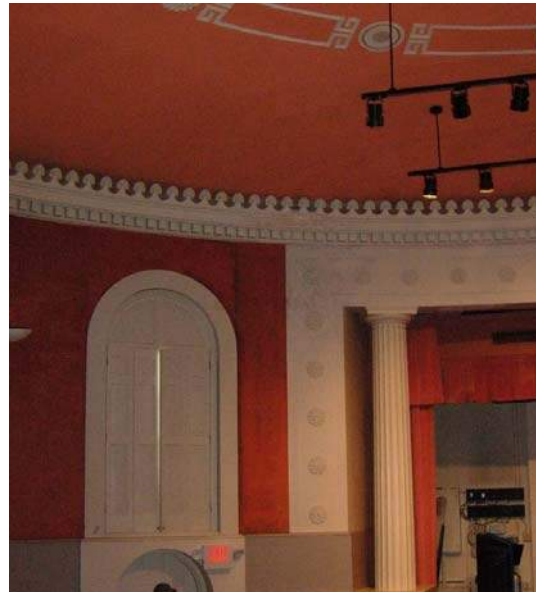
Image 4: Interior Plaster Damage corresponding to downspout and scupper, roof area "C" North

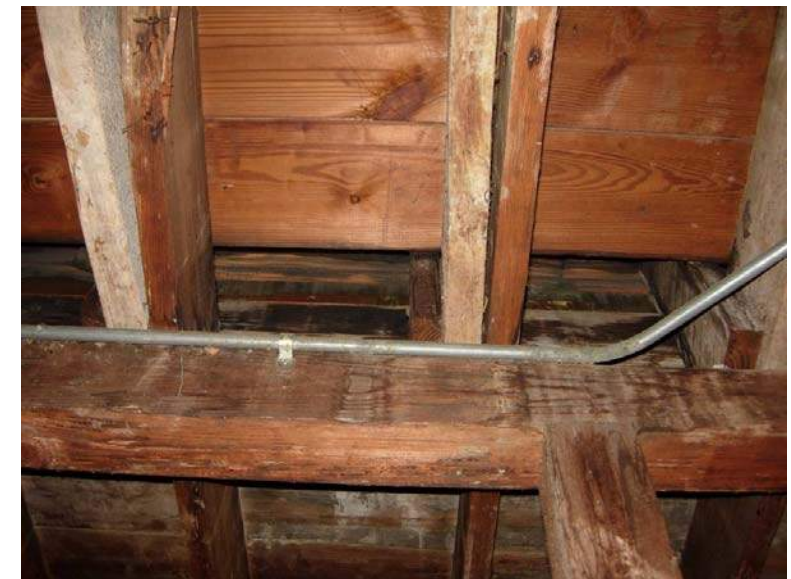
Image 6: Evidence of water infiltration under low slope roof ventilator

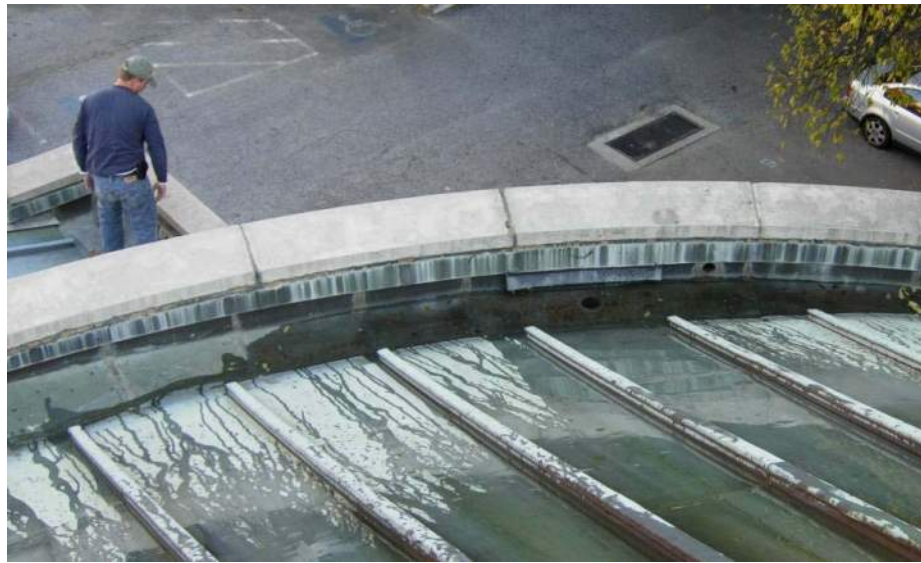
Image 7: Water test in gutter section "C" South, showing clogged drain, also excess copper piece under flashing

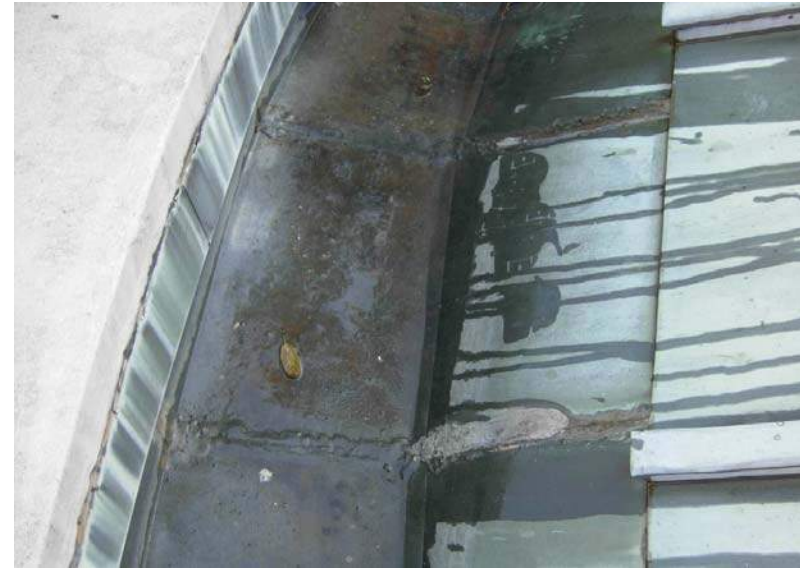
Image 9: Two improperly soldered flat lock seams, both with attempted re-soldering and/or sealant patch. These are in radius built in gutter areas "C", thus close transverse seams.

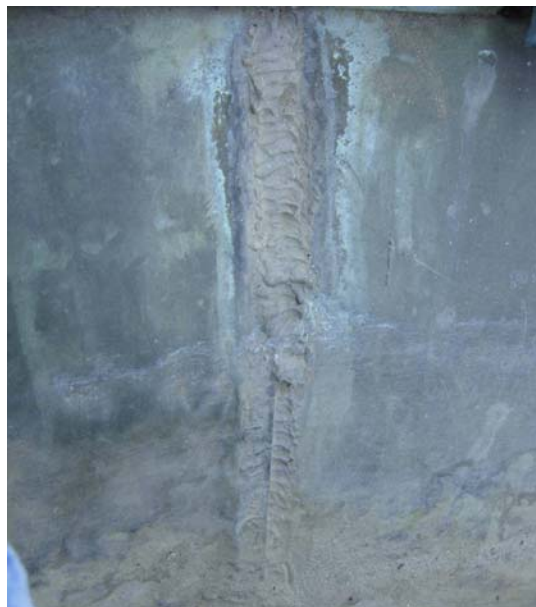
Image 8: Improperly soldered flat lock seam. Lower portion was original; upper appears to represent an attempted re-soldering of a failed seam.

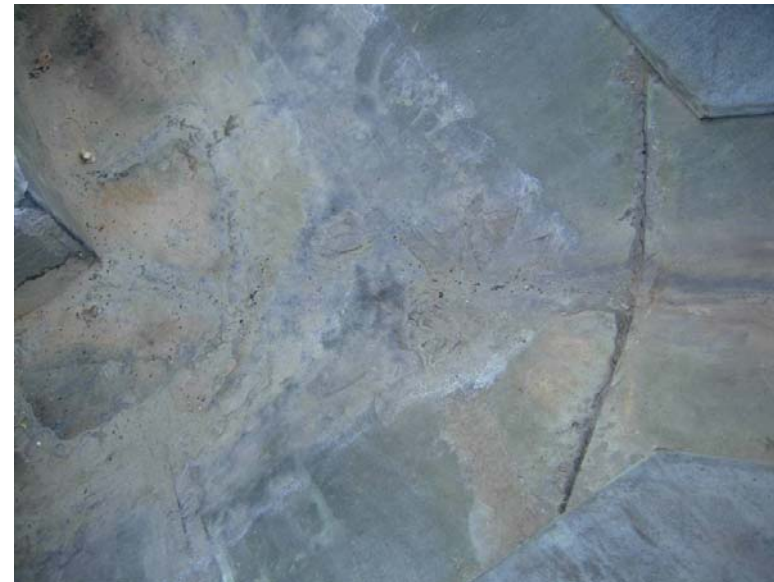
Image 10: improperly soldered flat lock seams, lap seams, and patches at corner roof area "B" North

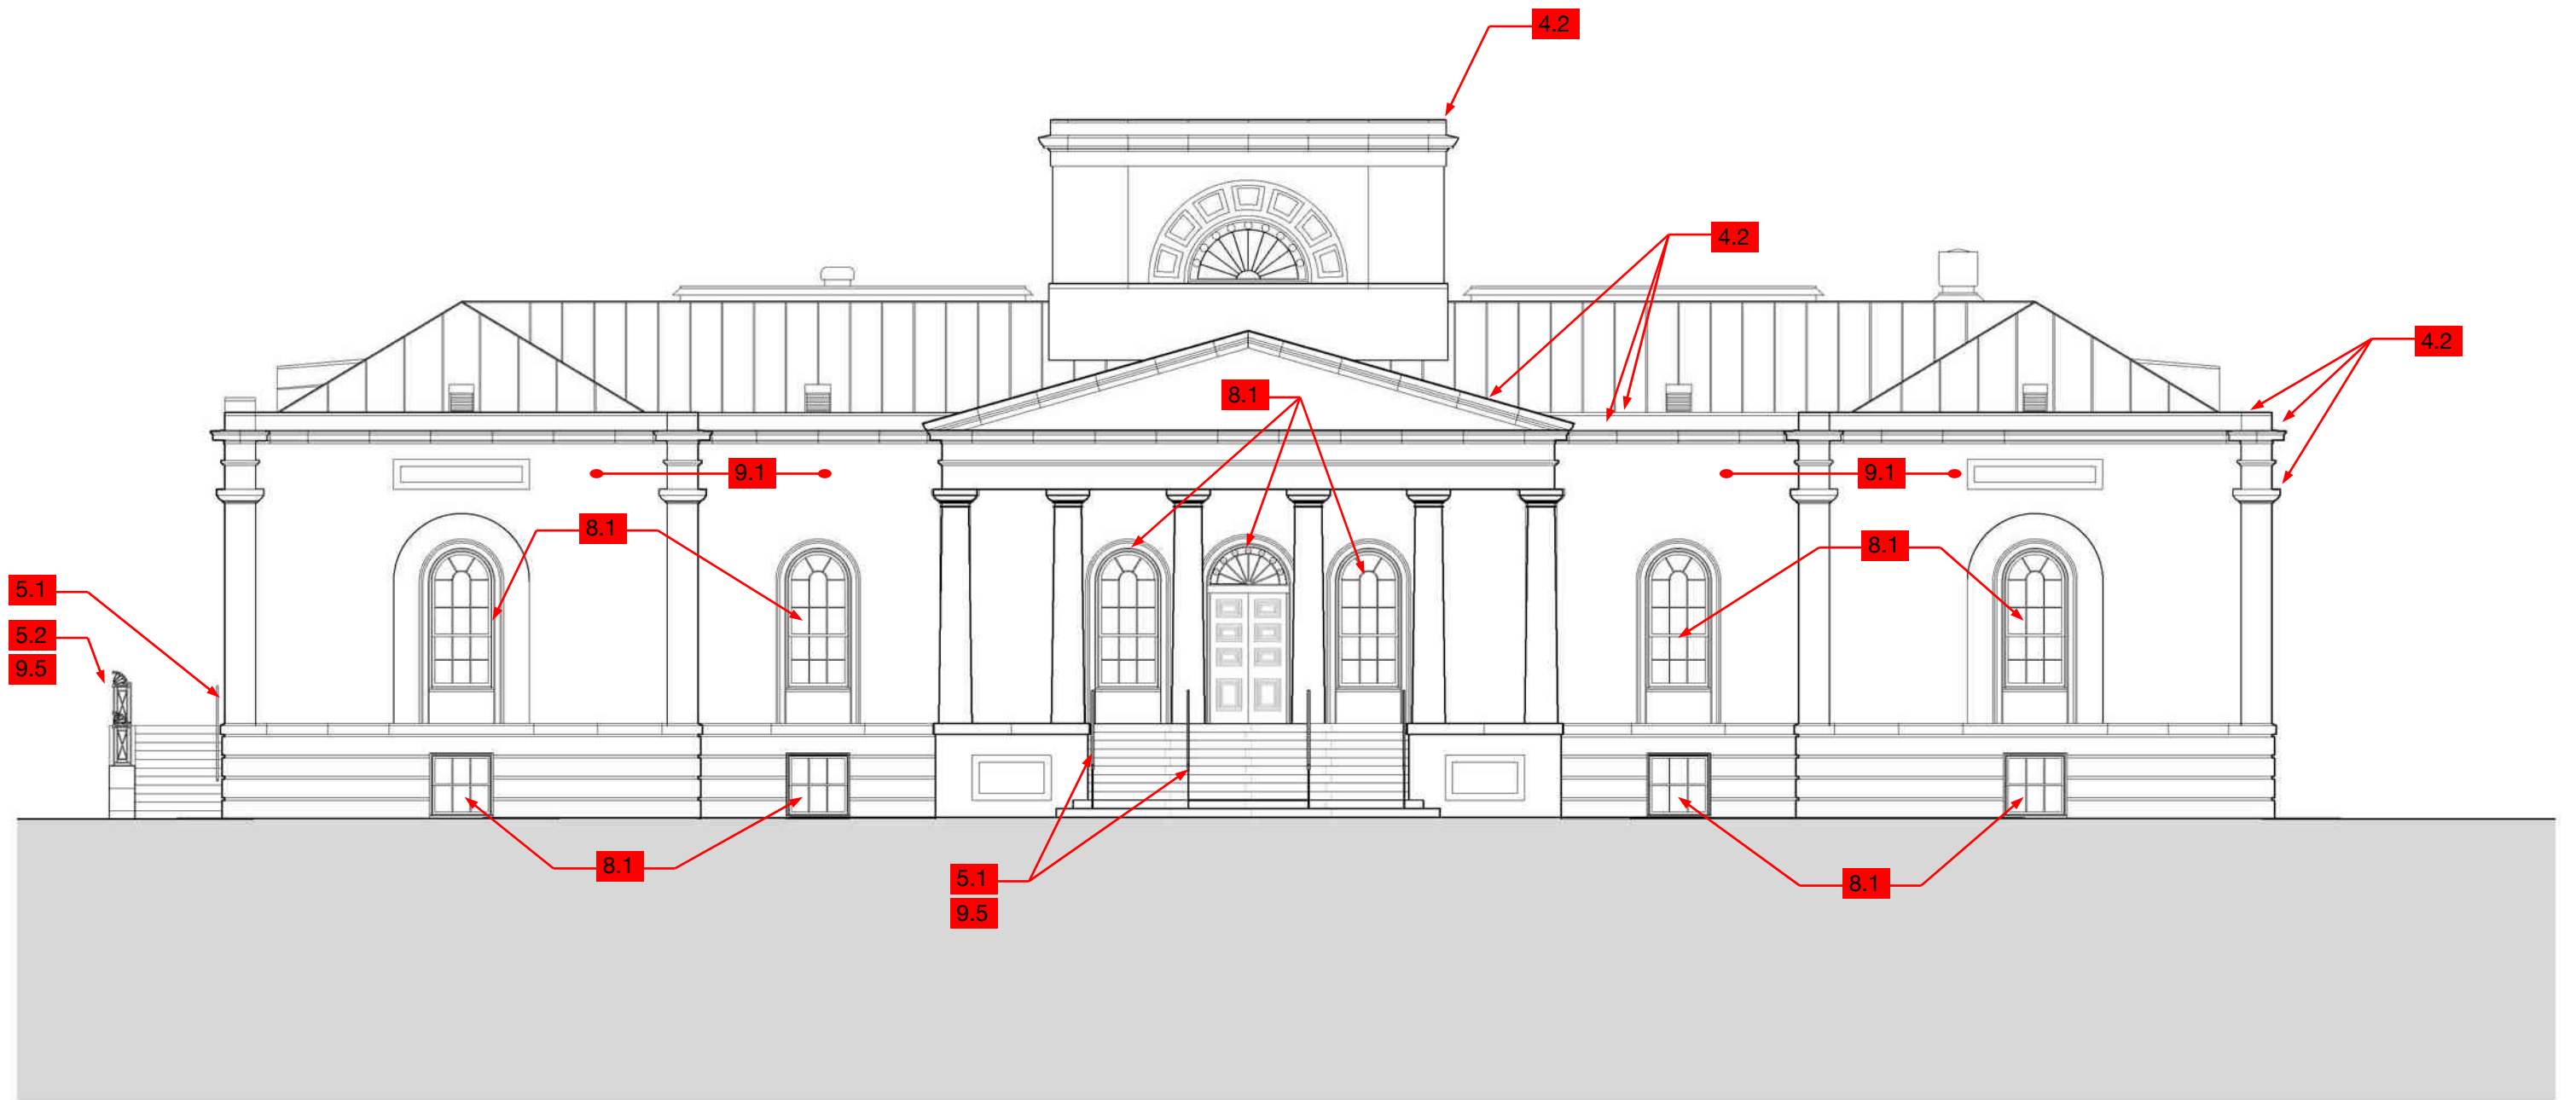
200825: GEORGIA INSTITUTE OF TECHNOLOGY CONDITION ASSESSMENT - ACADEMY OF MEDICINE	TITLE RECOMMENDED TREATMENT - WEST ELEVATION	
		DATE 11.14.2008	SHEET NUMBER 45
