CONDITION ASSESSMENT OF **THE ACADEMY OF MEDICINE** FOR THE GEORGIA INSTITUTE OF TECHNOLOGY

01.07.2009

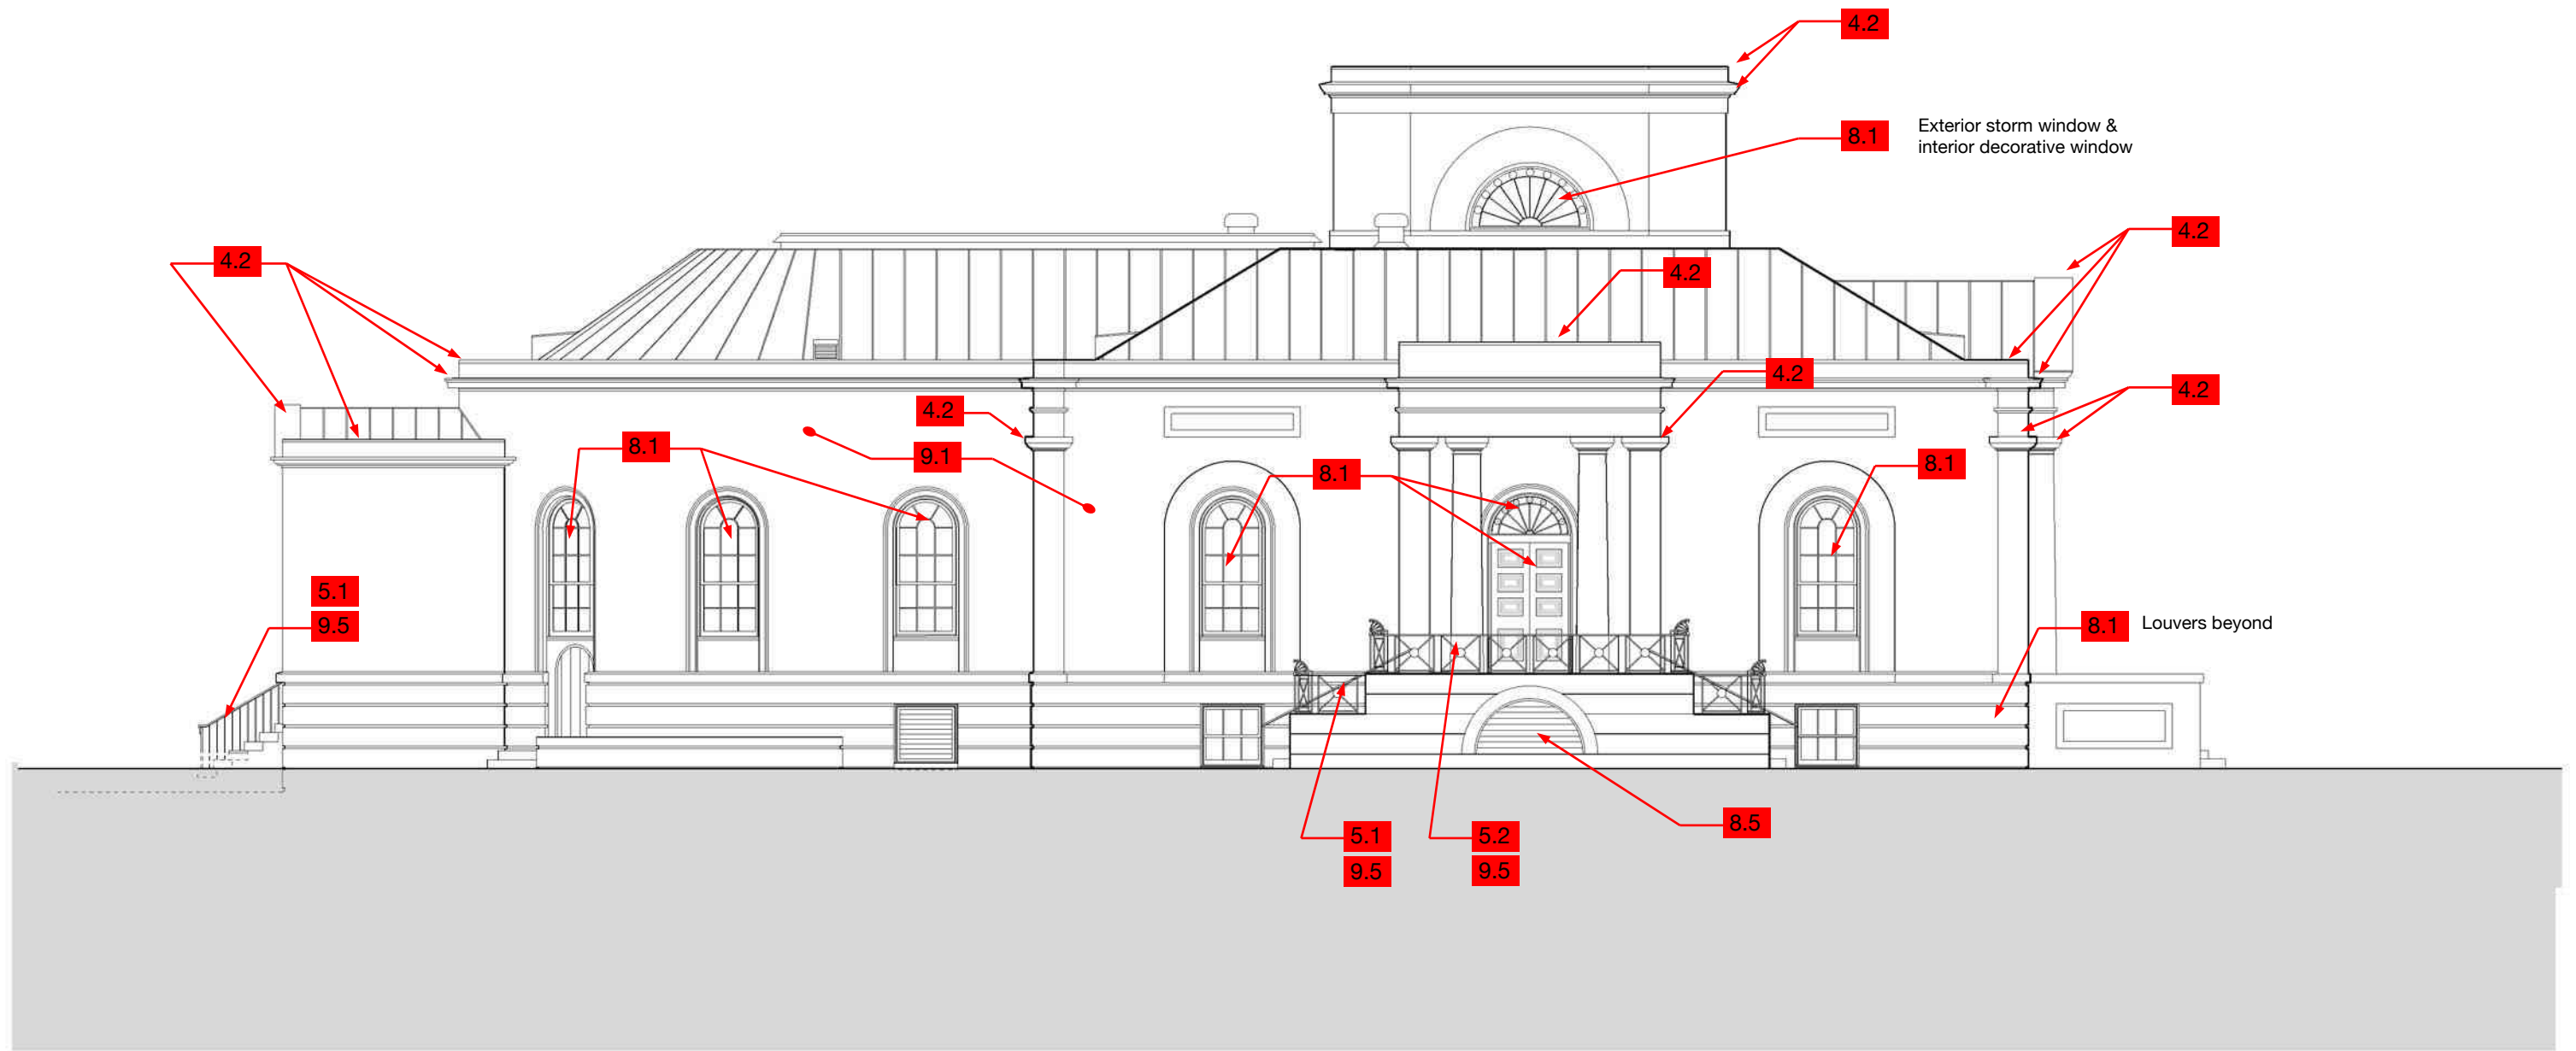
200825: GEORGIA INSTITUTE OF TECHNOLOGY CONDITION ASSESSMENT - ACADEMY OF MEDICINE	TITLE RECOMMENED TREATMENT - NORTH ELEVATION	
		DATE 11.14.2008	SHEET NUMBER 46

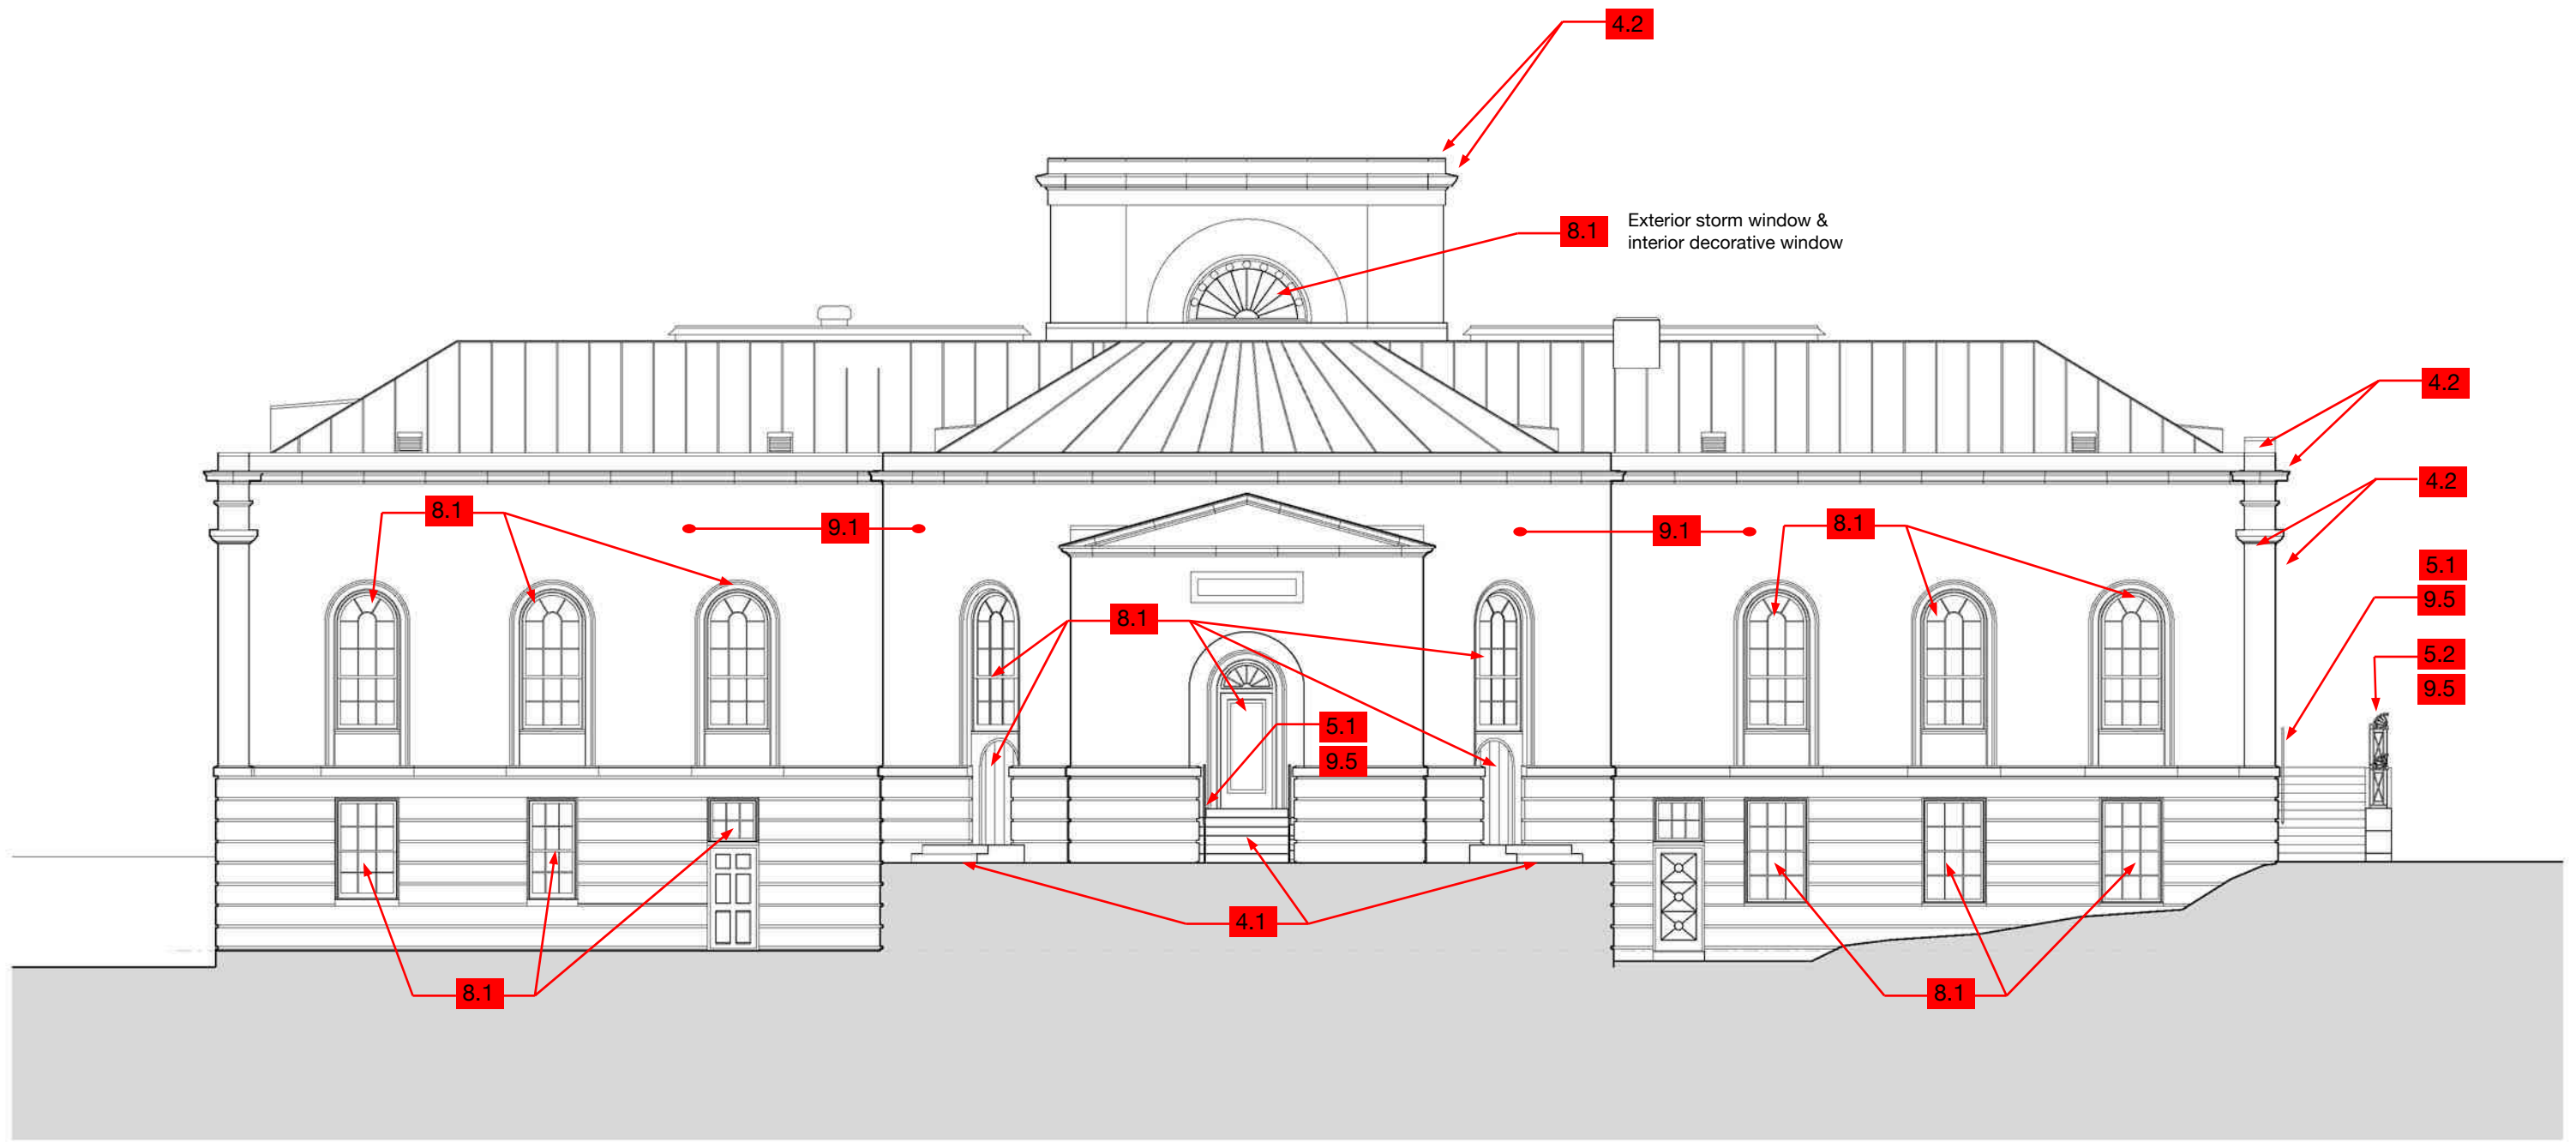
200825: GEORGIA INSTITUTE OF TECHNOLOGY CONDITION ASSESSMENT - ACADEMY OF MEDICINE	TITLE RECOMMENDED TREATMENT - EAST ELEVATION	
		DATE 11.14.2008	SHEET NUMBER 47

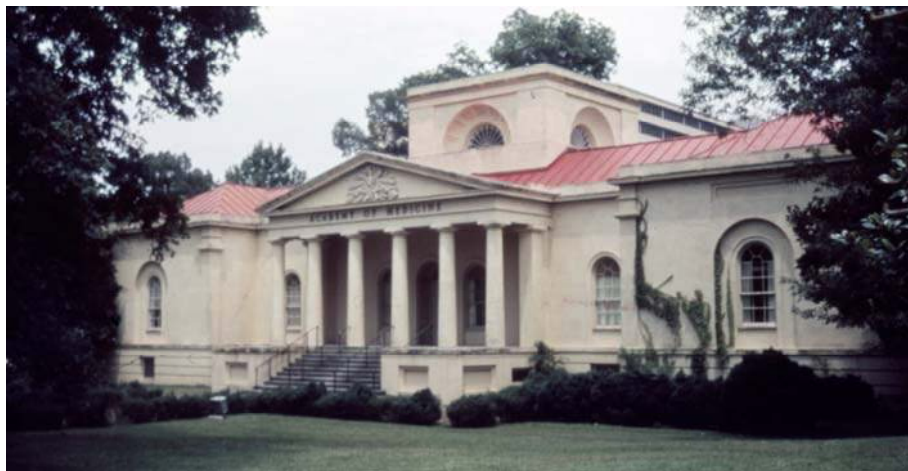
Possible image of original color scheme. (Source of slide: Atlanta History Center, slide taken prior to 1981 renovation)

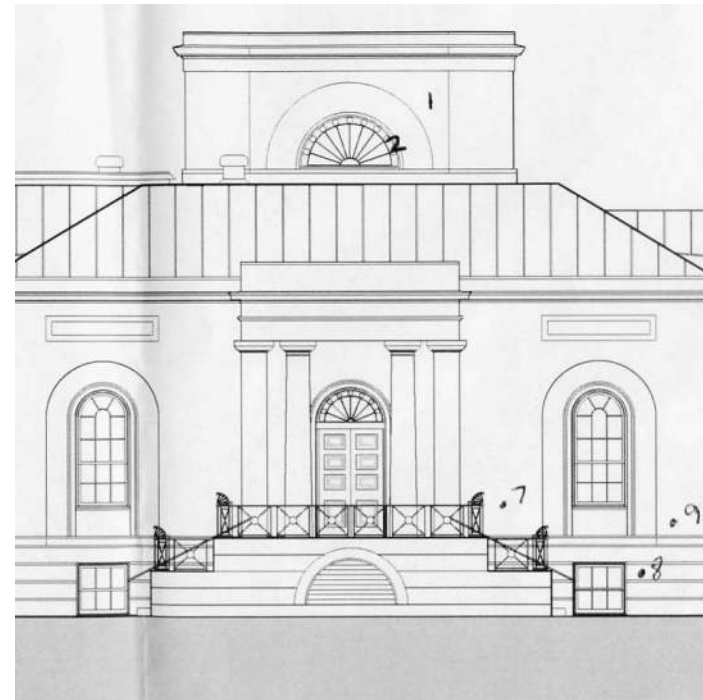
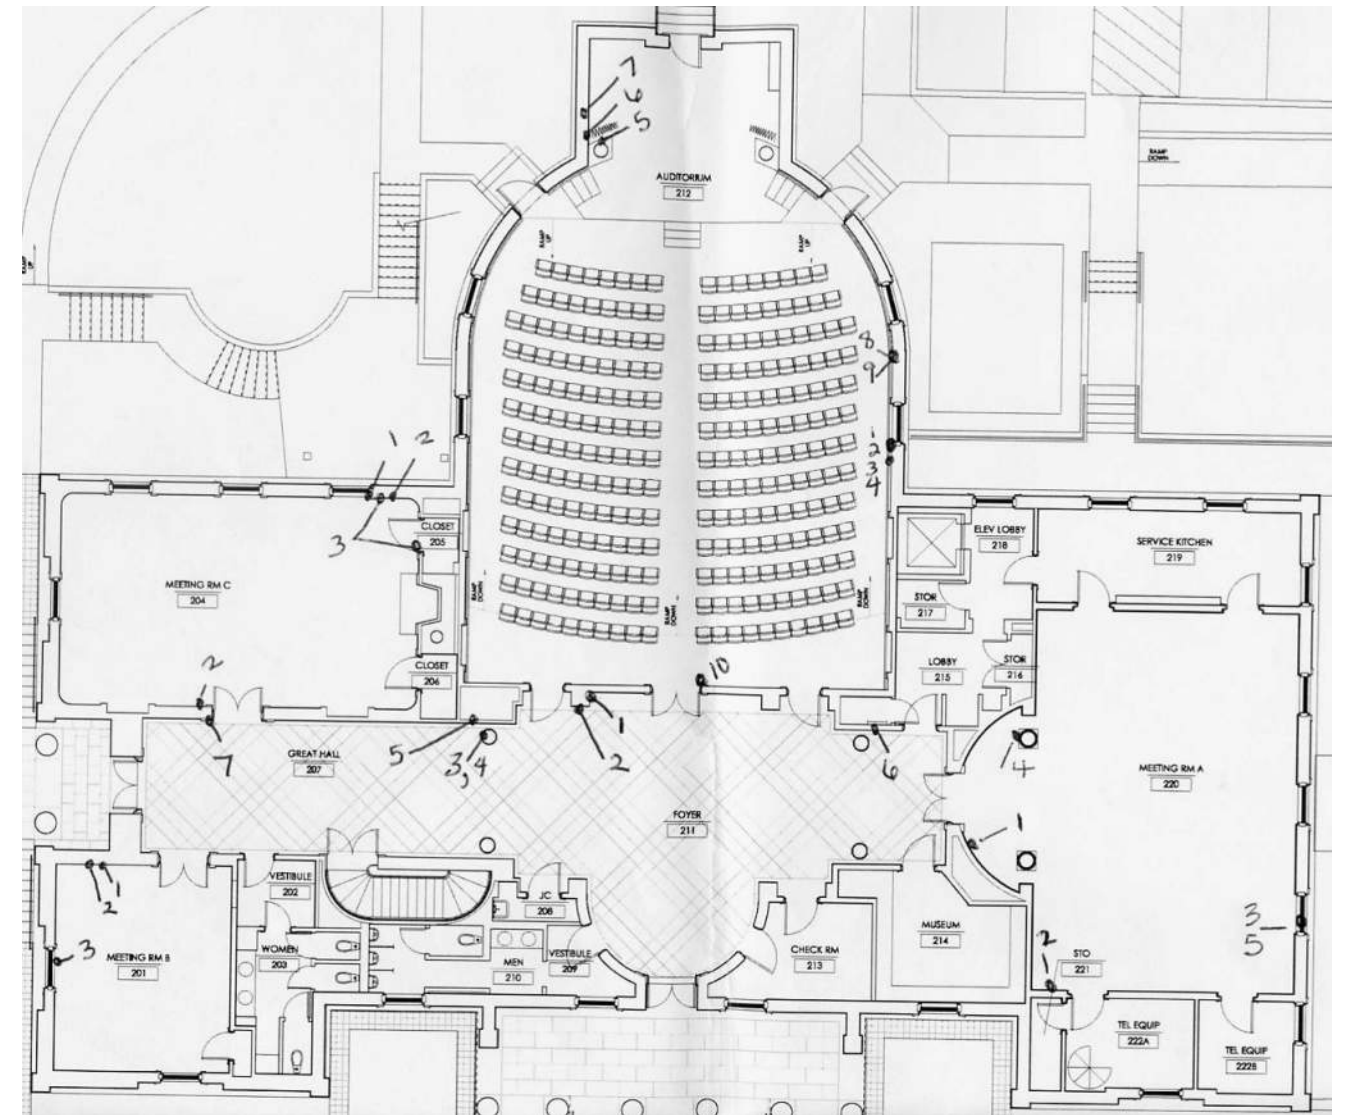
CONDITION ASSESSMENT PHOTO KEYNOTES

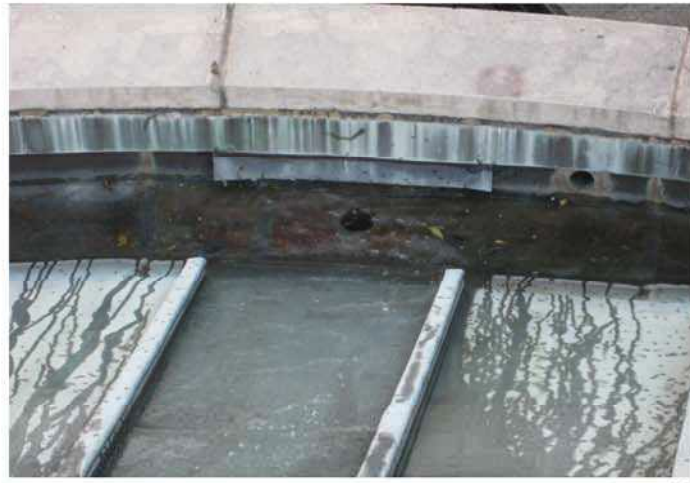
ACADEMY OF MEDICINE - CONDITION ASSESSMENT 875 WEST PEACHTREE STREET NE ATLANTA, GEORGIA 30309	TITLE CONDITION ASSESSMENT PHOTO KEYNOTES	
		DATE 11.21.08	SHEET NUMBER 51

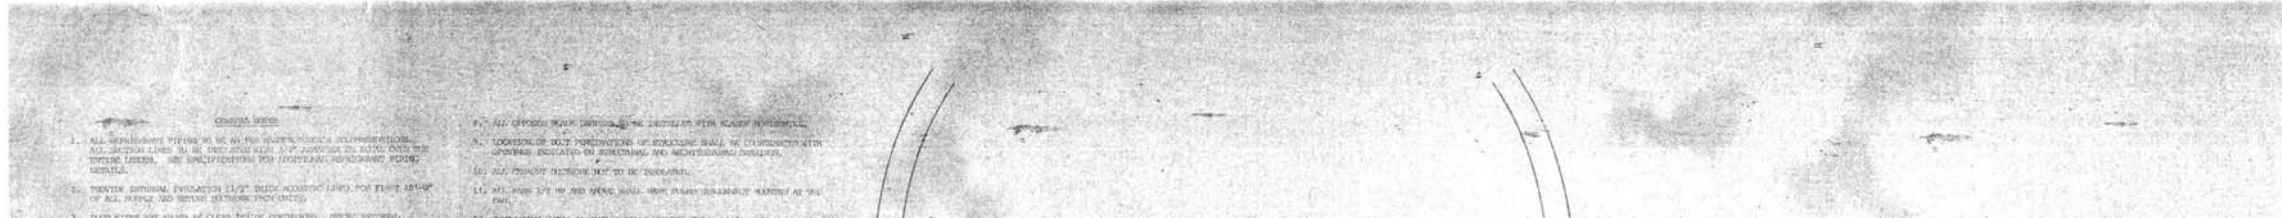
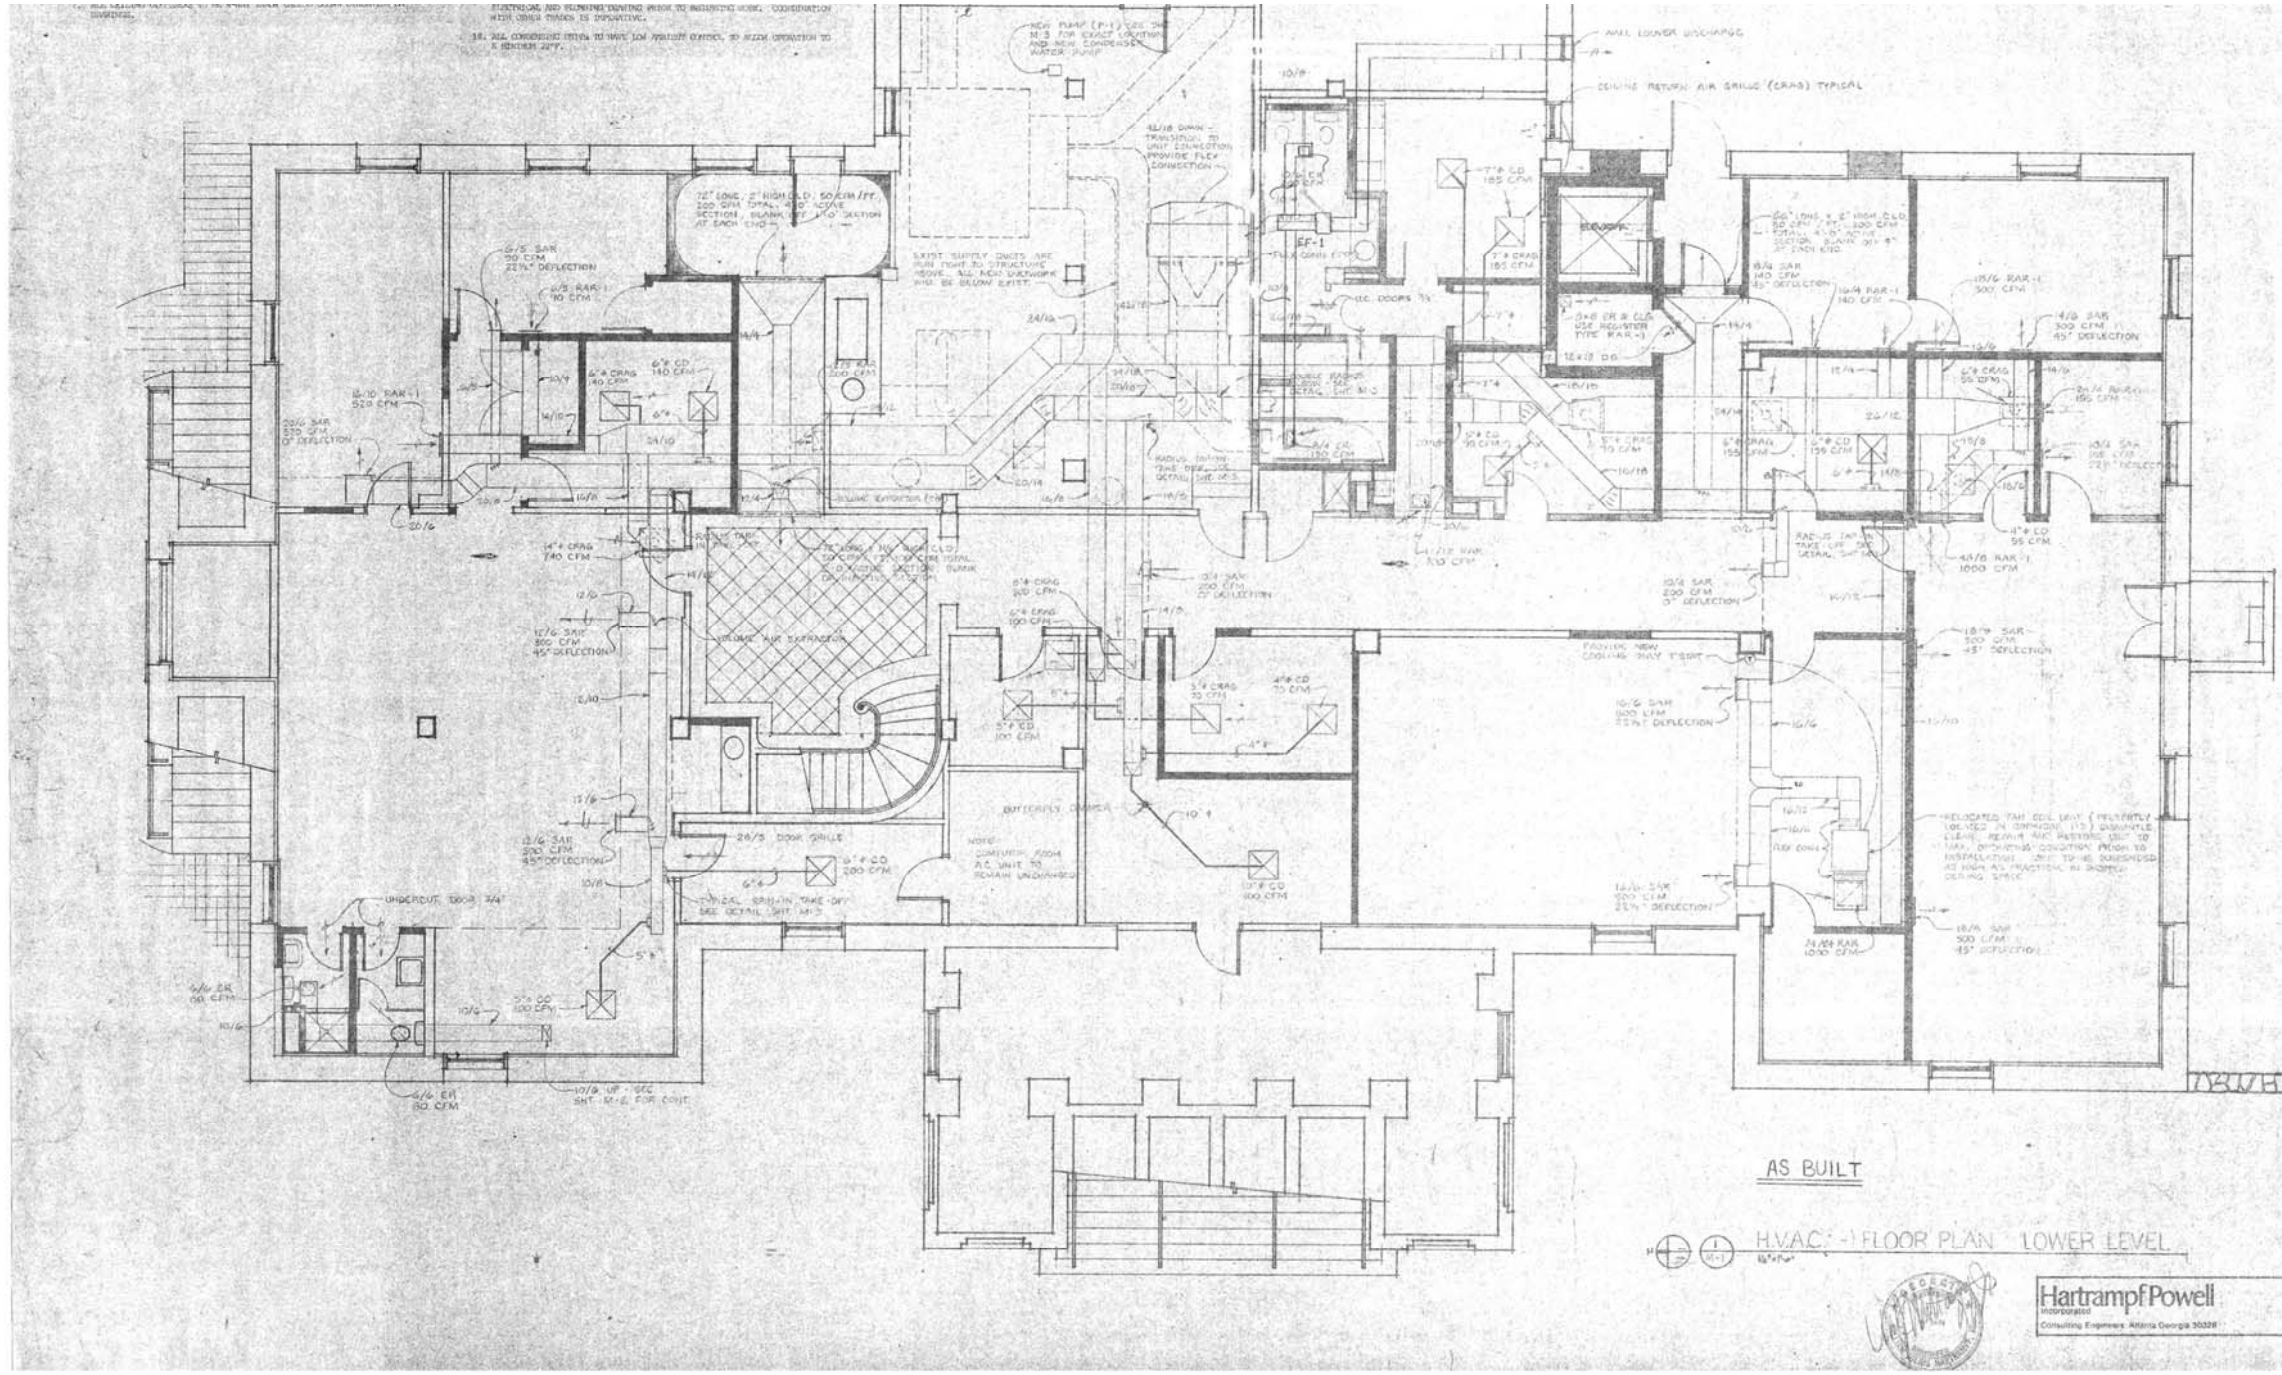
ACADEMY OF MEDICINE - CONDITION ASSESSMENT		TITLE	
		875 WEST PEACHTREE STREET NE ATLANTA, GEORGIA 30309		MECHANICAL LOWER LEVEL PLAN	
		DATE	SHEET NUMBER		
		11.21.08	58

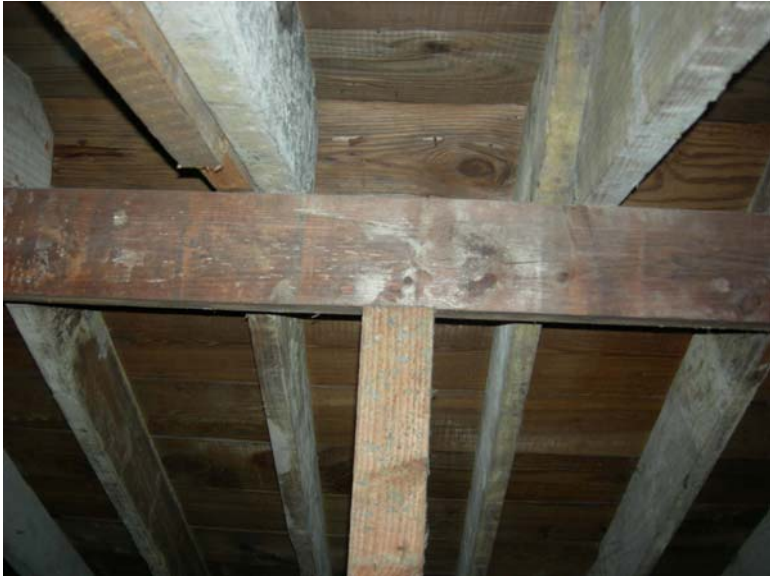
Photograph 01
Wood Beam to Post Connection

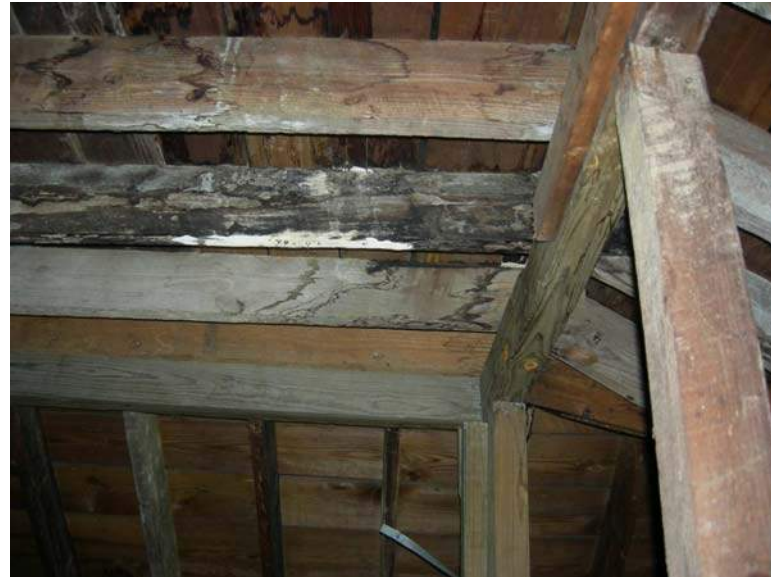
Photograph 04
Water damage at roof rafters

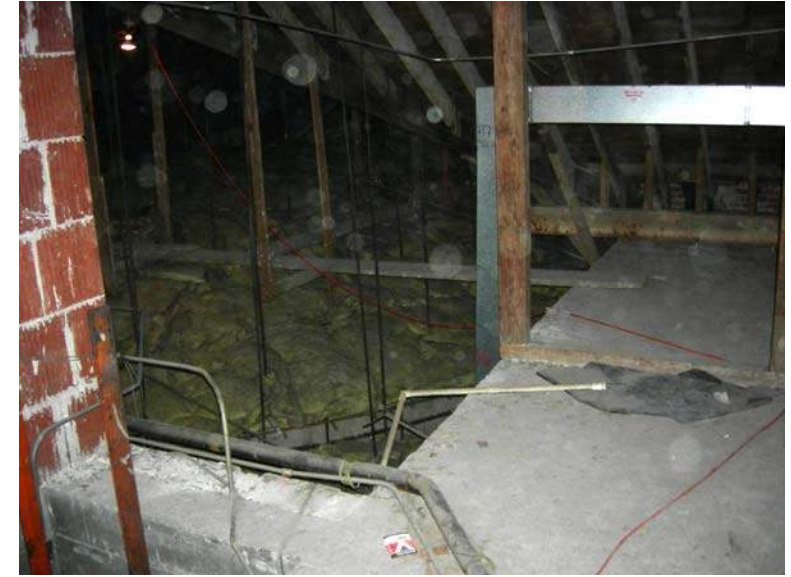
Photograph 06
Slab opening at Ceiling and catwalk

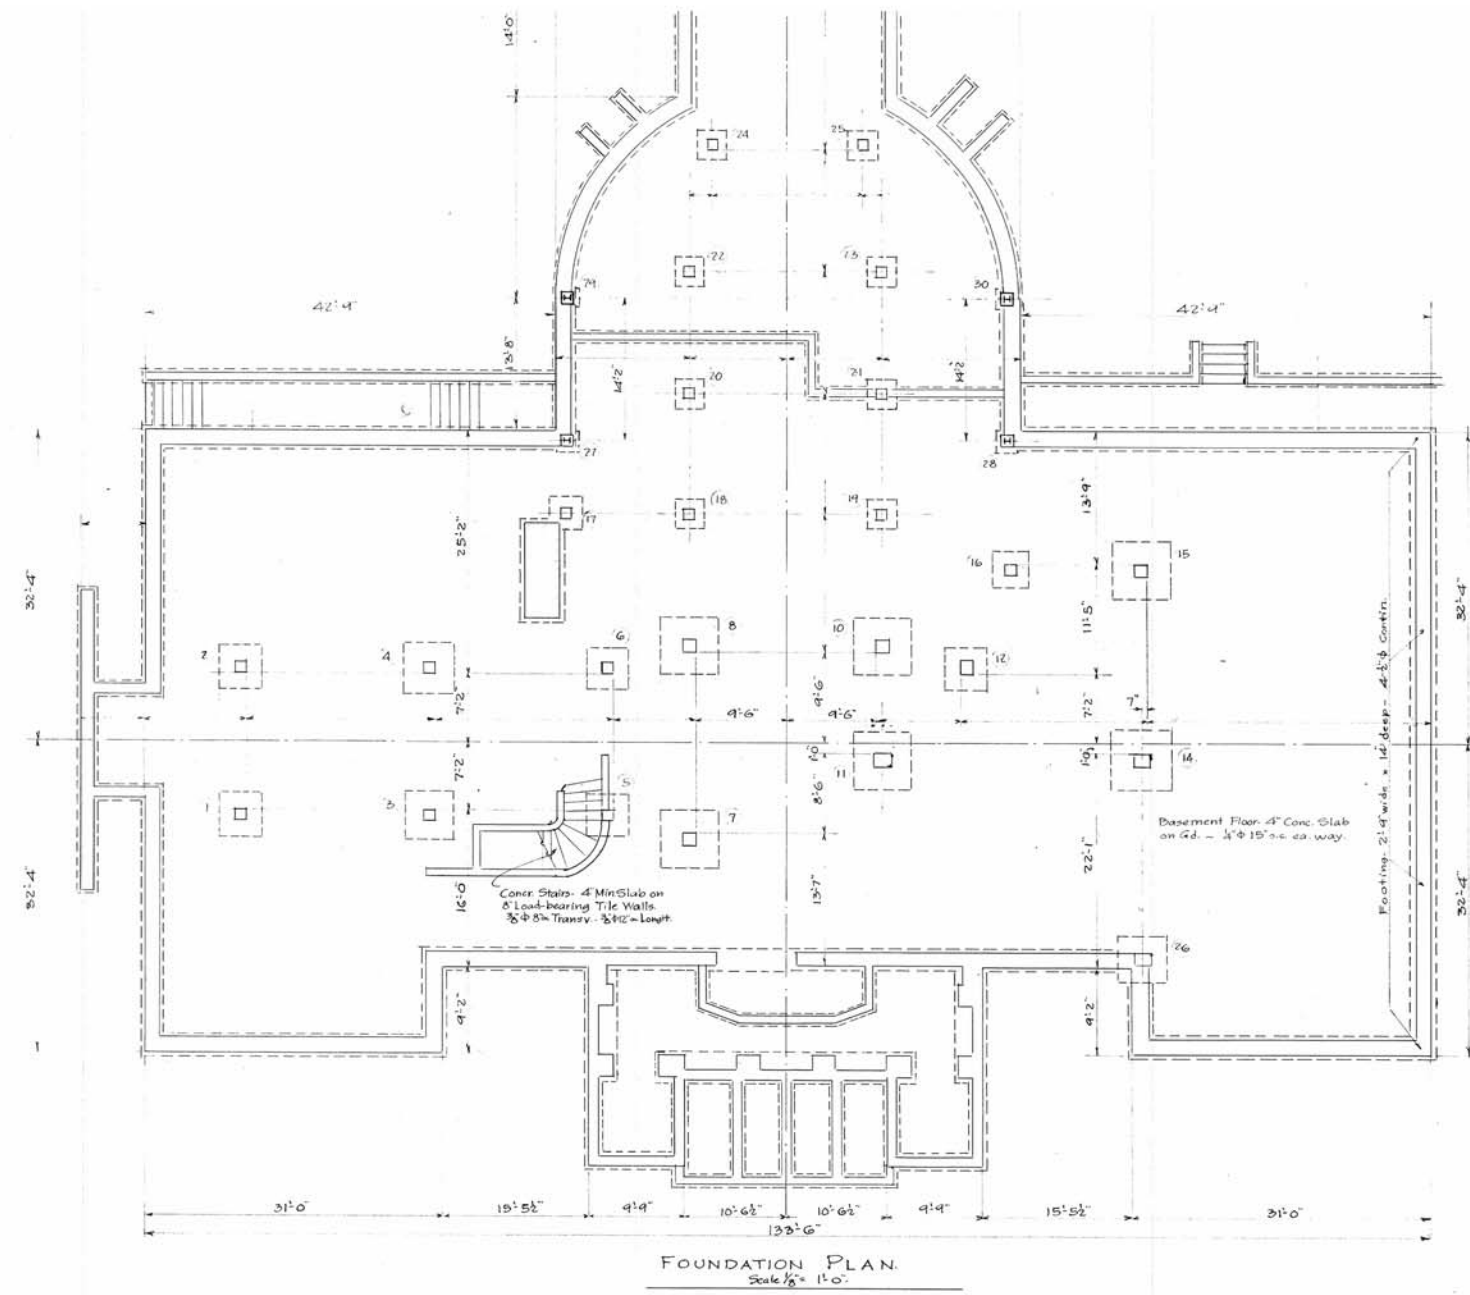
FOUNDATION PLAN.
Scale 1/8" = 1'-0"

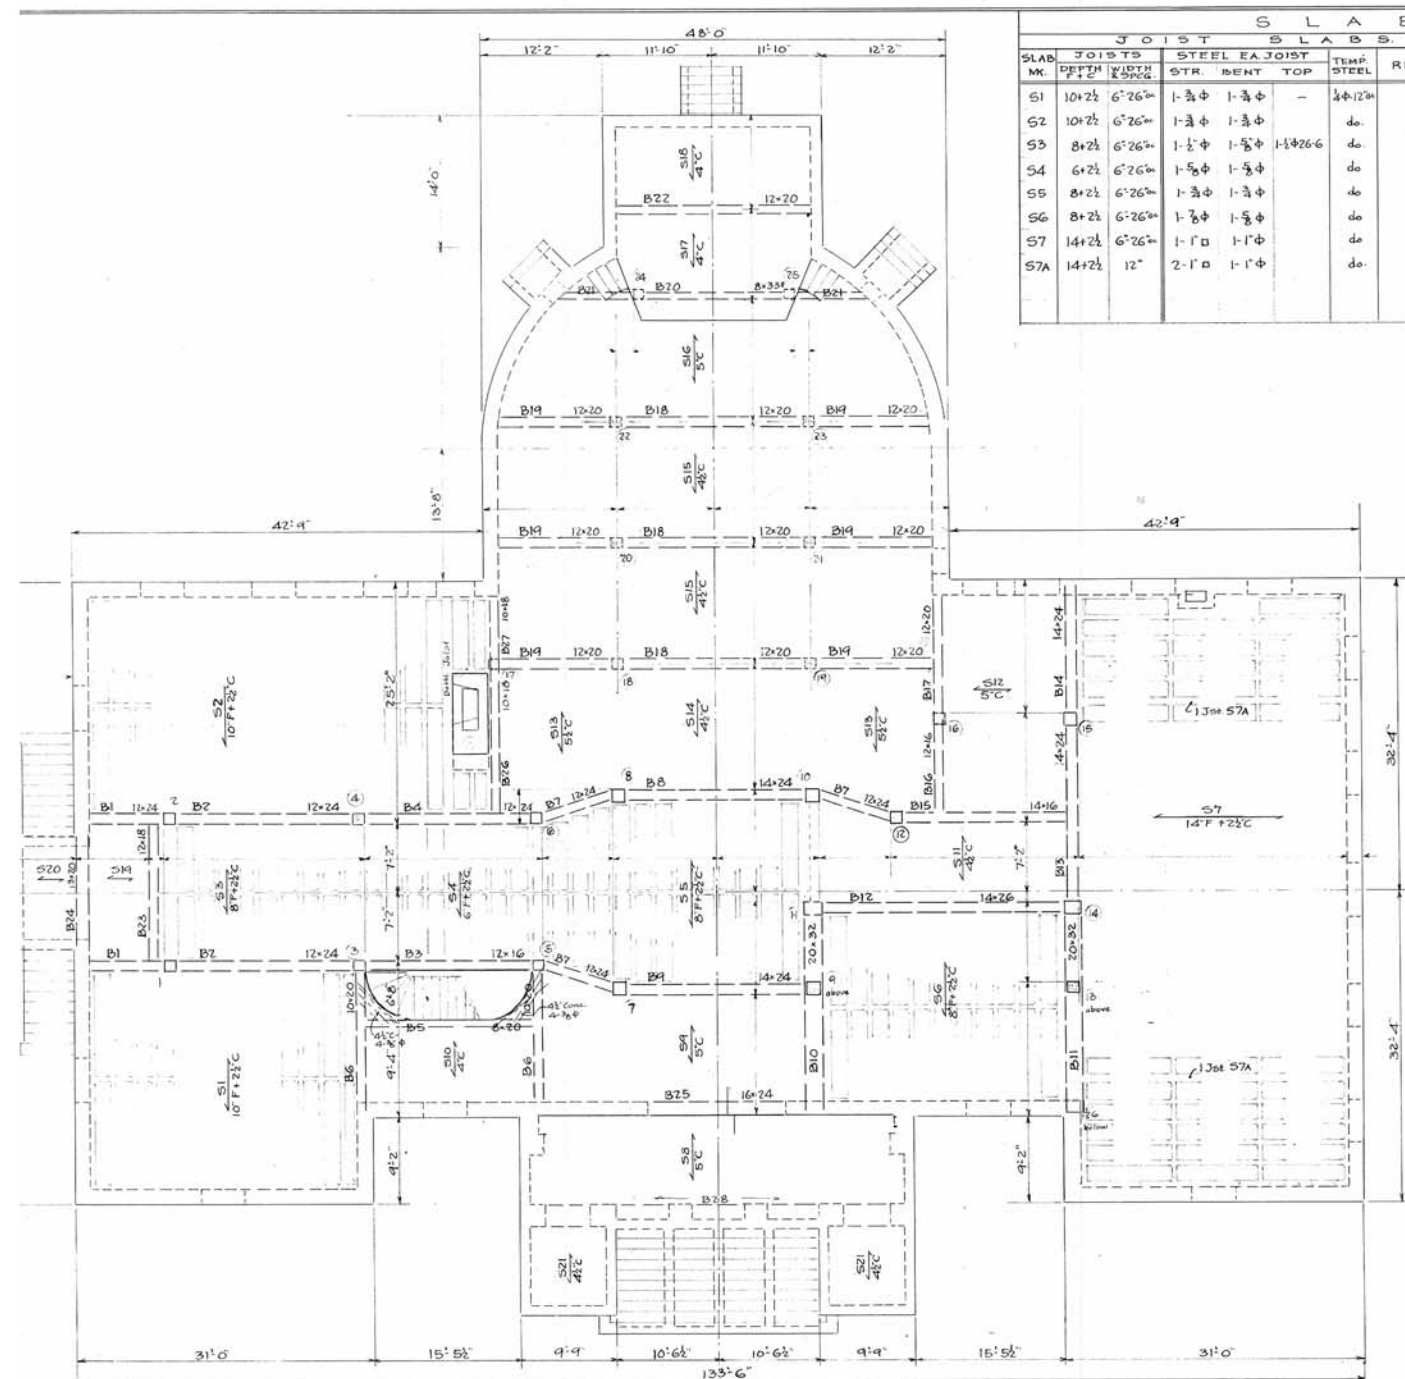
FIRST FLOOR FRAMING PLAN.
Scale 1/8" = 1'-0"

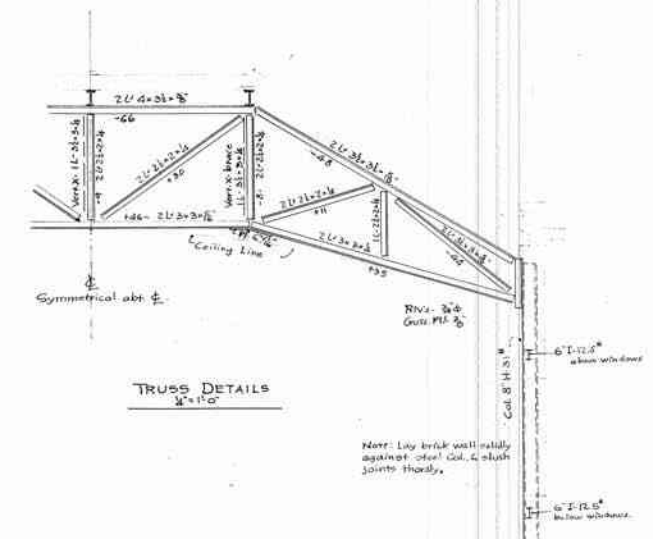
CEILING & ROOF FRAMING PLAN
Scale 1/8" = 1'-0"
